SERVICE PROCEDURE

G-07501-R2
AUGUST 2007

**SUBJECT: SAFETY RECALL (U.S., EXPORT)
BATTERY CABLES on certain 9000 Models built
4/1/2002 thru 12/25/2006 with Caterpillar® Engines**

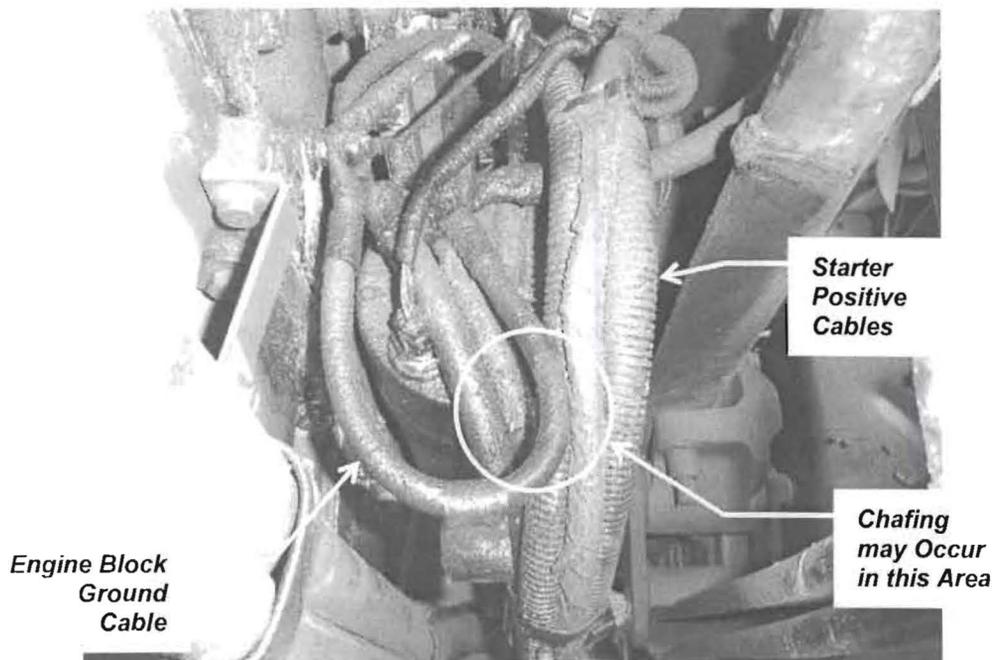
Figure 29 --

TO PREVENT CHAFING OF THE POSITIVE CABLES AGAINST THE ENGINE BLOCK GROUND CABLE (SEE FIGURE 29), PLEASE ENSURE ENGINE BLOCK GROUND CABLE IS CLOCKED IN THE DOWNWARD (6 O'CLOCK) POSITION, SEE FIGURE 30.

Chafing may occur between Engine Block Ground and Newly Located Positive cables.

- ***If contact or chafing of the ENGINE GROUND cable against the Battery Cables is present, rotate and tighten the ground cable on the starter terminal so it is straight down (6 o'clock position) and not contacting the starter positive cables, see figure 30.***

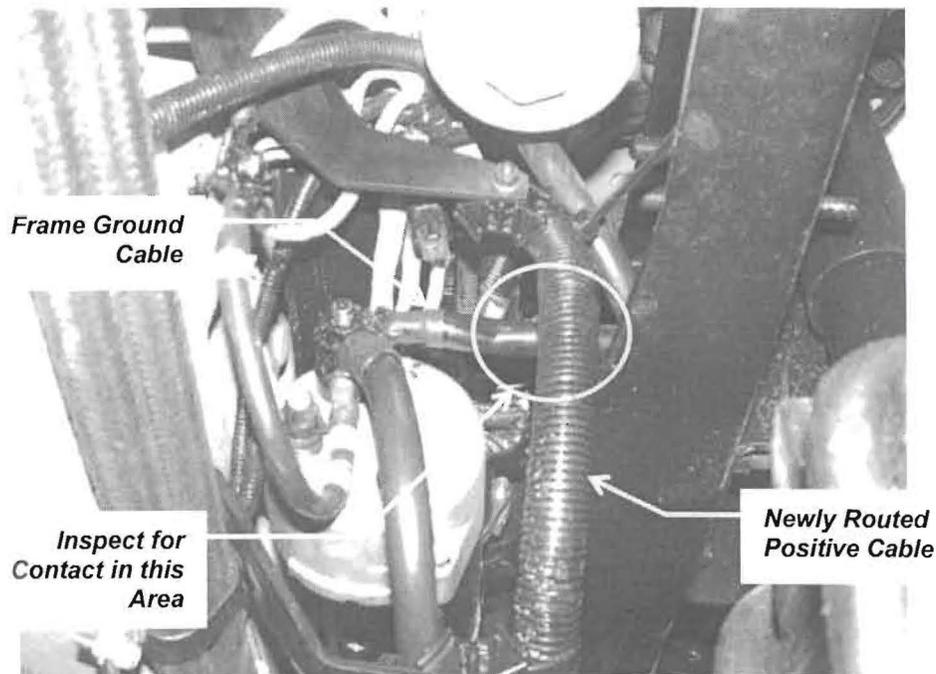
Figure 31 – FRAME Ground Inspection

TO PREVENT CHAFING OF THE POSITIVE CABLES AGAINST THE FRAME GROUND CABLE (SEE FIGURE 31), PLEASE ENSURE FRAME GROUND CABLE IS NOT IN CONTACT WITH THE NEWLY ROUTED POSITIVE CABLES, SEE FIGURE 32.

- Ensure cables are not in contact.
