Service Bulletin SBA0268

SUBJECT:
Workhorse Safety
Campaign
60601-C:
8.1 L Engine Fuel
Rail Pulse Damper
Retainer Clip
Replacement

BULLETIN NO: 60601-C

SUBJECT: 8.1 L Engine Fuel Rail Damper Retainer Clip

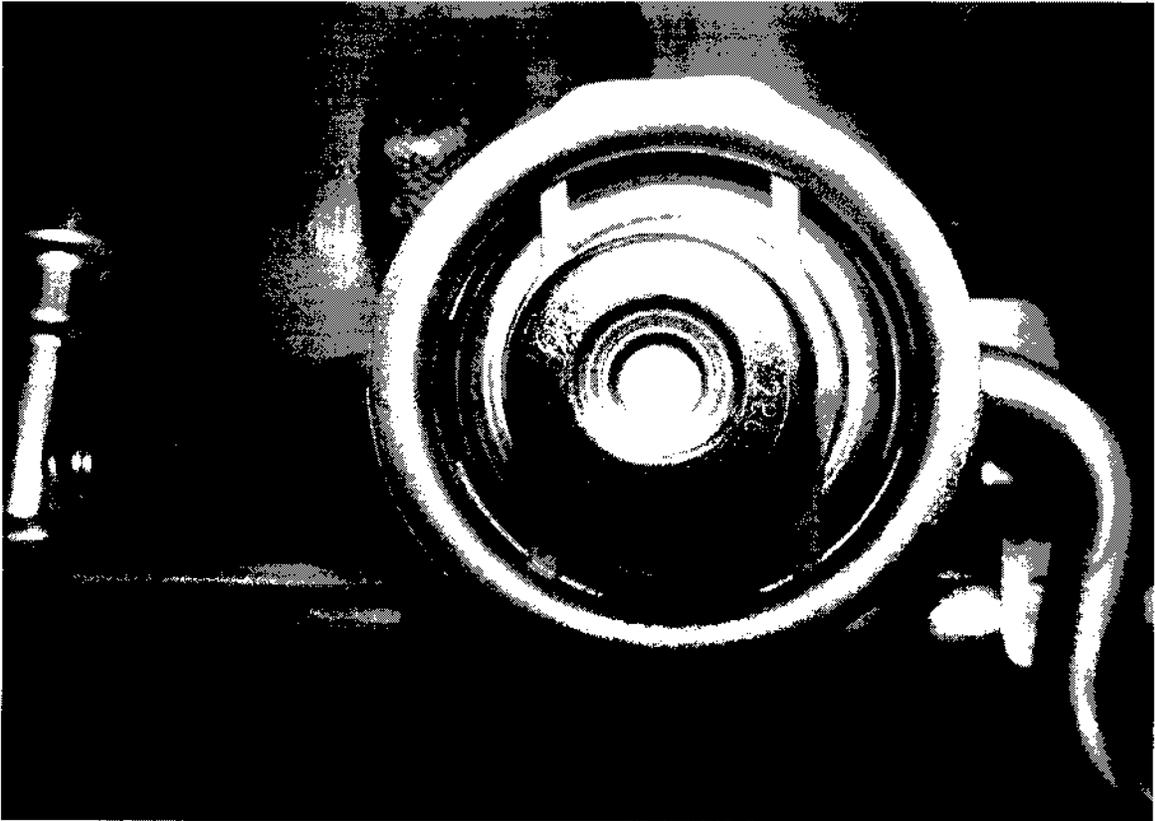
The defect involves the possible installation of an improperly heat treated fuel rail damper retainer clip. An improperly heat treated clip may break resulting in a gasoline fuel leak at the fuel rail damper. A vehicle fire can result if the leaking fuel is ignited by a spark, or flame.

Photo 2 and 3 retaining clip and damper held by the clip

6. Push down on the fuel damper while using a flat screw driver to remove the existing clip. (See photos 2 and 3)
7. Do not remove the fuel damper from the fuel rail. If the damper is removed the fuel damper o-ring must be replaced at the technician's/dealer's expense.

8. While holding down the damper, install the new clip in same position as removed clip.
9. Reconnect the negative battery cable.
10. Tighten the fuel filler cap.
