EA-02-034

## **INTERIM REPORT -- VRTC-DCD2037 (EA02-034)**

### **Tests of the Bosch Brakes (ZOPS) on a 2001 Monaco Holiday Rambler Ambassador Motorhome**

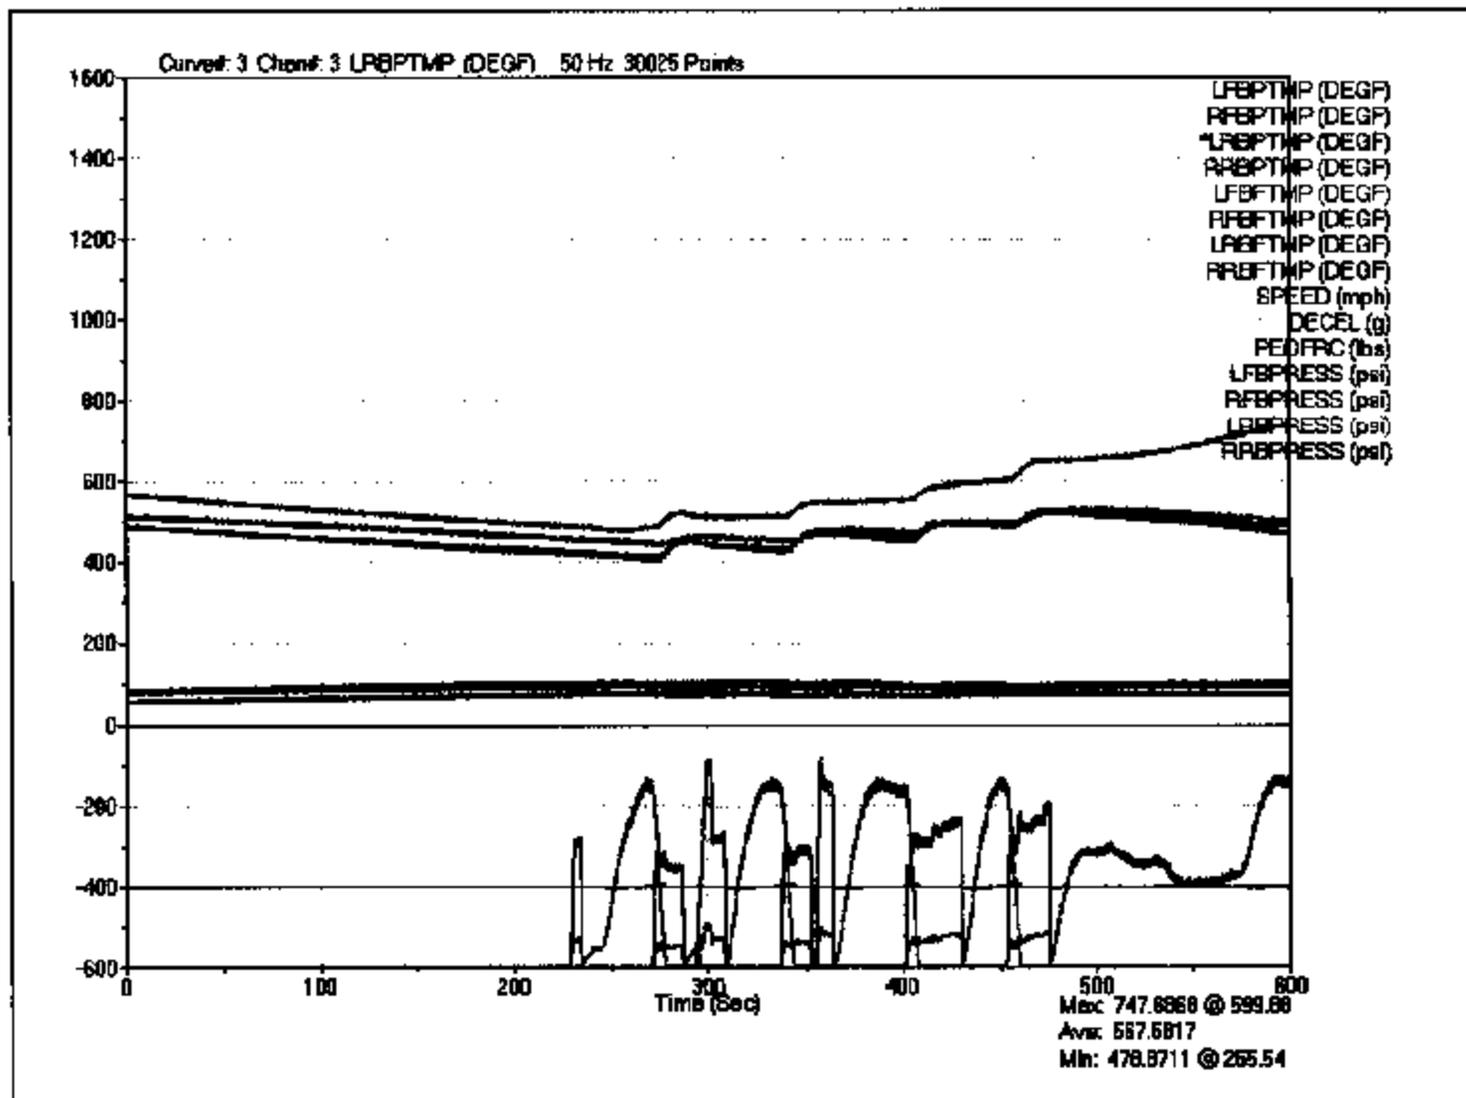
**Figure 20 – Data for First Test on MH1 Showing the End of the 5-Minute Break (for the Video Equipment), the Next Four Brake Applications, and the Beginning of the Abnormal Rise in the Left Rear Brake Lining Temperature**

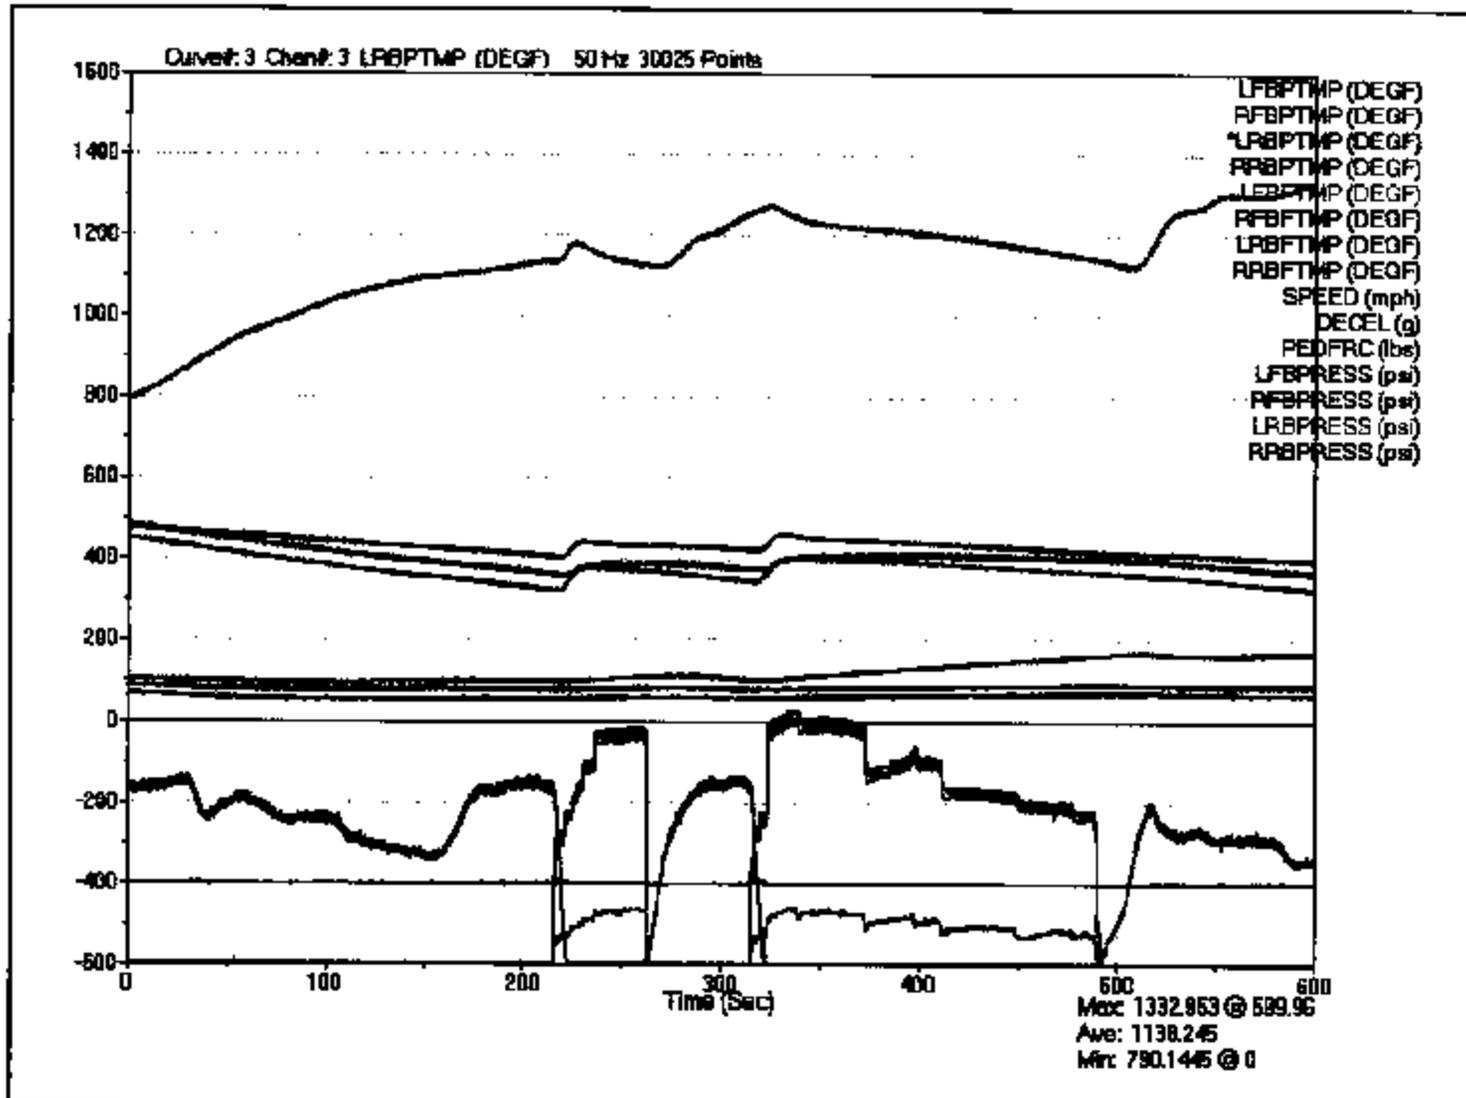
Figure 21 - Data for First Test on MH1 Showing the Abnormal Thermal Rise Continuing

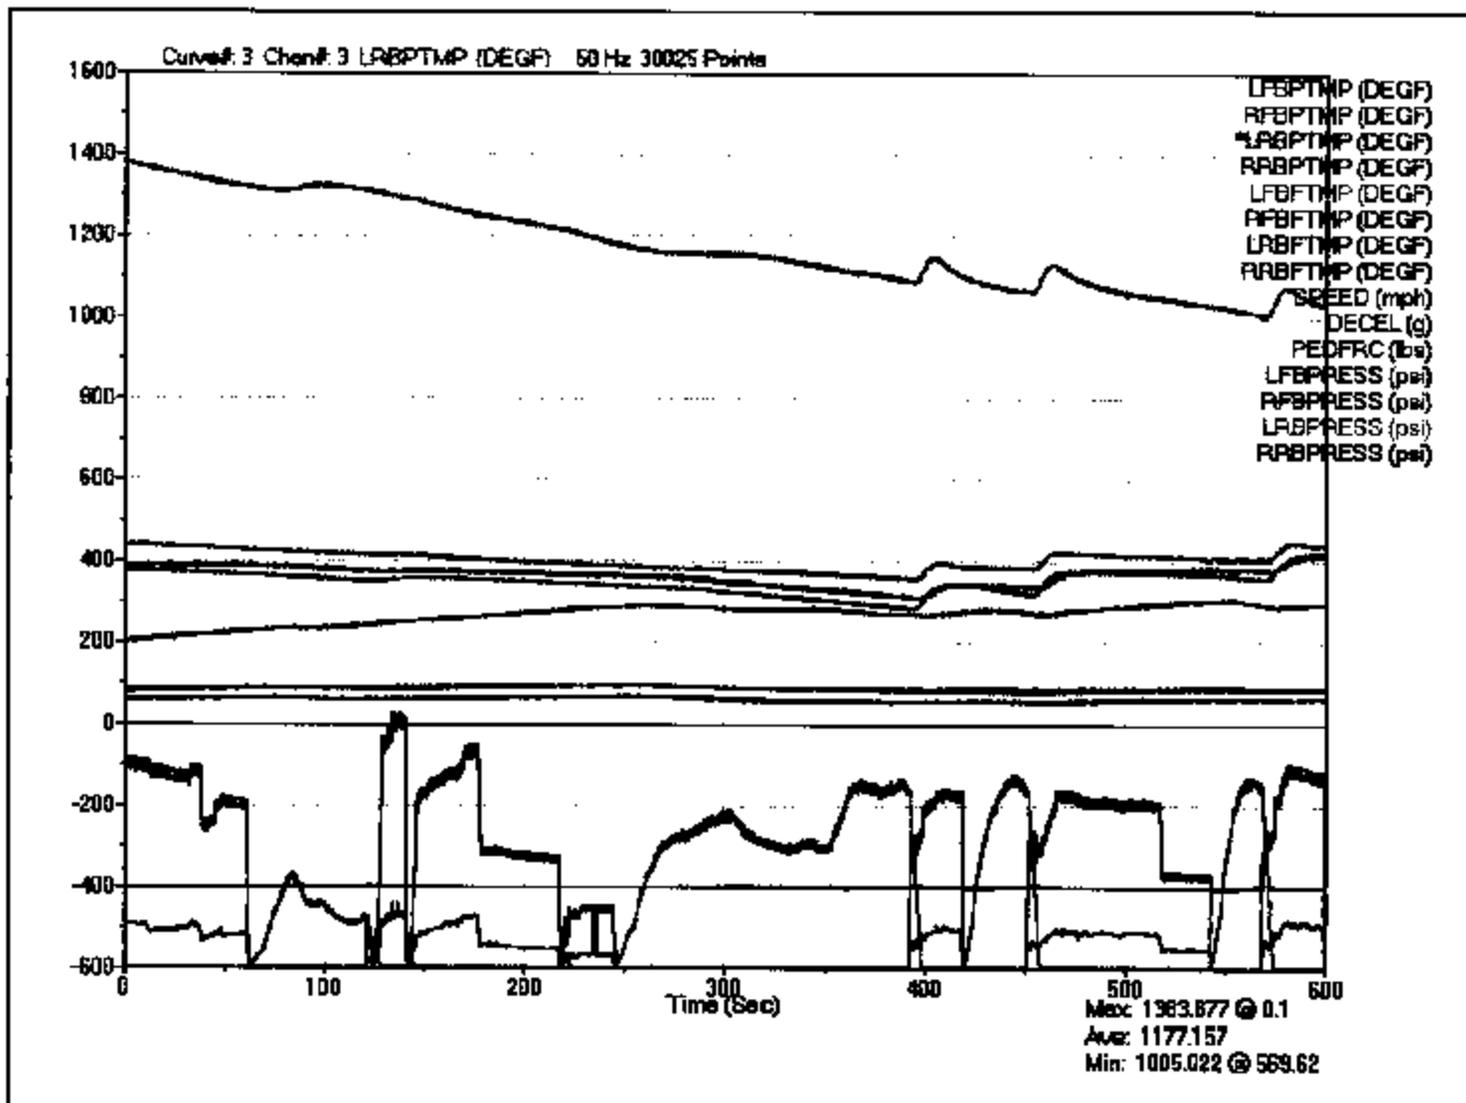
**Figure 22 - Data for First Test on MH1 Showing a Decline in the Abnormal Temperature on the Left Rear Lining**  
 (Notice more braking does not restart the abnormal thermal event)

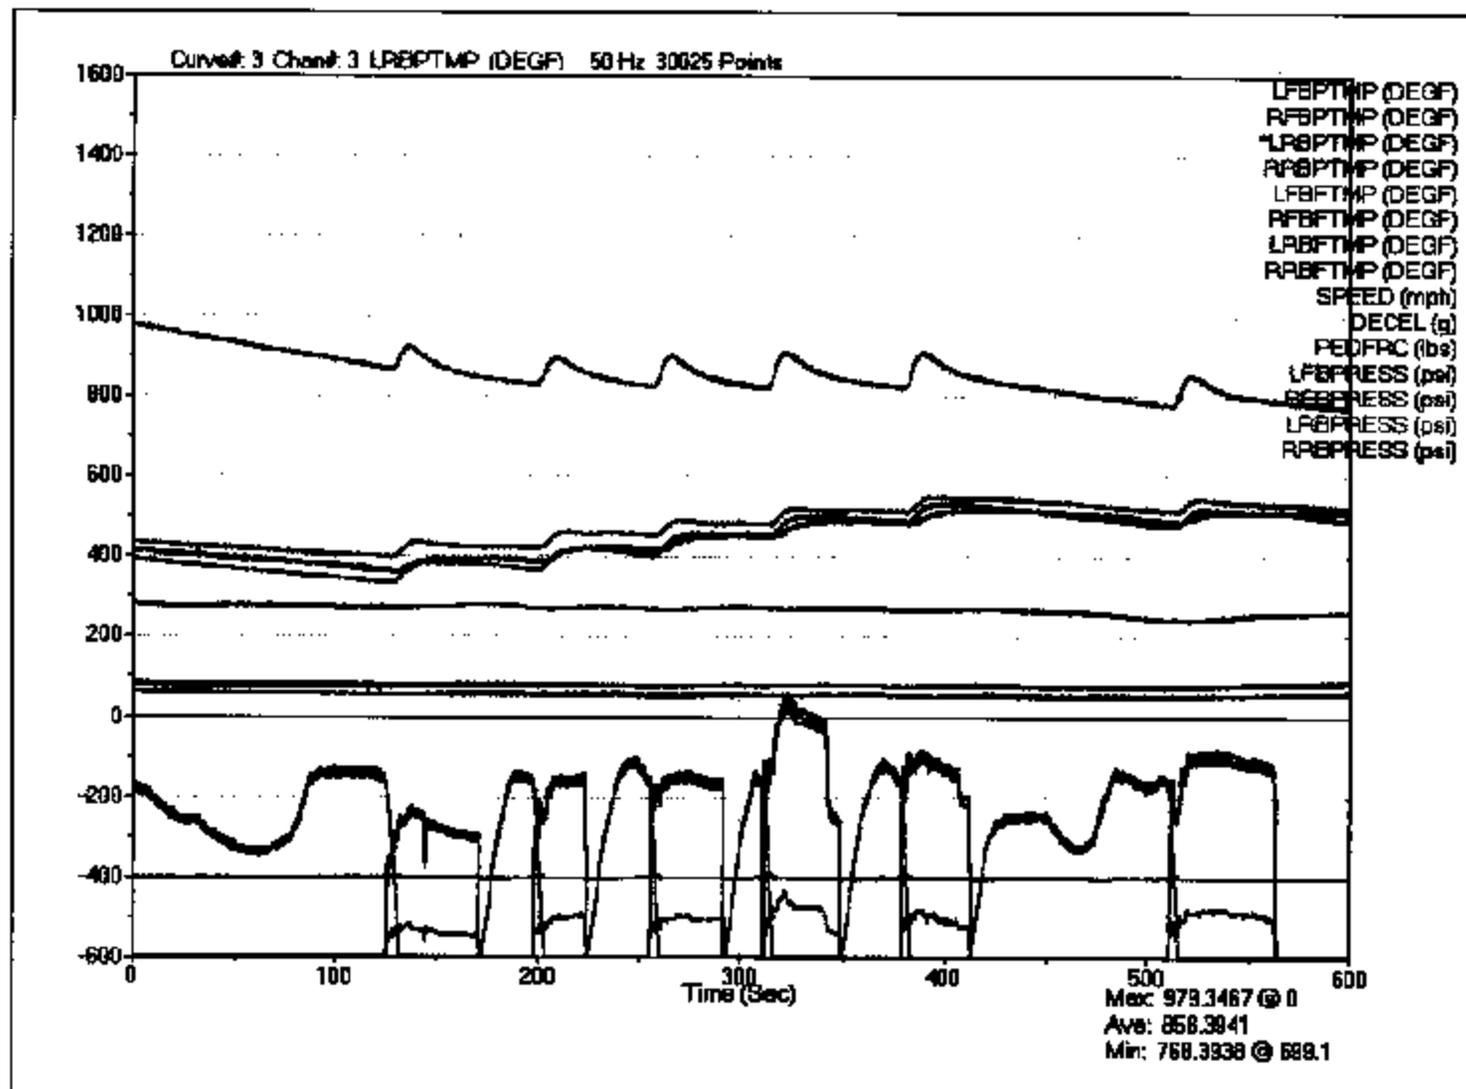
**Figure 23 –Data for First Test on MH1 Showing the Temperature of the Left Rear Lining Declining as Additional Braking Does Not Restart the Event (Notice the left rear brake fluid temperature rising to 306°F)**
