WORLD TRANS, INC.

World Trans has been notified by Capacity of Texas, who was notified by Dana Corporation that they are conducting a recall NHTS 99E-005 on front axles assemblies produced between May 1, 1996 and October 31, 1997. (see attached notice)

Subject: Notice of Defective Tie Rod Assemblies-NHTSA Recall 99E-005

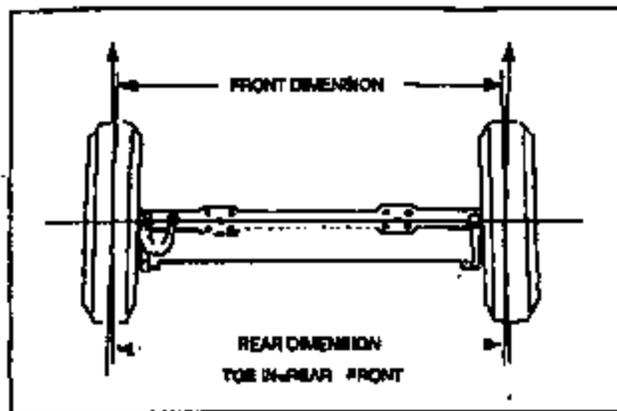
Figure 1.

To obtain accurate reading, two mechanics are required to insure that the pointers are always placed or adjusted to be exactly in front of the line scribed on both tires. Toe-in is the amount in fractions of an inch that the front wheels are closer together at the front than at the back (Figure 1).
