Subject: Information Report, NHTSA No. 99V-033.003

Recall Bulletin

September 1999
FL233AB U.S.
FC233AB Canada

Subject: FCCC Tie Rod Assemblies

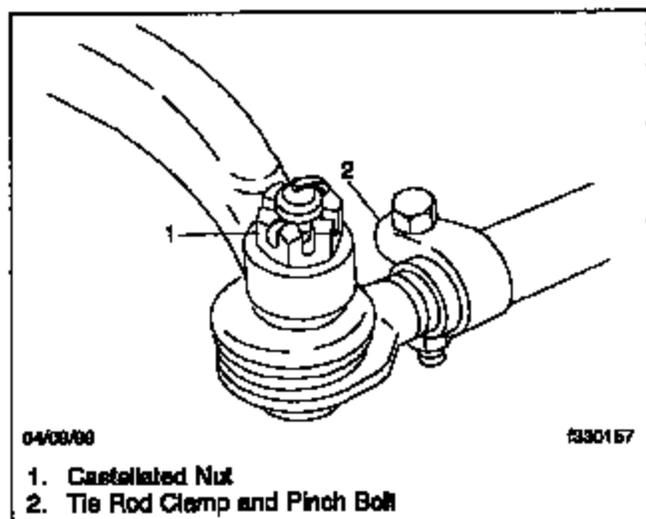
Fig. 1, Tie Rod End

In the affected assemblies the tie rod end can pull outboard and separate from the tie rod tube. This condition may occur as a result of improper thread engagement between the tie rod threads and the tie rod tube threads. Improper thread engagement and the possibility of insufficient clamp load on the tube clamp present a possible risk to motor vehicle safety. Separation of the tie rod tube could result in loss of steering control. This could, without prior warning, result in a possible vehicle crash.

1. Park the vehicle, set the parking brake, then chock the rear tires.
2. Remove the tie rod from the vehicle.
 - 2.1 Remove the cotter pin and the castellated nut from the tie-rod ball stud. See Fig. 1.
 - 2.2 Remove the tie-rod end from the tie-rod arm.
 - 2.3 Repeat the procedure at the other end of the tie rod. Then, remove the tie rod from the vehicle.
3. Install the new tie rod onto the tie rod arms.
4. At one end of the tie rod, install the castellated nut and tighten 80 lbf-ft (108 N-m). Install a new cotter pin through the ball stud and the slot in the castellated nut. If the cotter pin cannot be installed, tighten the nut so the next slot in it lines up with the hole in the ball stud. *Do not back off the nut.*
5. Repeat the procedure at the other end of the tie rod.
6. Go to "Toe-in Checking."

1. Loosen the tie-rod clamp pinch bolts. See Fig. 1.
2. Set the pointer on the scale end of the trammel bar to read 1/16-inch (1.6 mm) toe-in. Lock the pointer in place.
3. Position the trammel bar at the front of the tires. Make sure the pointer at the opposite end (without the scale) of the bar is centered on the scribed line of the tire.
4. Adjust the length of the tie rod by turning the tie-rod tube. Adjust the tie-rod length so the pointer on the scale end of the trammel bar is centered on the scribe line of the tire.
5. If the vehicle is equipped with power steering, turn on the engine. Turn the steering wheel left and right to center the steering linkage.
6. Make sure the front tires are straight ahead. Shut down the engine, if applicable.
7. Check the toe-in measurement again.
