**Coachmen**<sup>®</sup>  
RECREATIONAL VEHICLE COMPANY

**RE:** Safety Recall 99V-076

Coachmen RV Company has determined that a defect which relates to motor vehicle safety exists in certain 1993-1999 Santara and Sportscoach Class A motorhomes and 1994-1998 Destiny Class A motorhomes.

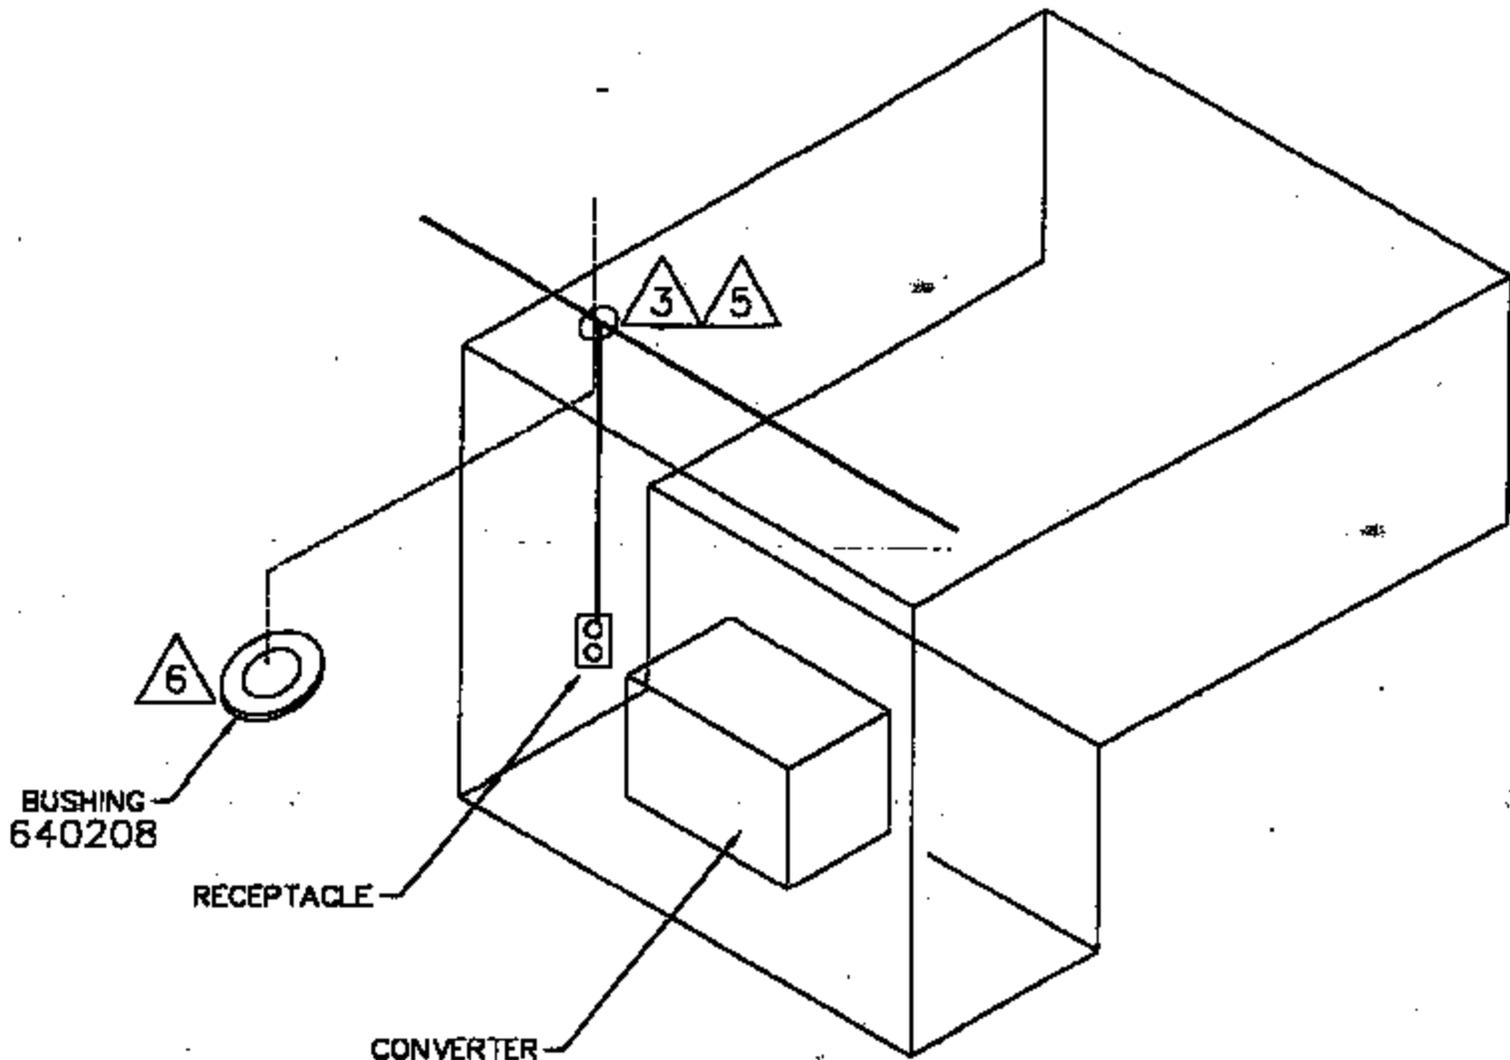
2) Locate the wires for the power converter.

3) Follow the wires to the top of the compartment. Find the hole in the floor where the wires are coming down through.

4) Verify that the wires are protected with a plastic grommet or solid conduit that passes through the metal floor skin. The floor assembly only has metal on the bottom side.

5) Verify that the hole is sealed, if not seal hole.

6) If no grommet or conduit is found. Add a bushing plate (640208), to keep the wires away from the floor assembly metal.
