Service Bulletin No. 274

MODEL D Series Coaches	TYPE Field Change Program	SECTION/GROUP 7 – Electrical	DATE Dec. 22, 2006
SUBJECT BOOST CONNECTOR			
CONDITIONS

Ref. NHTSA Recall No.: 06V-481

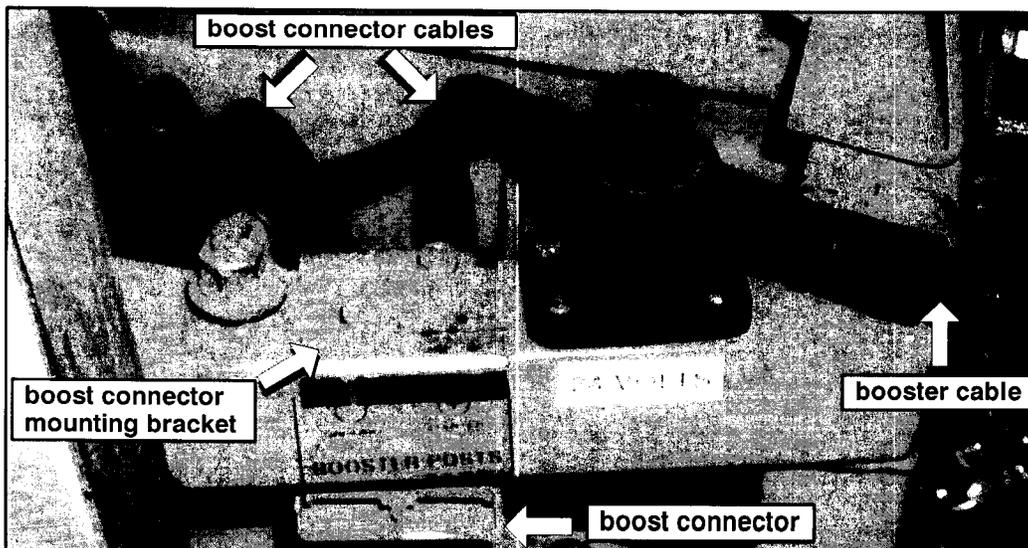
Motor Coach Industries, Inc. ("MCI") has determined that a defect which relates to motor vehicle safety may exist in certain MCI D series coaches that contain a boost connector. MCI has become aware that the boost connector's plastic housing may crack, which can allow the positive and negative leads to come in contact. In rare conditions, this may cause an overheat with arcing, and could result in a thermal event.

Figure 1. Existing boost connector.

2. Open the rear, side service compartment door and locate the boost connector (Figure 1).
3. Clearly identify the existing coach harnesses that are routed to the 24 Volt and Ground booster posts.
4. Remove and retain the nuts, washers, boost connector cables and booster cable from the booster posts.

5. Remove the two capscrews that secure the mounting bracket to the frame. Discard the mounting bracket and the existing boost connector.

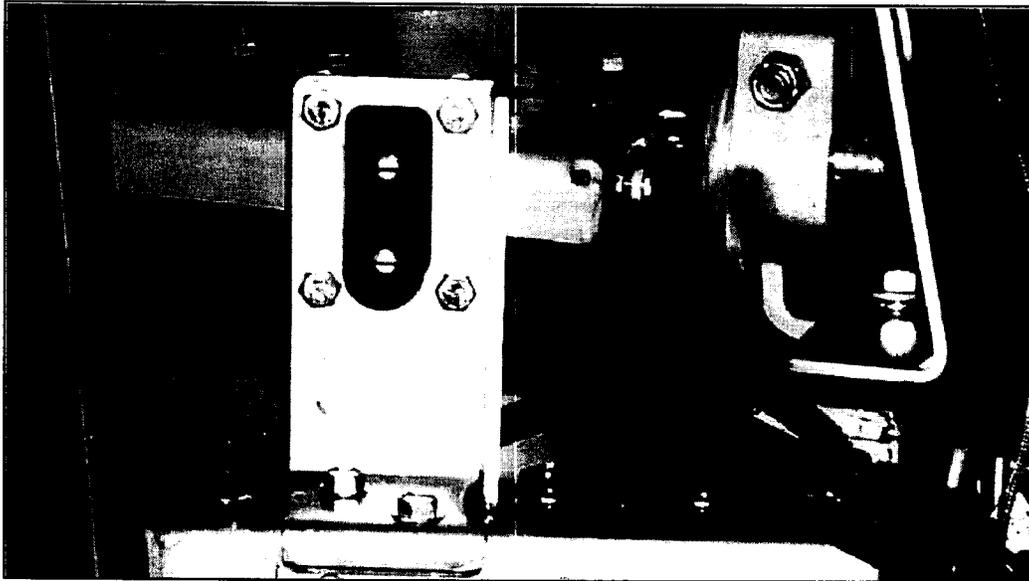
Figure 3. Reference photo.

8. Install the booster connector assembly (mounting bracket) to the frame and secure the protective cap (p/n 07-08-2149) using two screws (p/n 19-1-529) (Figures 3 and 4).

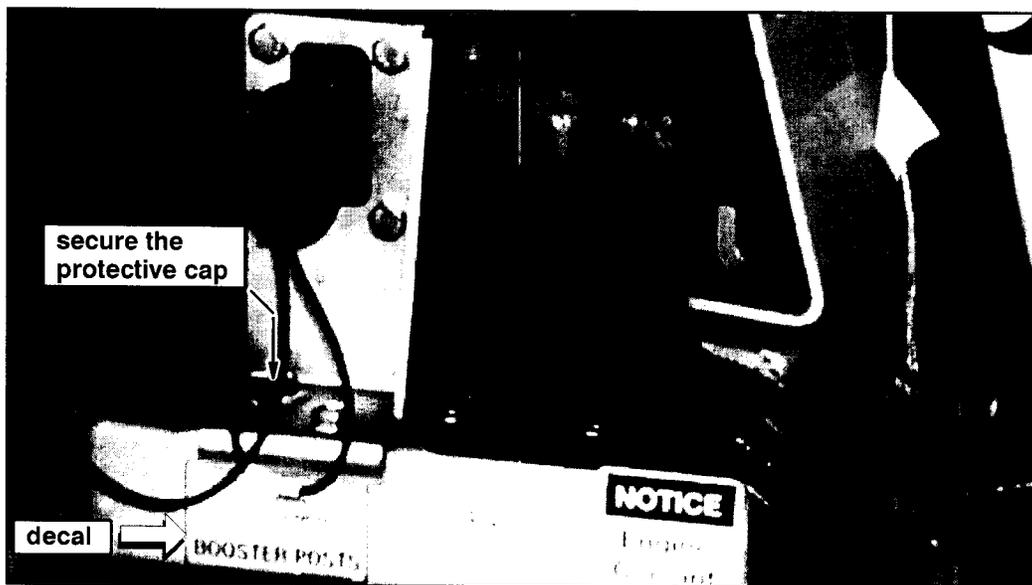
Figure 4. Reference photo.

9. Using a clean cloth and an isopropyl alcohol and water mixture, clean the decal application area shown in Figure 4. Apply the booster posts decal (p/n 07-08-2150).
