GM SERVICE AND PARTS OPERATIONS

DCS2198

Subject: 15 204 – Noncompliance - A-Pillar Trim Replacement
A-Pillar Trim Replacement - Additional Population

Models: 2002-2008 Saab 9-5
VIN Range: 23000252 - 83512093

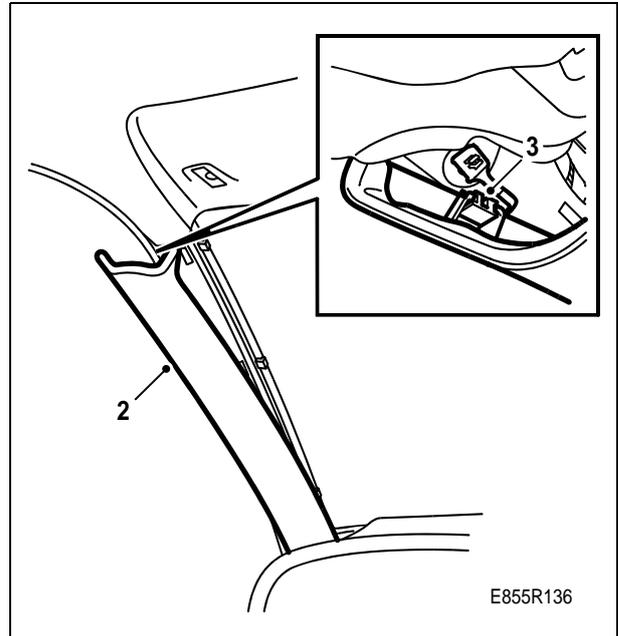
The A-pillar trim does not fulfil the FMVSS 201U legal requirement with regard to head protection.

- 1 Remove the door weatherstrip from the A-pillar.
- 2 Pull the A-pillar trim loose (fastened with clips).
- 3 Remove the top clip from the A-pillar using diagonal cutting pliers.
- 4 Lift away the trim.
