ODI RESUME

Investigation: EA 09-003
 Prompted By: PE 08-053
 Date Opened: 01/15/2009
 Principal Investigator: Peter Kivett
 Subject: Drag Link Failure

Manufacturer: Volvo Trucks North America
 Products: Model Year 1998 - 2005 Volvo VNL and VN Trucks
 Population: 193,000 (Estimated)

Problem Description: Drag-link failure resulting in a loss of steering control.

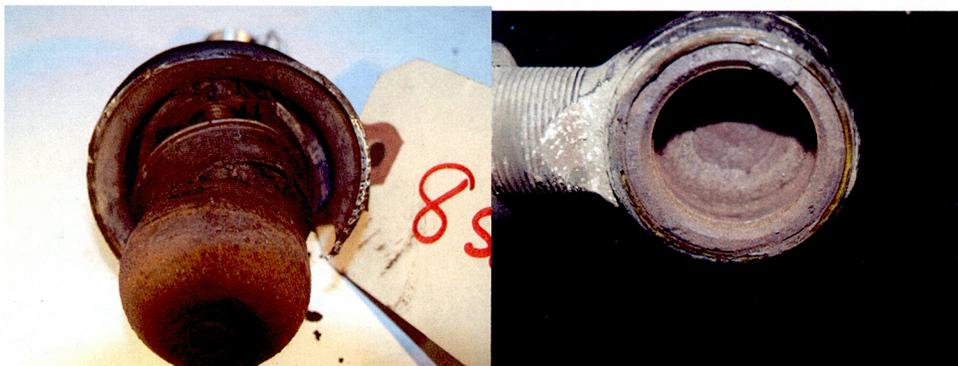
ODI theorizes that moisture can penetrate into the ball and socket assembly of the drag link ball joint (Figure 1), which at some point will compromise the joint integrity.

Figure 1: Drag link steering ends recovered from the field with extensive corrosion

Since there is no "Zerk" fitting (Figure 2) to flush the ball joint free of foreign contaminants, ODI theorizes that ultimately corrosion causes the ball and socket to wear. Eventually, due to the heavy loads and constant road vibration, this wear causes the ball to detach from the socket resulting in a catastrophic failure of the drag link.

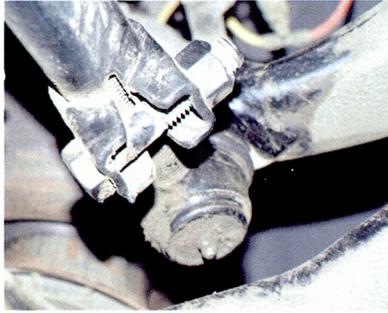
Figure 2: Photo of a peer vehicle that uses a “Zerk” fitting
