Subject: Medium Duty Axle Spindle Nuts

Models Affected: Specific Freightliner Business Class and Business Class M2 vehicles; Sterling Acterra vehicles; and Freightliner Custom Chassis FS65 and B2 school bus chassis (Thomas Built Buses C2 Saf-T-Liner) and FB65 shuttle bus chassis manufactured between January 26, 2000, and March 24, 2008, by ArvinMeritor or Axle Alliance Company with 6,000 or 8,000 pound front axles and a four-piece spindle nut set.

December 2008
FL527AB
NHTSA #08V-137

Work Instructions

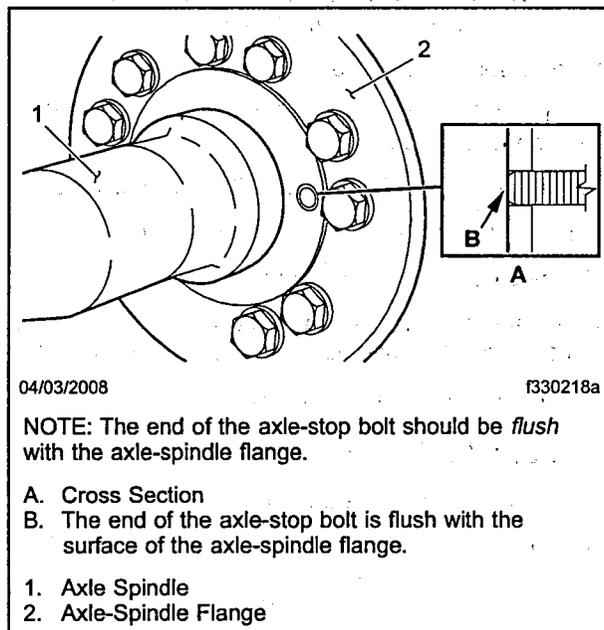
Fig. 3, End of Axle-Stop Bolt Installed Flush with Axle-Spindle Flange

10. Verify whether the end of the axle-stop bolt is flush with the outboard surface of the axle-spindle flange by placing a straight edge on the surface of the flange to see if the axle-stop bolt end protrudes.

If the bolt end is flush with the axle-spindle flange (see Fig. 3), go to the next step.

If the bolt end protrudes at all, adjust the length of the axle-stop bolt on the outboard side of the axle flange, following the instructions in **Group 33** of the applicable vehicle service/workshop manual.

Adjust the length of the bolt just enough so that the outboard bolt end is flush with the outboard surface of the axle-spindle flange. Keep in mind the minimum clearance between the axle stop and other components:

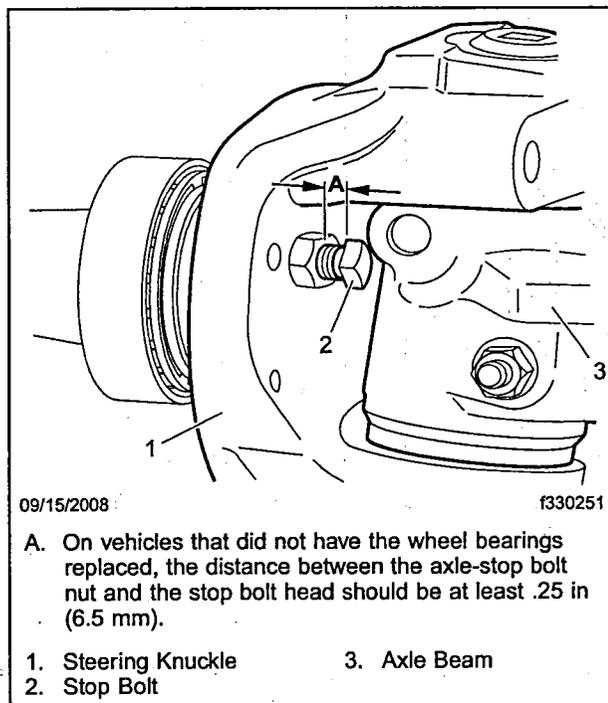
Fig. 4, Stop Bolt, Gap Between the Nut and Head

- 1.1 Measure the distance between the axle-stop bolt nut and the stop bolt head. See **Fig. 4**.

If the gap is 1/4 inch (6.5 mm) or more, go to the next substep.

If the gap is less than 1/4 inch (6.5 mm), back off the axle-stop bolt until the gap is at least 1/4 inch (6.5 mm).

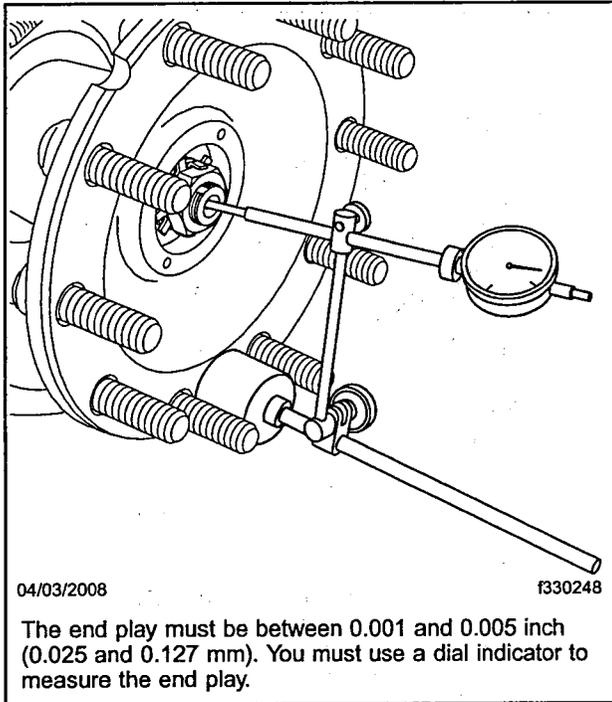
Fig. 7, Using the Dial Indicator

IMPORTANT: The end play must be between 0.001 and 0.005 inch (0.025 and 0.127 mm). *Use the dial indicator to measure this.* Correct end play is crucial.

3. Attach a dial indicator to the hub, and set the point of the indicator in line with the end of the axle spindle. The point of the indicator should be parallel to the spindle axis. See Fig. 7.
