**National Highway
Traffic Safety
Administration**

Subject: FINAL REPORT: "Plant City Trip Report"

Draft Deliberative Document – for Internal Use Only
Plant City, FL Workhorse-Bosch Trip Report

Purpose: To examine a complaint vehicle that had experienced brake drag and hot brakes at multiple wheel-ends with representatives of the chassis and brake manufacturers.

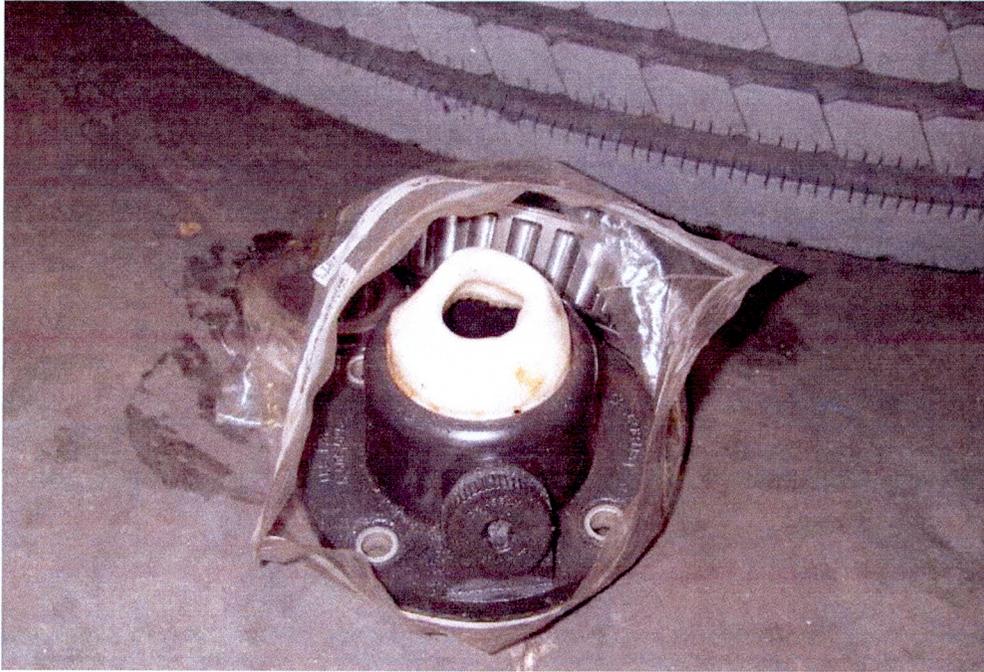
Inspection: Prior to the arrival of the other participants, the technician repaired the leaking left front wheel bearing seal. The left hub cover, melted from the last thermal event, is displayed in Figure 5. He did not disturb the brake system. The vehicle was visually inspected by the group to check several obvious items and to insure it was safe to drive. The vehicle appeared to be in good condition. The brake-linkage bell crank was not equipped with a Zerk fitting but was found to operate normally. The brake fluid level and condition appeared to be normal, and the brake pedal was found to have normal travel. The data label from the ABS ECHU, which had some undercoating sprayed on it, is shown in Figure 6. There were multiple mud dauber wasp tubes on the frame rails, as shown in Figure 7, which could indicate the amount of use of the vehicle. The ABS sensors were examined and appeared to be in good condition. The accordion boots on the caliper slide pins appeared intact at all four wheel-ends. The rear-axle splash shields were removed for inspection of the brake rotors and for the installation of the infrared-temperature sensors. The caliper housings appeared to have been through different amounts of heating. The right front caliper had been replaced in early 2006 and had the factory paint intact, as shown in Figure 8. The brake rotor had been replaced and still appeared to be new, as shown in Figure 9. Since the replacement of this caliper and rotor two years ago, this brake appears to be working normally. The left front caliper was missing the paint on the middle “finger” of the caliper housing, as shown in Figure 10, which could indicate excess heat at that location. The left front brake rotor showed additional signs of overheating with lining transfer to the rotor and pitting, as shown in Figures 11 and 12. The rear brakes showed more evidence of overheating with the loss of paint on all three fingers of the calipers, brake lining transfer to the rotors and heavy pitting of the rotors, as shown in Figures 13 through 17. The Tech2 revealed the fault codes: 0031 “right rear wheel speed sensor circuit open or shorted”, 0026 “left front wheel speed signal missing” and 0086 “ABS indicator lamp circuit shorted to battery”. The fault codes were cleared. The initial residual-drag turning torques for each wheel was RF: 11 ft-lb, LF: 20 ft-lb, LR: 27 ft-lb, and RR: 24 ft-lb, measured using a VRTC-built lug nut crossbar¹ and a dial torque wrench with a maximum torque indicator. The leveling jacks were going to be used to lift the vehicle with two 2” x 12” x 12” boards under each jack, however, the on-board generator did not run and the “house”, or non-engine, batteries were in poor condition.

Figure 5 – Left Hub Cover After the Owner Experienced a Hot Brake and Failed Inner Wheel Bearing Seal Just Prior to This Inspection and Testing

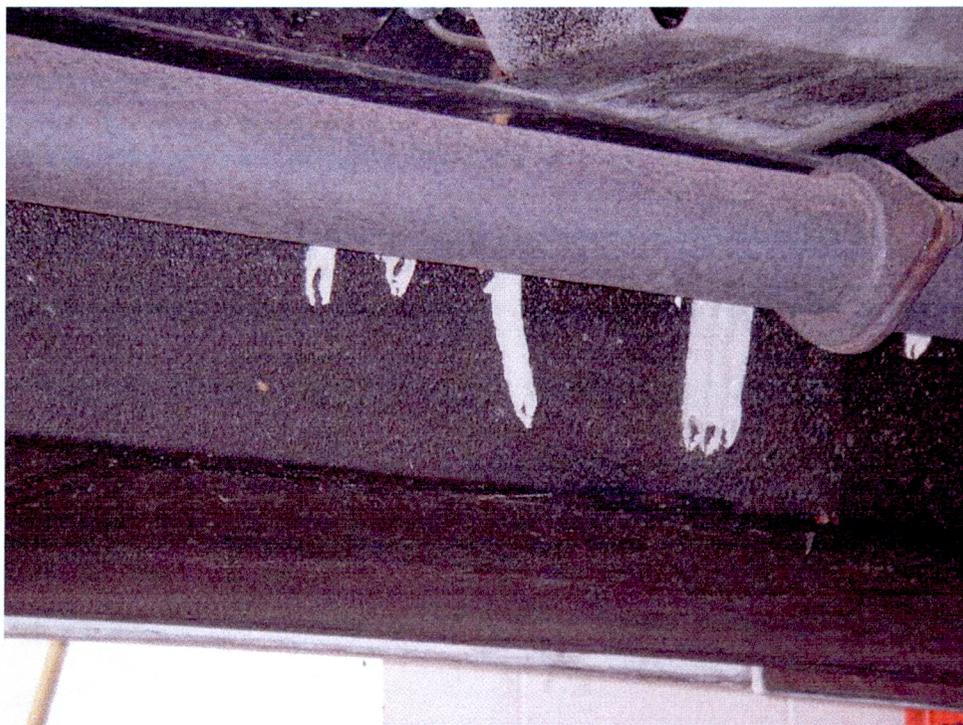
Figure 7 – Mud Dauber Wasp Tubes were Found on the Frame Rails of the Motorhome That May Indicate the Level of Use of the Vehicle

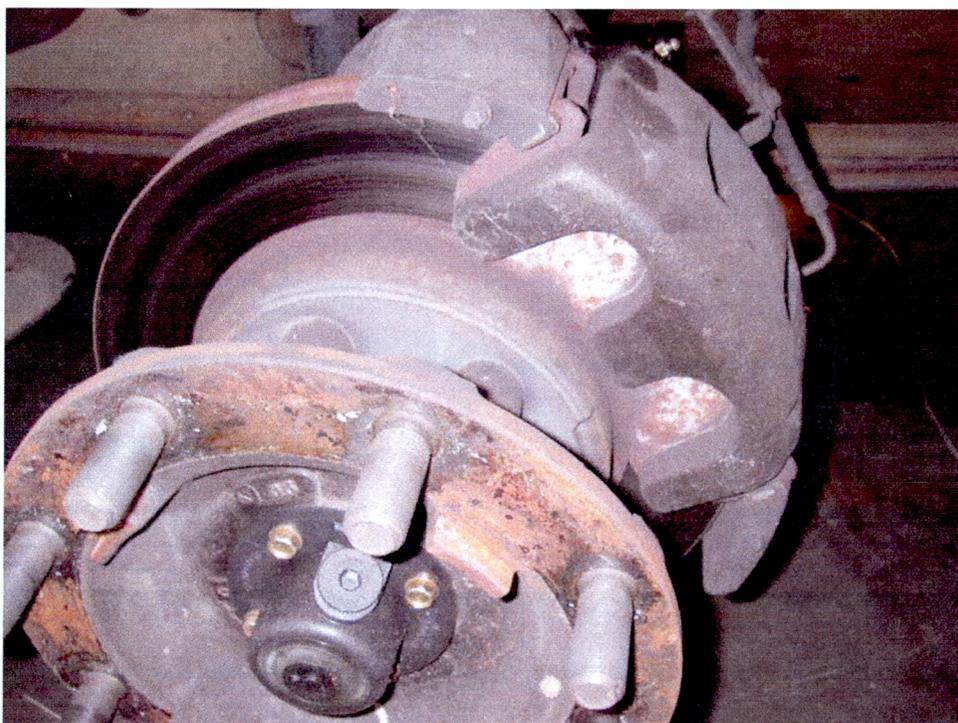
Figure 8 – Overall View of the Right Front Brake Showing the Clean Rotor and the Paint on the Caliper Housing

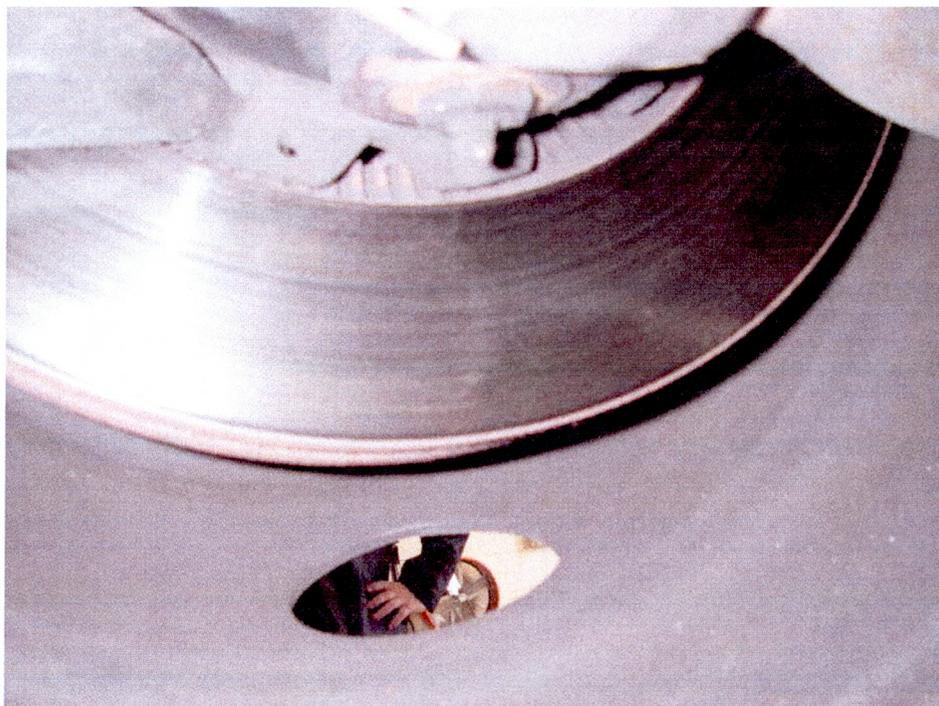
Figure 9 – The Right Front Rotor had Been Previously Replaced and Still Looked New

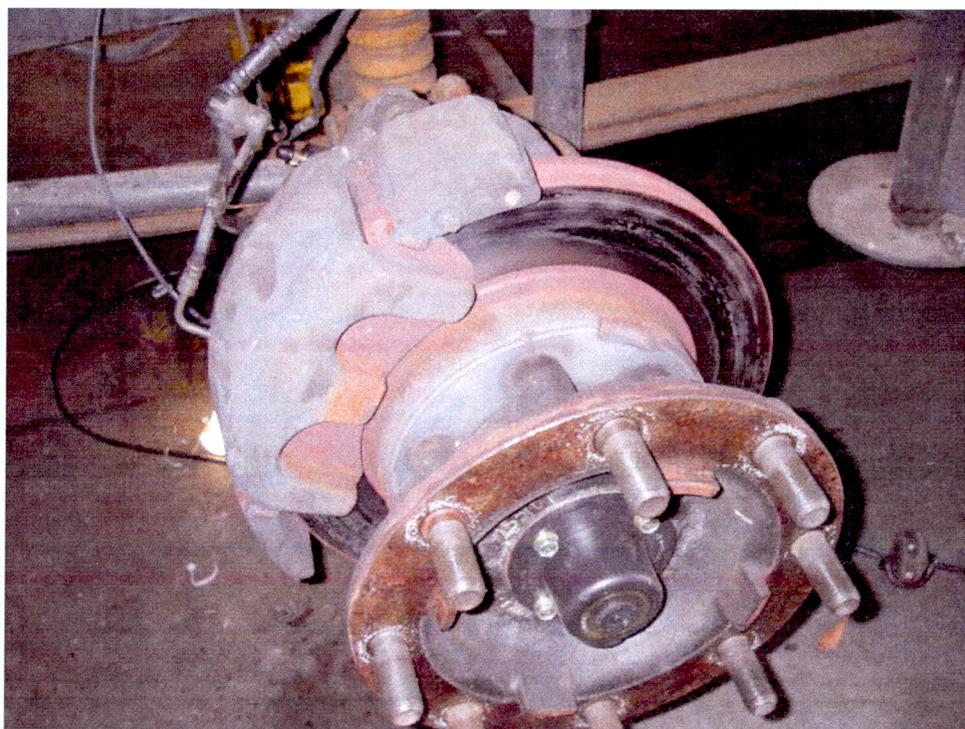
Figure 10 – Overall View of the Left Front Brake Showing the Marks on the Rotor and the Paint Missing on the Center Finger of the Caliper Housing

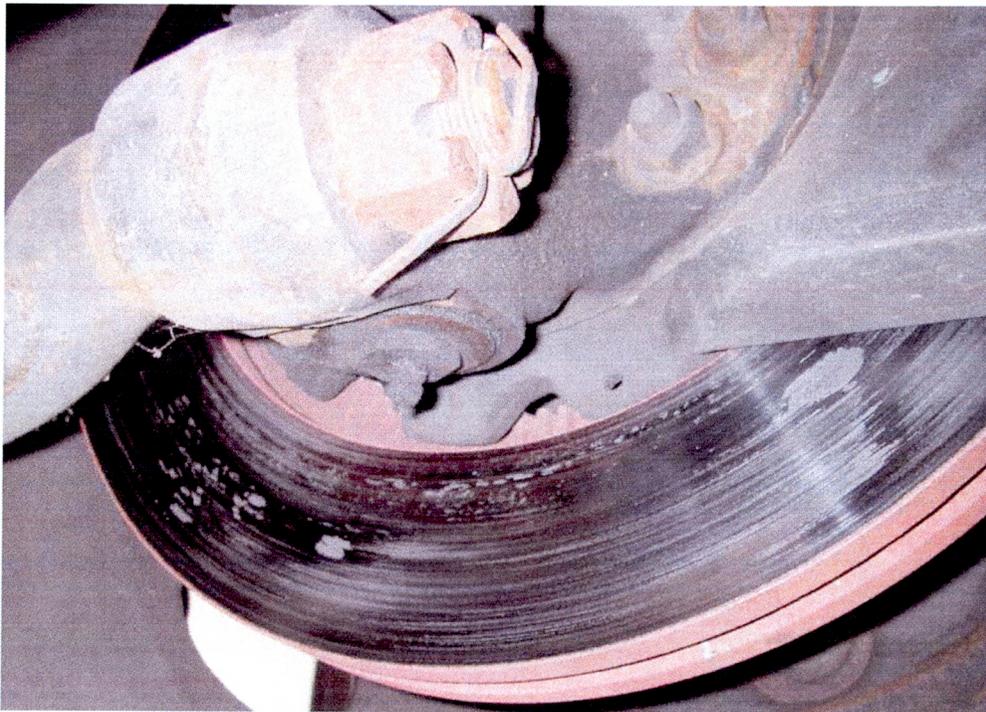
Figure 11 – Lining Material Transfer and Pitting on the Left Front Brake Rotor, Indicating High Brake Temperatures

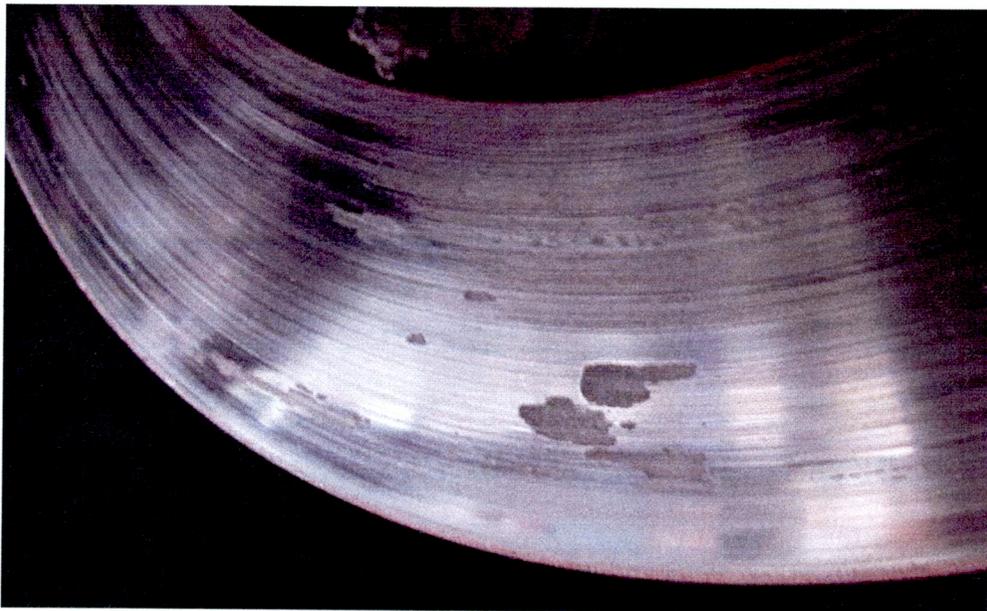
Figure 12 – Another View of the Pitting on the Left Front Brake Rotor

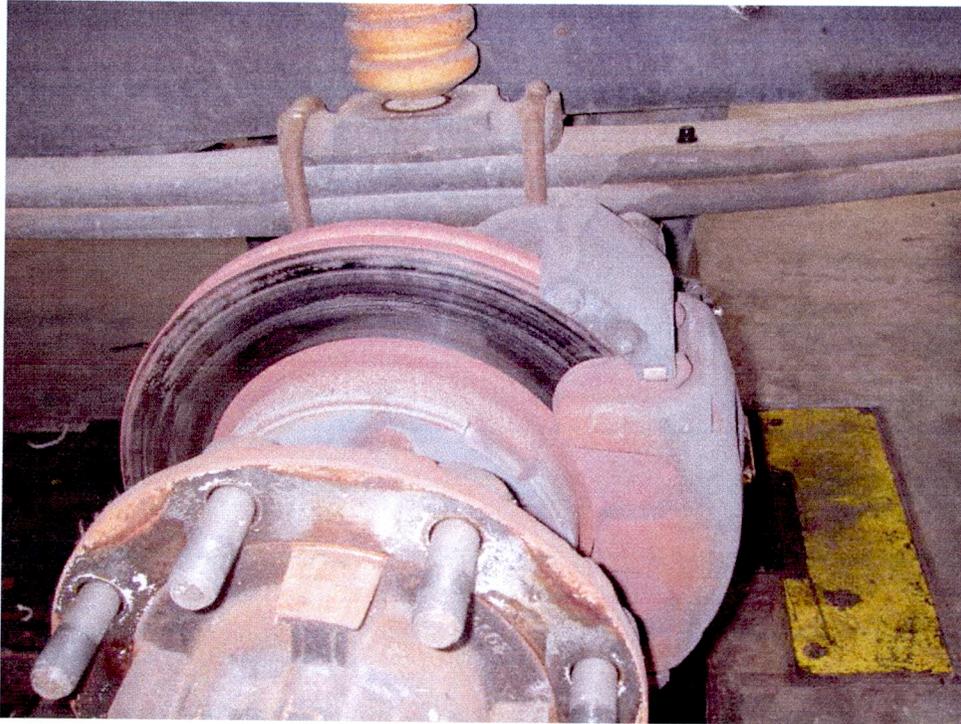
Figure 13 – Overall View of the Left Rear Brake Showing the Marks on the Rotor and the Paint Missing From a Significant Portion of the Caliper

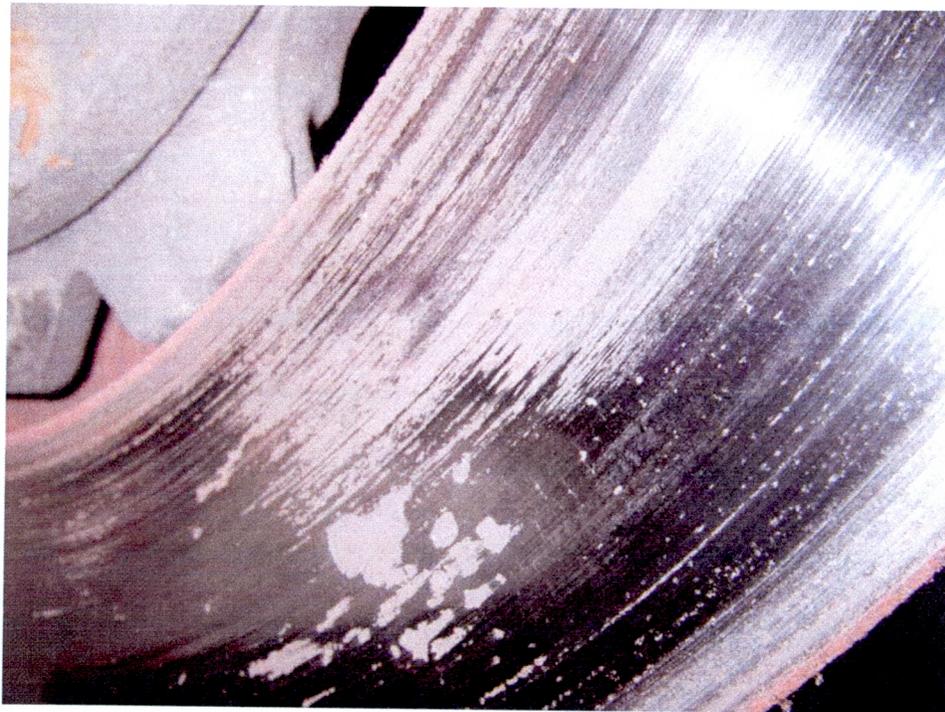
Figure 14 – Left Rear Brake Rotor Showing the Material Transfer and Pitting of the Rotor Surface

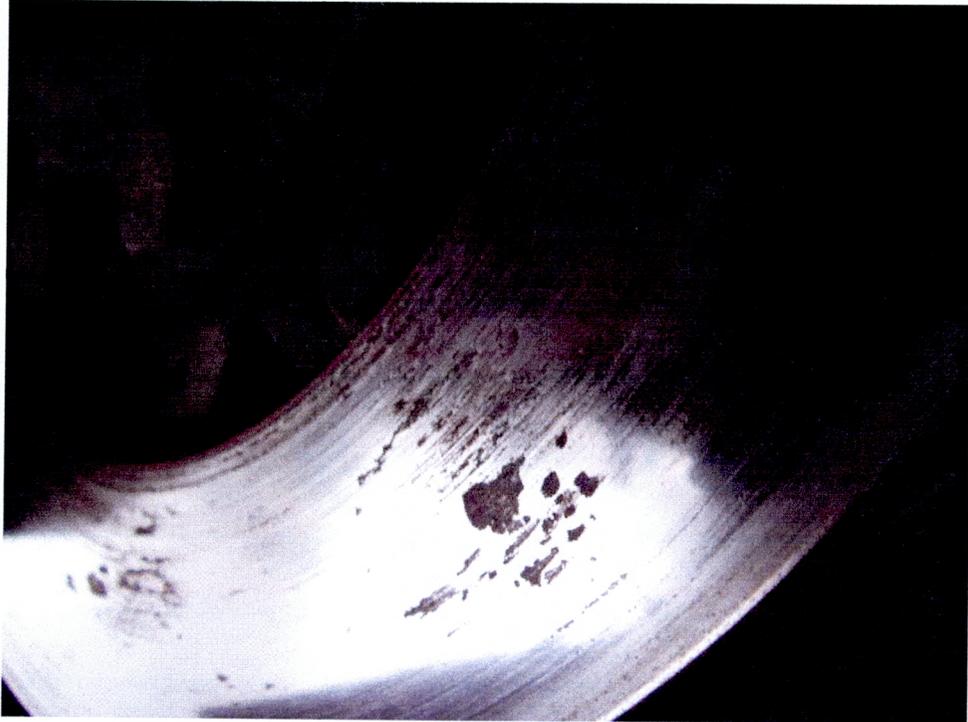
Figure 15 – Another View of the Pitting on the Left Rear Rotor

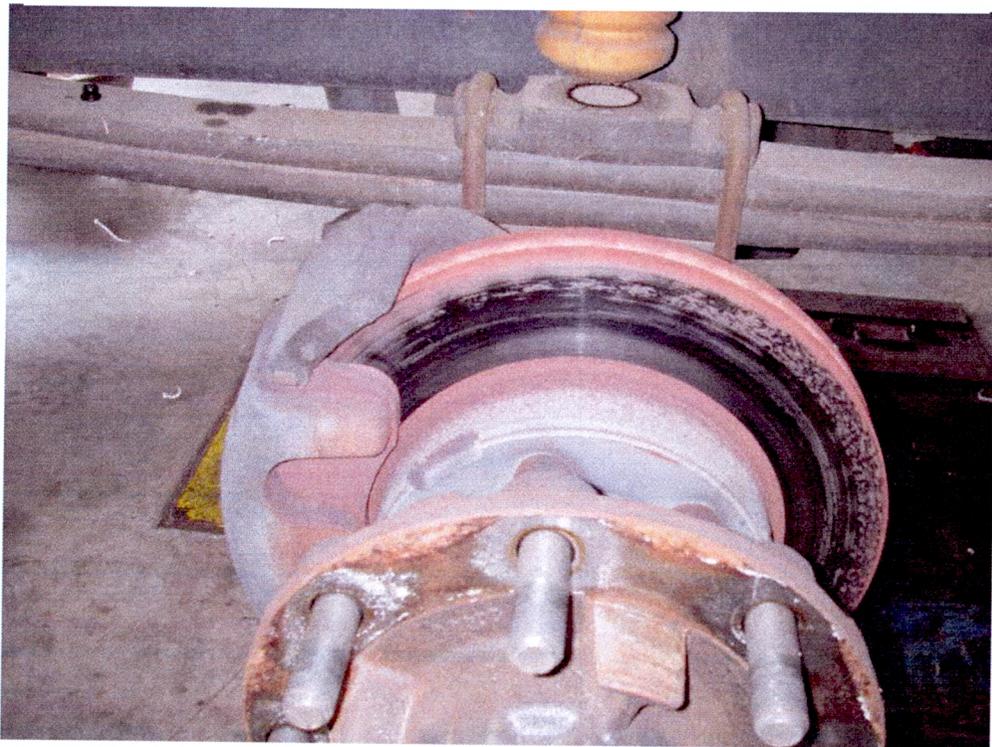
Figure 16 – Overall View of the Right Rear Rotor Showing the Marks on the Rotor and the Paint Missing From a Significant Portion of the Caliper

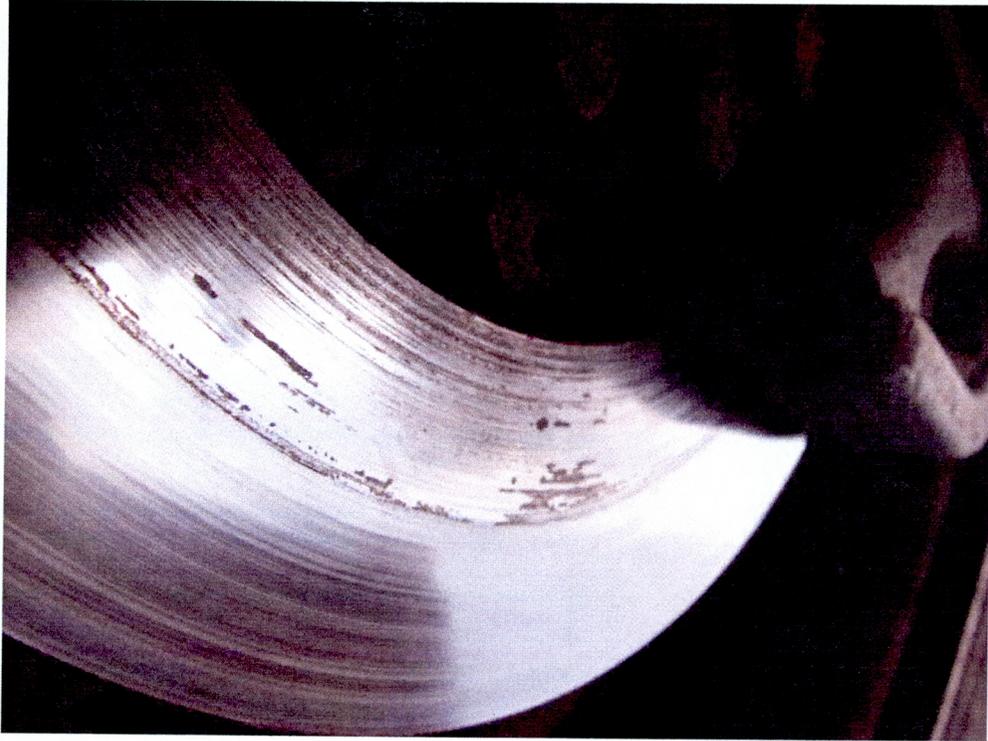
Figure 17 – Pitting on the Right Rear Brake Rotor
