Subject: FINAL REPORT: "Hammond, LA Workhorse-Bosch Trip
Report"

Hammond, LA Workhorse-Bosch Trip Report

Date: January 8, 2008

Purpose: Examine a complaint vehicle that had experienced a thermal event at a wheel-end with representatives of the chassis and brake manufacturers.

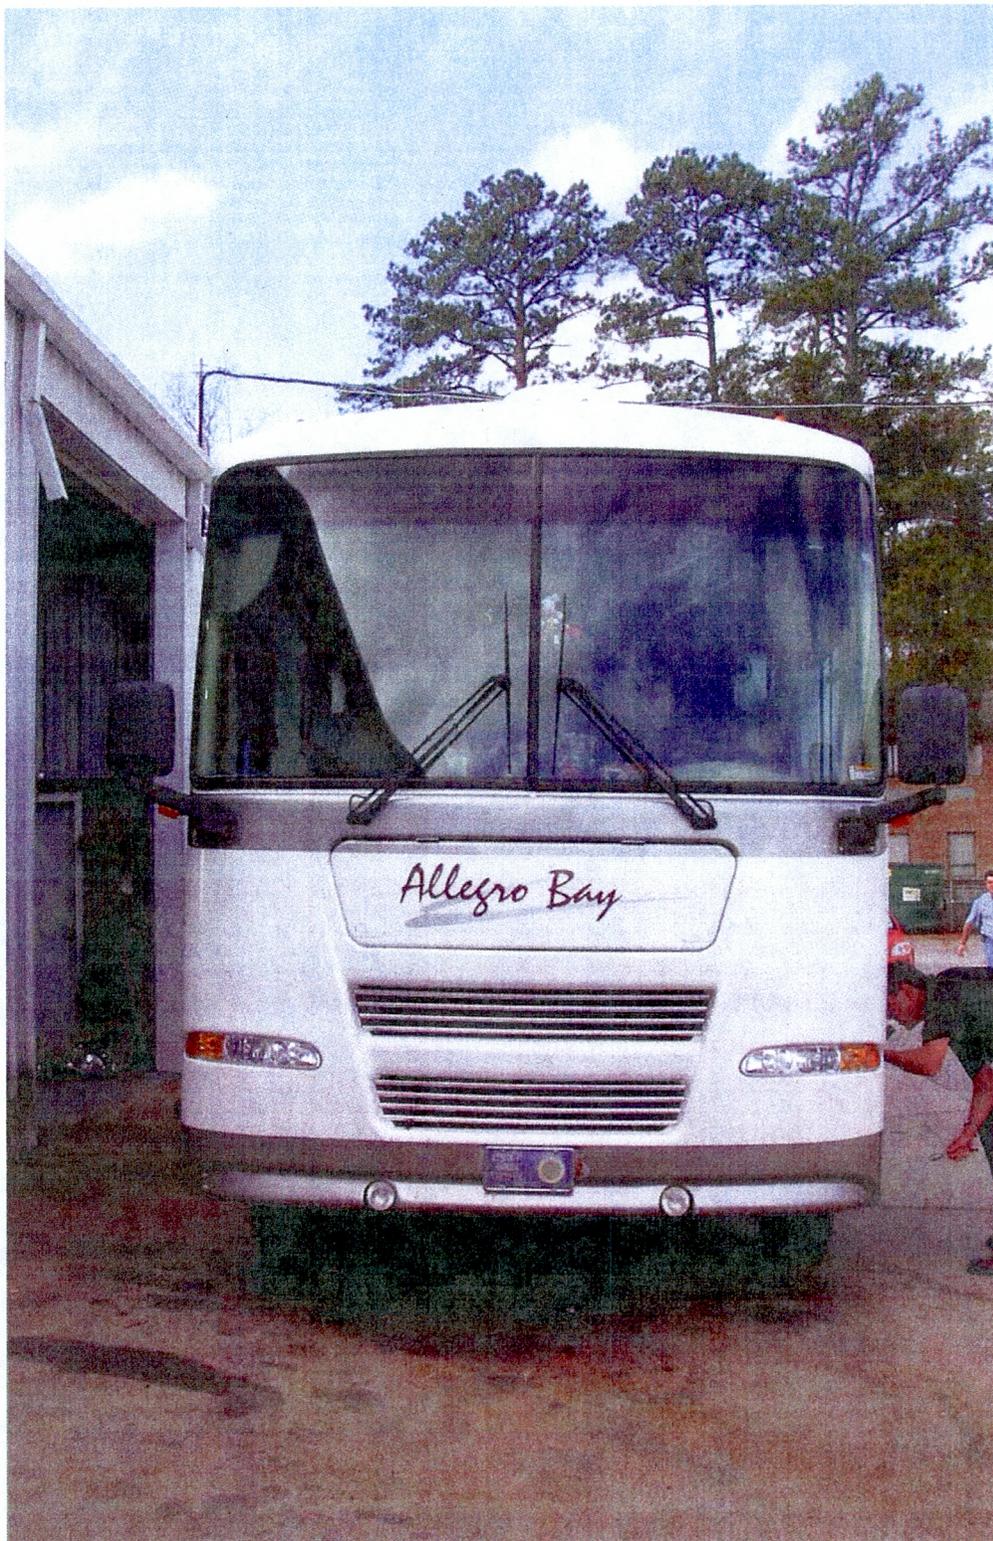
Figure 1 - View of the Complaint Vehicle During the Initial Inspection

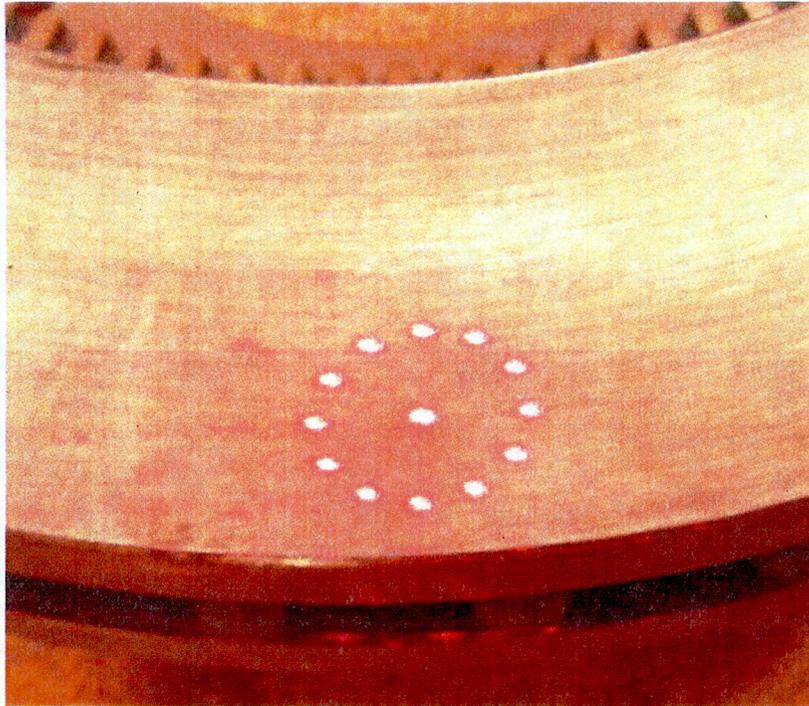
Figure 3 - Handheld Infrared Thermometer Temperature Sensing Area During this Field Trip

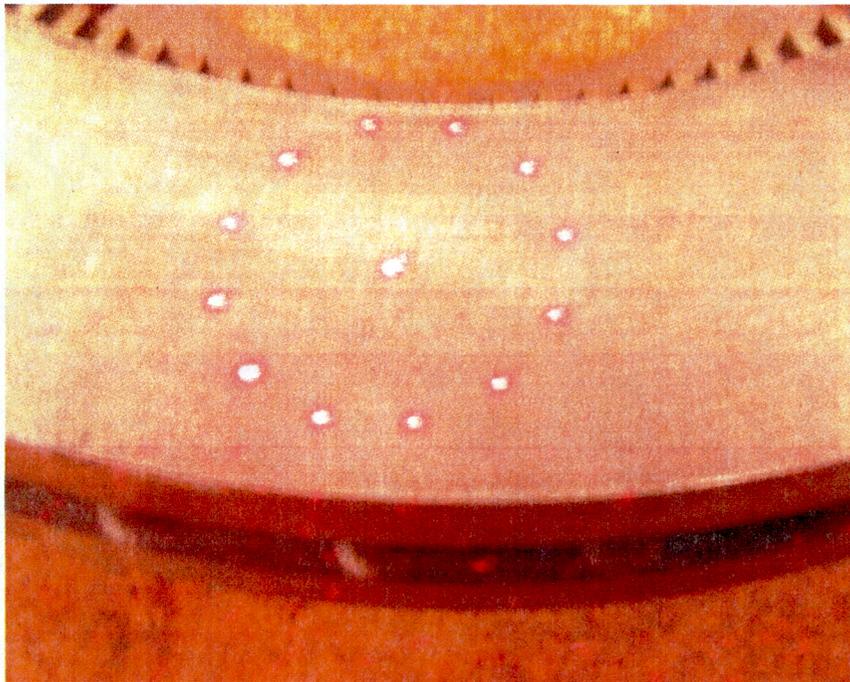
Figure 4 - Handheld Infrared Thermometer Temperature Sensing Area During the Pasadena, TX Field Trip
