Mazda North American Operations

SUBJECT: 2007-2009 CX-9 Power-Adjustable Driver's Seat Voluntary Safety Recall 5309B

CX-9 POWER ADJUSTABLE DRIVER'S SEAT RECALL 5309B

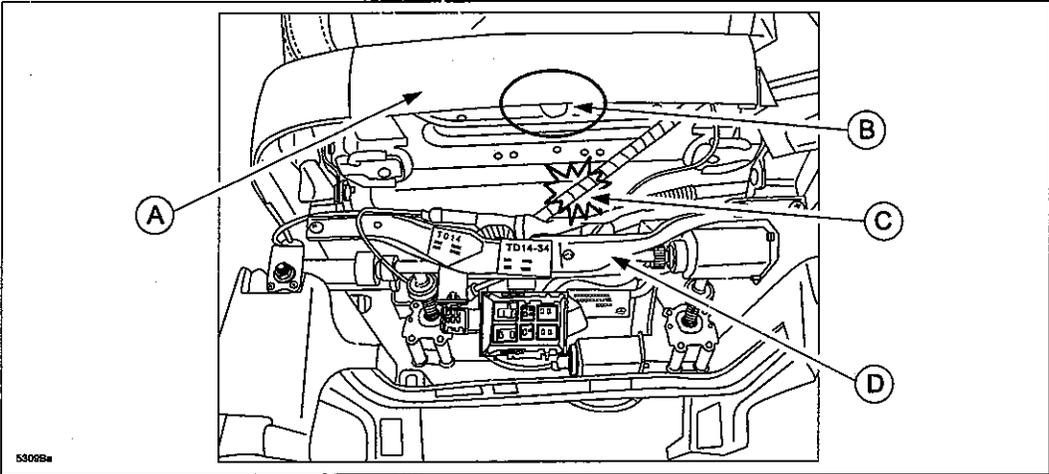
The driver seat front cover bracket may contact the seat harness routed underneath the seat cushion and cause damage on the harness covering.

Check condition of seat harness.

- A: Front Cover
- B: Bracket
- C: Seat Harness
- D: Seat Frame

Condition of wire harness	What to do
OK (Harness has no damage)	1) Attach duct/cloth tape on the seat cushion frame. 2) Fasten the seat harness on the seat frame with a tie wrap.
NG (Harness has damage)	1) Put insulation/electrical tape on seat harness and/or on the bare wire. 2) Attach duct/cloth tape on the seat cushion frame. 3) Fasten seat harness on the seat frame with a tie wrap.

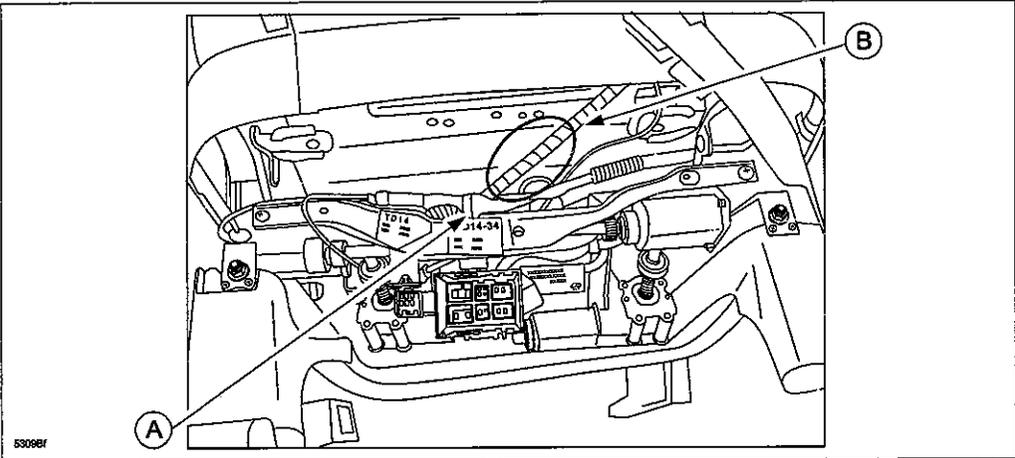
3. Inspect seat harness for any damage between the fastener (A) and the front of the seat (B).

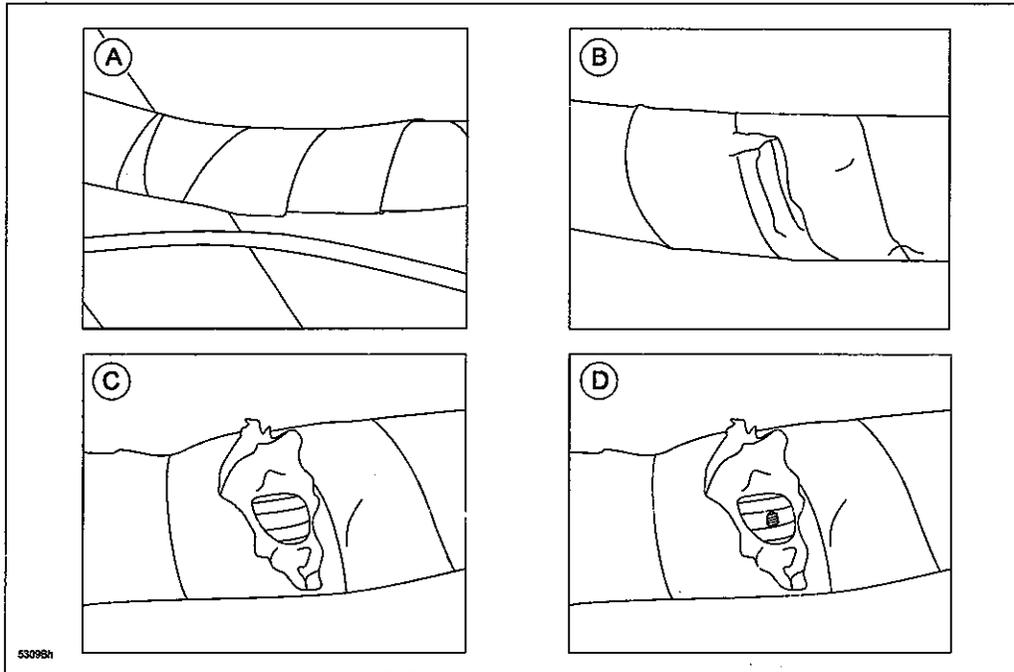
4. From the illustrations below, identify which of the following four (4) conditions exists (A, B, C, or D), and then proceed to the appropriate step.

Condition of wire harness	What to do
A	Harness is OK (no signs of visible damage)	Proceed to SERVICE PROCEDURE Step 2
B	Damage exists on PVC tube (electric wire is not visible)	Proceed to SERVICE PROCEDURE Step 1
C	Electric wire covering is visible	Proceed to SERVICE PROCEDURE Step 1
D	Electric Wire covering is damaged and bare wire is visible	Proceed to ELECTRIC WIRE REPAIR PROCEDURE

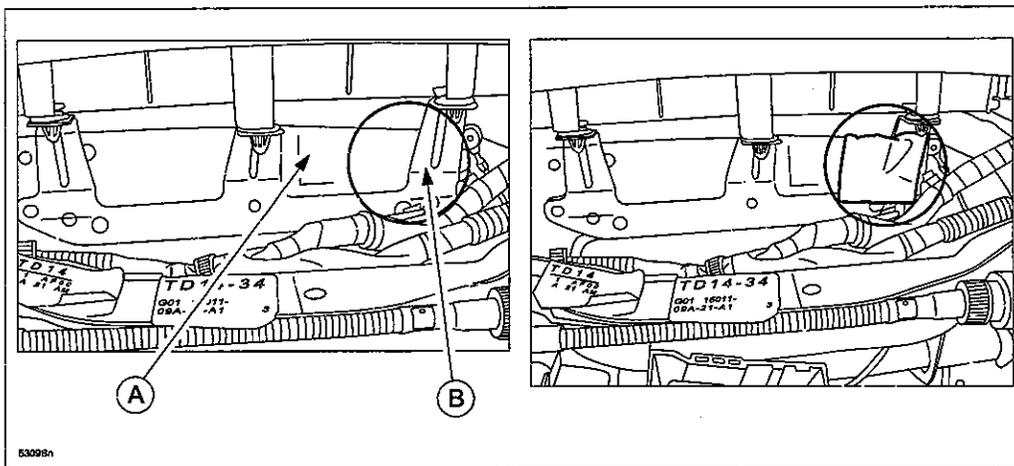
NOTE: The duct/cloth tape prevents possible harness damage from contact with the cover bracket once the repair is completed.

2. Attach duct/cloth tape to the cushion frame (A) and front cover bracket (B) as shown in the illustration.
