Volvo Trucks North America, Inc.

99V-055.004 (01)

**CAMPAIGN NOTICE: Meritor Automatic Slack Adjusters Shipped Between January 8 and January 14, 1999**

## ASA (Automatic Slack Adjuster)

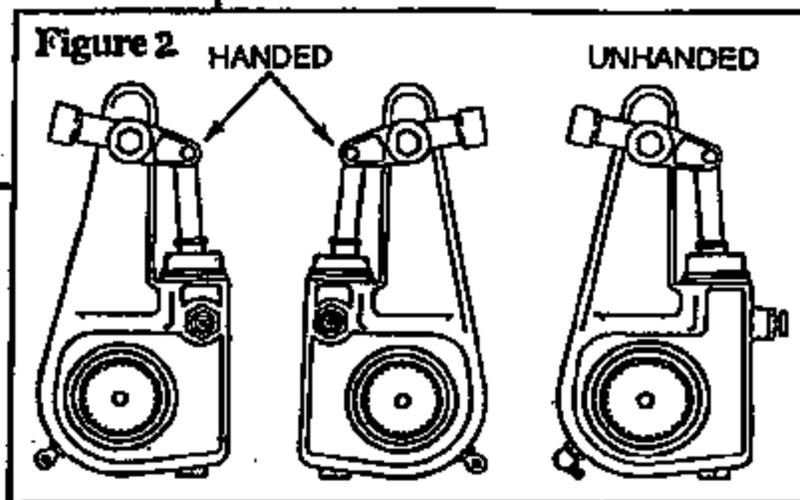
The Guide Pawl Cap may be found in one of the three locations shown in Fig. 2, depending on the style of slack adjuster supplied
