RE: Safety Recall Campaign 98KW1
Chassis Built with Meritor Automatic Slack Adjusters All
Models Built Between January 11, 1999 and April 7, 1999.

**FEDERAL RECALL CAMPAIGN 99KW1
CHASSIS BUILT WITH MERITOR AUTOMATIC SLACK ADJUSTERS
ALL MODELS BUILT BETWEEN JANUARY 11, 1999 AND APRIL 7, 1999**

Check Pull Pawl Assemblies for Meritor Automatic Slack Adjusters Shipped Between January 8, 1999, and January 14, 1999

RE: Safety Recall 449-A (PACCAR Number 99-PB-01)
Meritor Automatic Slack Adjusters
Expiration Date: None

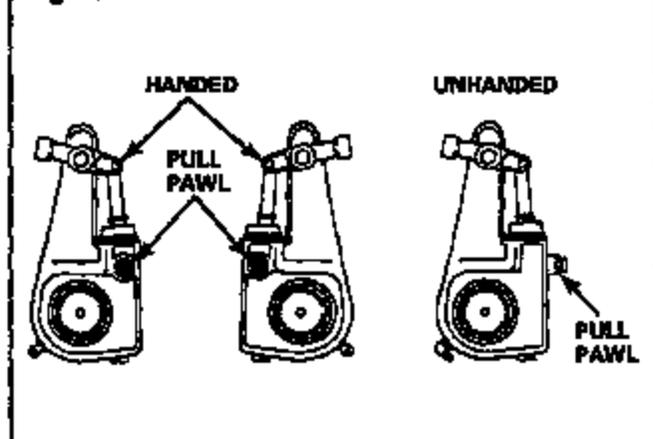
Figure 1

2. If the brake has a spring brake, compress and lock the spring, so that the brake is released completely. Check that no air pressure remains in the service half of the air chamber.
3. Locate the automatic slack adjuster pull pawl. The pull pawl is located in one of three possible locations. Figure 1.

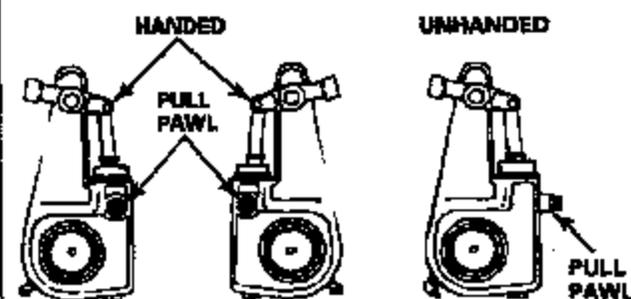
Figure 1

2. If the brake has a spring brake, compress and lock the spring, so that the brake is released completely. Check that no air pressure remains in the service half of the air chamber.
3. Locate the automatic slack adjuster pull pawl. The pull pawl is located in one of three possible locations. Figure 1.
