# UPDATE

SUBJECT:		No: <b>SR-89-002</b>	
<b>LOWER BALL JOINT — SAFETY RECALL CAMPAIGN</b>		DATE: <b>June, 1999</b>	
		MODEL: <b>See below</b>	
CIRCULATE TO:	<input checked="" type="checkbox"/> GENERAL MANAGER	<input checked="" type="checkbox"/> PARTS MANAGER	<input checked="" type="checkbox"/> TECHNICIAN
<input checked="" type="checkbox"/> SERVICE ADVISOR	<input checked="" type="checkbox"/> SERVICE MANAGER	<input checked="" type="checkbox"/> WARRANTY PROCESSOR	<input checked="" type="checkbox"/> SALES MANAGER

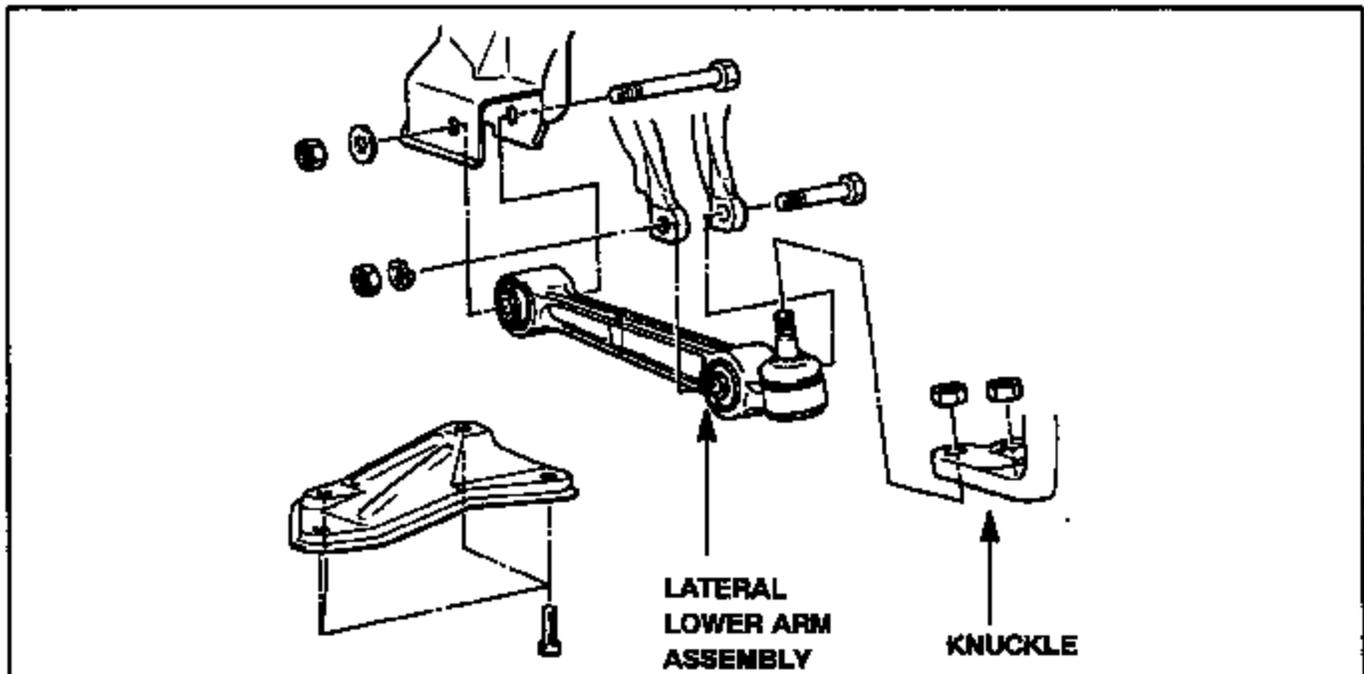
2. Inspect the lateral lower arm ball joint rubber boot on both sides for cracks and damage. Gently push the boot in with your fingers. Do not remove any parts for the inspection. Damage to the boot is evident if any cuts or tearing are observed or if grease comes out when it is pushed in.
3. If the rubber boot is not damaged, repeat the inspection on the other side of the vehicle. If the boot is not damaged on either side of the vehicle, this campaign procedure is complete.
