Reference: NHTSA Identification Number 99V-066.003

Safety Recall No. 827 **Lower Lateral Arm Ball Joint Boots**

1995-1996 (FJ) Dodge Avenger, Chrysler Sebring Coupe and Eagle Talon

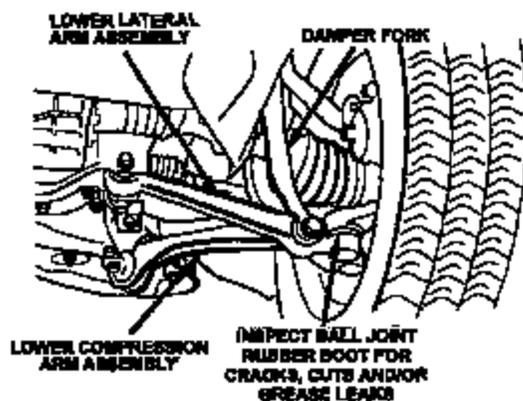
Figure 1

2. Inspect the LEFT ball joint rubber boot on the lower lateral arm. Using a light, look for cracks, cuts and/or other damage by pushing the boot with your fingers (Figure 1). The boot is damaged if there is evidence of grease leakage. If necessary, use a clean cloth or cotton swab as an aid to determine if grease is present.

3. Inspect the RIGHT ball joint rubber boot on the lower lateral arm. Using a light, look for cracks, cuts and/or other damage by pushing the boot with your fingers (Figure 1). The boot is damaged if there is evidence of grease leakage. If necessary, use a clean cloth or cotton swab as an aid to determine if grease is present.
4. If either rubber boot is damaged, proceed to Section “B” – Lower Lateral Arm Replacement. If no damage is found at either rubber boot, no further action is required.
5. Lower the vehicle from the hoist and return the vehicle to the owner.
