# Campaign Service BULLETIN

BULLETIN NUMBER:  
SB99-06-S001ISSUE DATE:  
JUNE 1999GROUP:  
SUSPENSION

## 1997-98 OASIS (VO) LOWER BALL JOINT REPLACEMENT SAFETY CAMPAIGN 99V-069

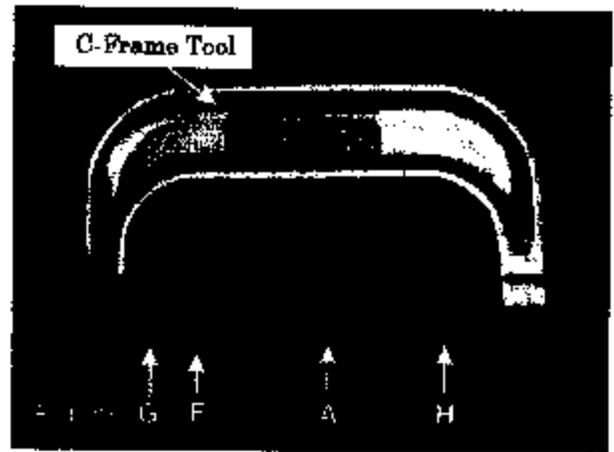
Figure 6: Arrange adapters to C-Frame Tool.

11. Arrange the special tools for ball joint removal. (Figure 6)

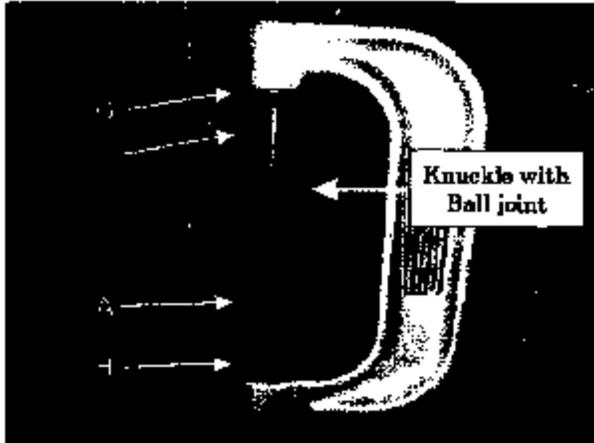
**Figure 8:** Position the adapters for ball joint removal.

14. Position the special tool onto the lower ball joint and knuckle. (Figure 8)

- To avoid damaging the special tools, verify that the correct tools are used and aligned properly.

15. Using the C-frame with proper adapters (G, F, A, and H), press the lower ball joint out of the knuckle by tightening the C-frame.

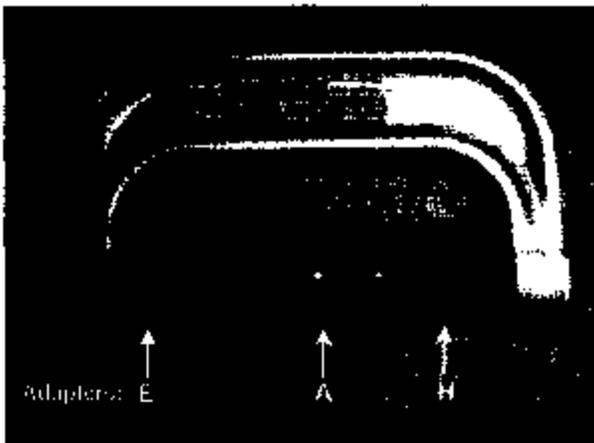
**Figure 9:** Arrange adapters to C-Frame Tool.

16. Arrange the special tools for ball joint installation. (Figure 9)

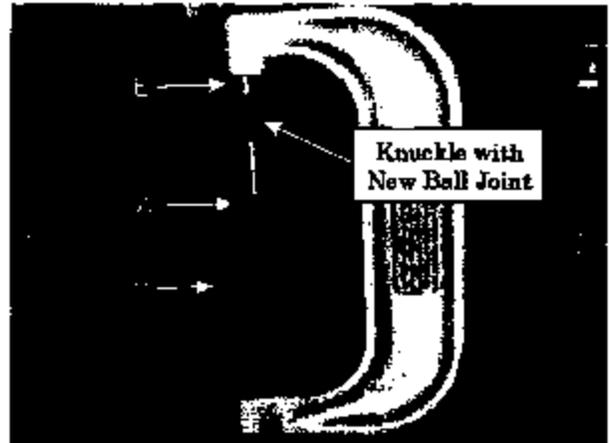
**Figure 10:** Position the adapters for ball joint installation.

18. Position the special tools on the ball joint and the knuckle. (Figure 10)

19. Using the C-frame with proper adapters (E, A, and H), press the lower ball joint into the knuckle by tightening the C-frame.
