RECALL CAMPAIGN

**REF. NO. 167
FUEL LINES**

456 GT/GTA

JULY 1999

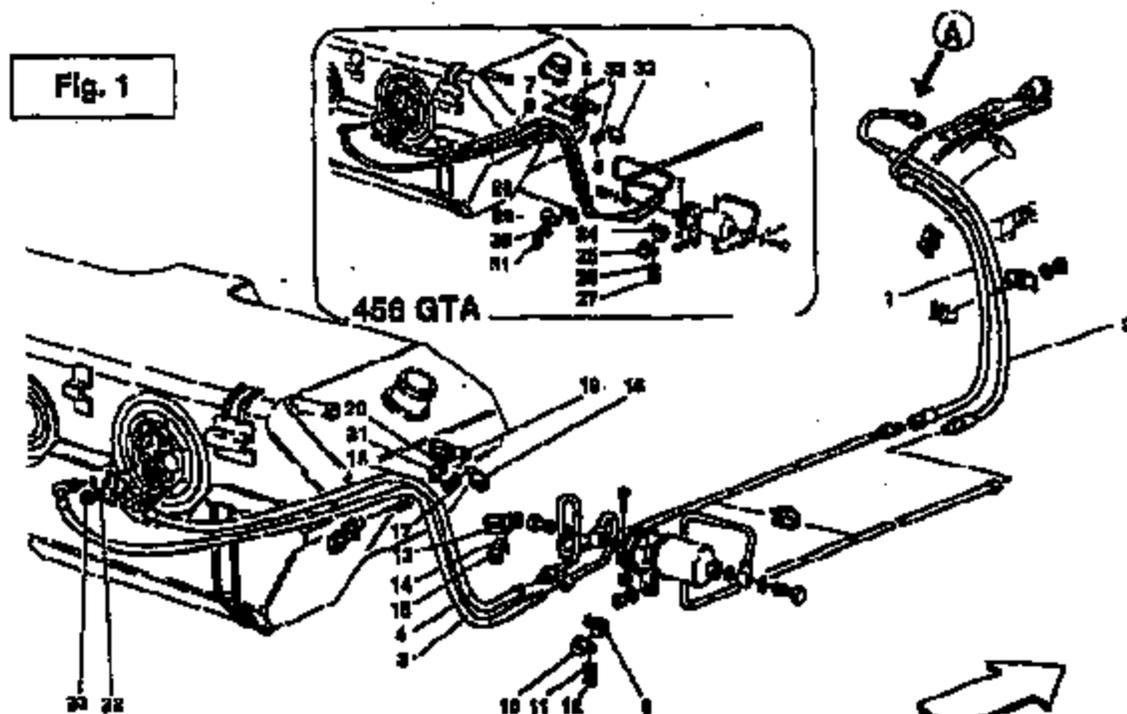
- 6) Remove the front wheels
- 7) Remove the rear section of the front inner fender panels
- 8) Loosen the inside of the left and right under tray covers
- 9) Release the supply and return hoses from their retaining clips on the right side.
- 10) Remove the cable ties on both the left and right sides.
- 11) Remove the water hose clamp on the right side to gain better access.
- 12) Remove both left and right fuel rail covers
- 13) Remove the left side fuel lines (Items 1 and 2 in figure 1)
- 14) Remove the right side fuel lines (Items 1 and 2 in figure 1)

- 15) Install the new right side supply (part number 178527) and right side return (part number 174046) fuel lines tightening the unions to a torque of 34 Nm.(25 lb.ft.)

- 16) Install the new left side supply (part number 178526) and left side return (part number 174051) fuel lines tightening the unions to a torque of 34 Nm.(25 lb.ft.)

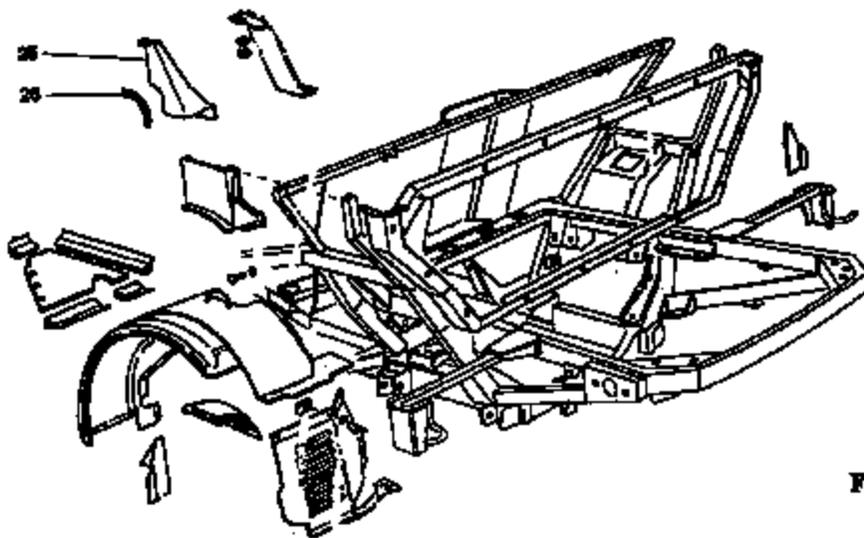
FIGURE 2

- 27) Remove both rear wheels.
- 28) Remove the sheet metal panel (#25 figure 2)
Ensure that the protective rubber strip (# 26 figure 2) stays in place.

- 32) Identify the new lines and separate left from right.
- 33) Route the new line in place of the one removed.
- 34) Connect the new line to the rigid metal pipe and torque to 34 Nm. (25 lbs. Ft.)
- 35) Note the position of the line at fuel pump and remove the other line from the fuel pump and rigid metal pipe.
- 36) Route the new line in place of the one removed.
- 37) Connect the new line to the rigid metal pipe and torque to 34 Nm. (25 lbs. Ft.)
- 38) Connect both lines to the fuel pump taking care not to damage the sealing rings.
- 39) Repeat the above steps on the right side to replace the lines.
- 40) Please mark all updated vehicles with a dot of re paint on the fuel line 178527 upper fitting.
