File In Section: Product Recalls
Bulletin No.: 08048C
Date: April 2009

PRODUCT SAFETY RECALL

SUBJECT: Heated Windshield Washer Module Short Circuit – Add Wire Harness

MODELS: 2006-2008 Buick Lucerne
2008 Buick Enclave
2006-2008 Cadillac DTS
2007-2008 Cadillac Escalade, Escalade ESV, Escalade EXT
2007-2008 Chevrolet Avalanche, Silverado, Suburban, Tahoe
2007-2008 GMC Acadia, Sierra, Yukon, Yukon XL
2006-2008 HUMMER H2
2007-2008 Saturn OUTLOOK
Equipped with Heated Washer Fluid System

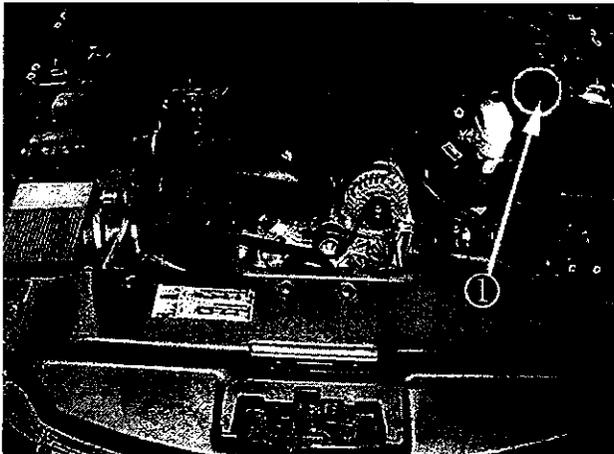
2196095

Important: The windshield solvent heater module (1) is located on the driver's side of the engine compartment near the front fender upper brace (if equipped), master cylinder reservoir, and lower plenum panel. For the Cadillac DTS and Buick Lucerne, the windshield solvent heater module is mounted to the front of dash on the passenger's side of the engine compartment.

1. Locate the windshield solvent heater module.
