Brake Cam Tube Reinforcement With Super Single Wheels/Tires and Bendix Brakes

VNL

RVXX0901, Brake Cam Tube Reinforcement With Super Single Wheels/Tires and Bendix Brakes

(June 2009)

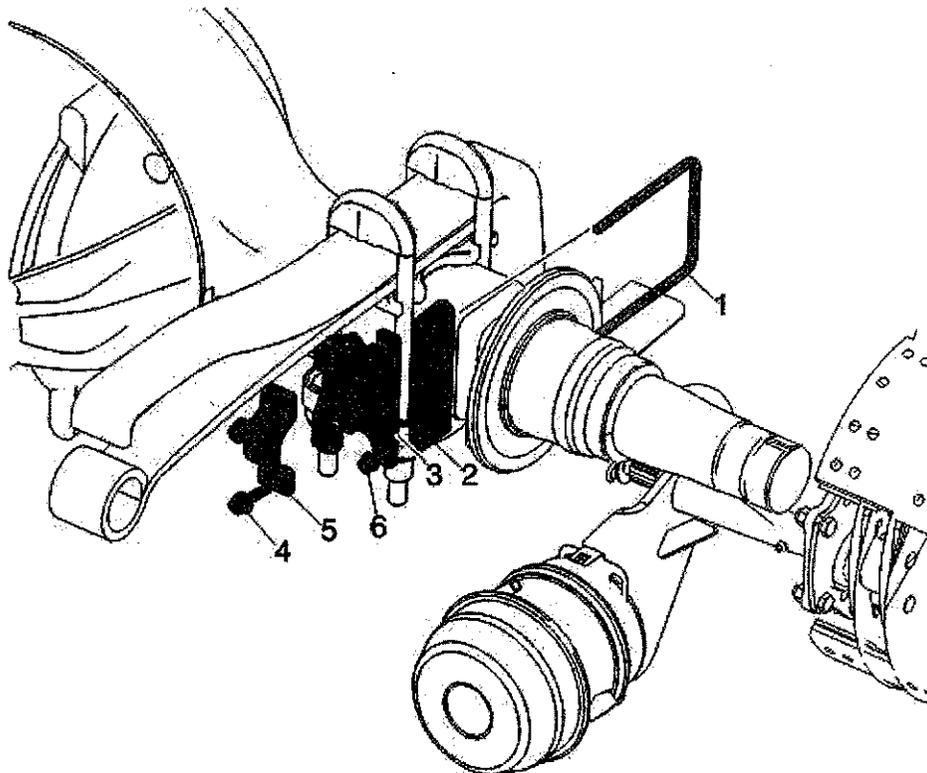
W5028771

1. U-bolt Aftermarket rear brake cam tube (PN: 21386200)
2. Seat Aftermarket rear brake cam tube (PN: 21386198)
3. Bracket Aftermarket rear brake cam tube (PN:21386196)
4. Flange bolt (PN: 969445)
5. Strap aftermarket rear brake came tube (PN: 21370743)
6. Flange lock nut (PN: 969316)

4. Tighten all hardware and torque to: 60 Nm ± 10 Nm (44 ft-lb ± 7 ft-lb). Maintain an equal gap between the fastening ends of the strap and bracket.
5. Install tie straps to secure wheel speed sensor harness to brake cam tube as shown.
6. Repeat steps 2-5 for remaining brake cam tubes.

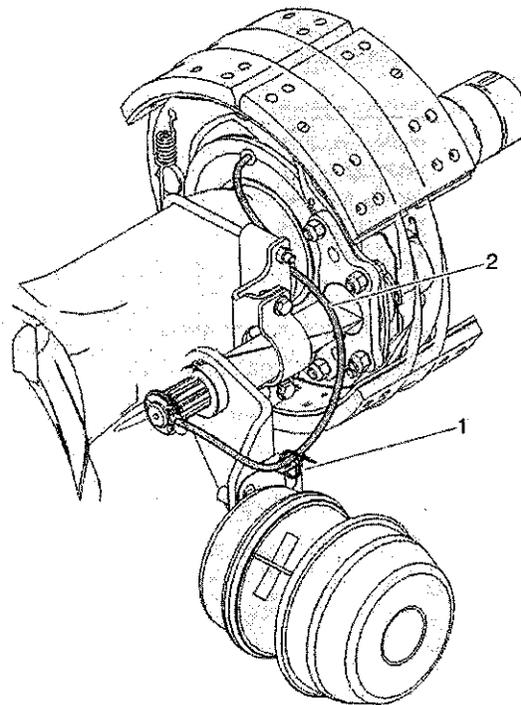
W5029638

1. Cable Tie (PN: 983472)
2. Cable Tie (PN: 948211)

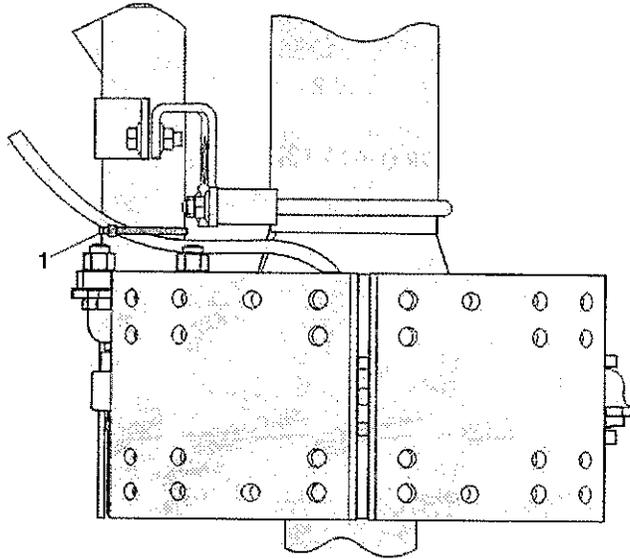
W5029639

1. Cable Tie (PN: 983472)
