# RECALL CAMPAIGN BULLETIN

NTB09-038

## VOLUNTARY SAFETY RECALL CAMPAIGN 2003 – 2007 NISSAN MURANO ENGINE AIR INTAKE DUCT

**CAMPAIGN ID #:** R0902  
**NHTSA #:** 09V-169  
**APPLIED VEHICLES:** 2003 – 2007 Murano (Z50)

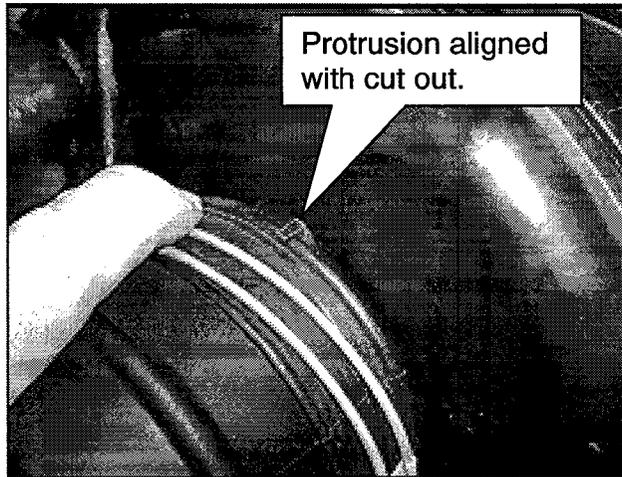
Figure 3

Protrusion aligned with cut out.

- Make sure to align the resonator protrusion with the air duct cut out.
