Fleetwood Enterprises, Inc.  
Motor Home Division  
Recreational Vehicle Group  
2970 Myers Street, P.O. Box 7638  
Riverside, California 92513-7638  
(909) 351-3800 FAX (909) 351-3986

FIRST NOTICE**IMPORTANT RECALL INFORMATION**

## TRAILER HITCH HUCK BOLT REPLACEMENT PROCEDURE

This procedure is for inspection and correction of the trailer hitch attachment to 1998 Flair chassis frame extensions.

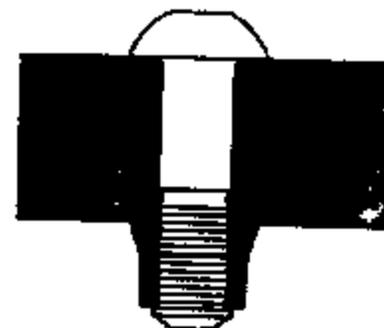
ILLUSTRATION 1

If the huck bolts are installed per illustration #1 then no further action is needed.

CORRECT COLLAR INSTALLATION SHOWN
