RE: Safety Recall Campaign No. 99V-101

TECHNICAL SERVICE BULLETIN TS-99-2

**SUBJECT: 1999 GRAND TOUR SERIES, CHEYENNE and NEVADA MODELS
"TIRE CLEARANCE SAFETY RECALL"**

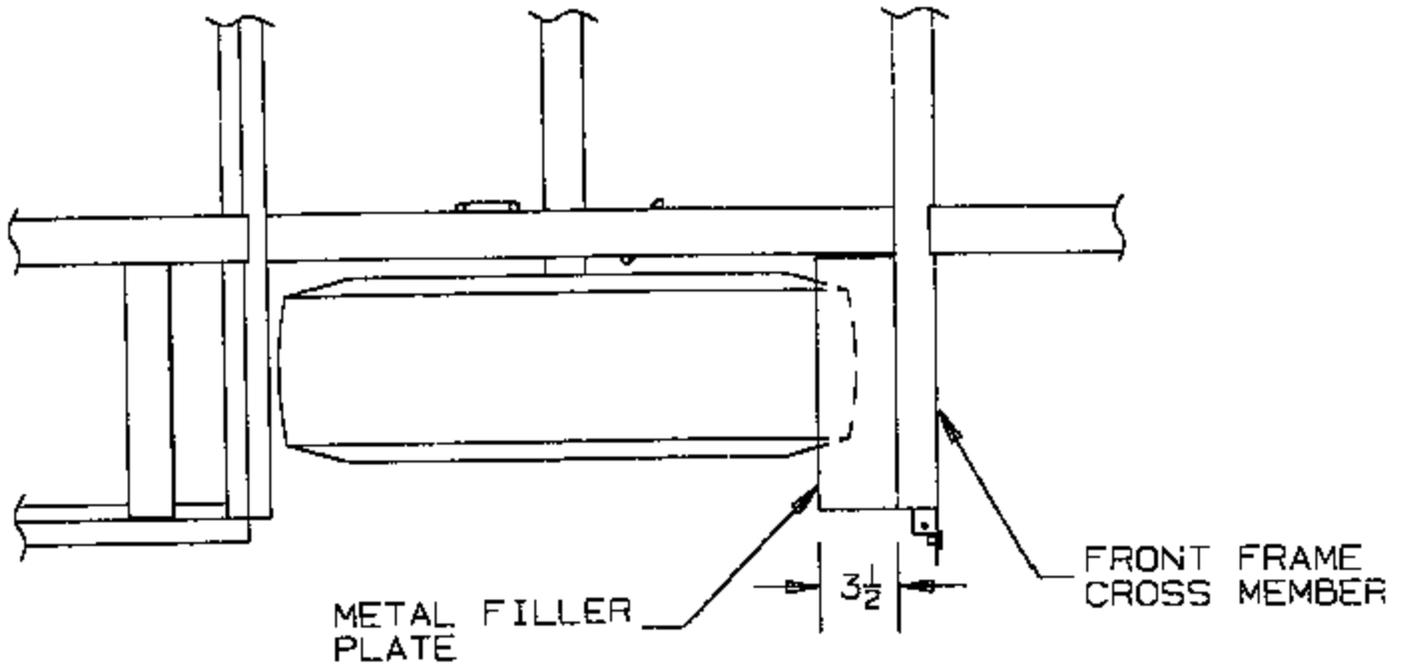
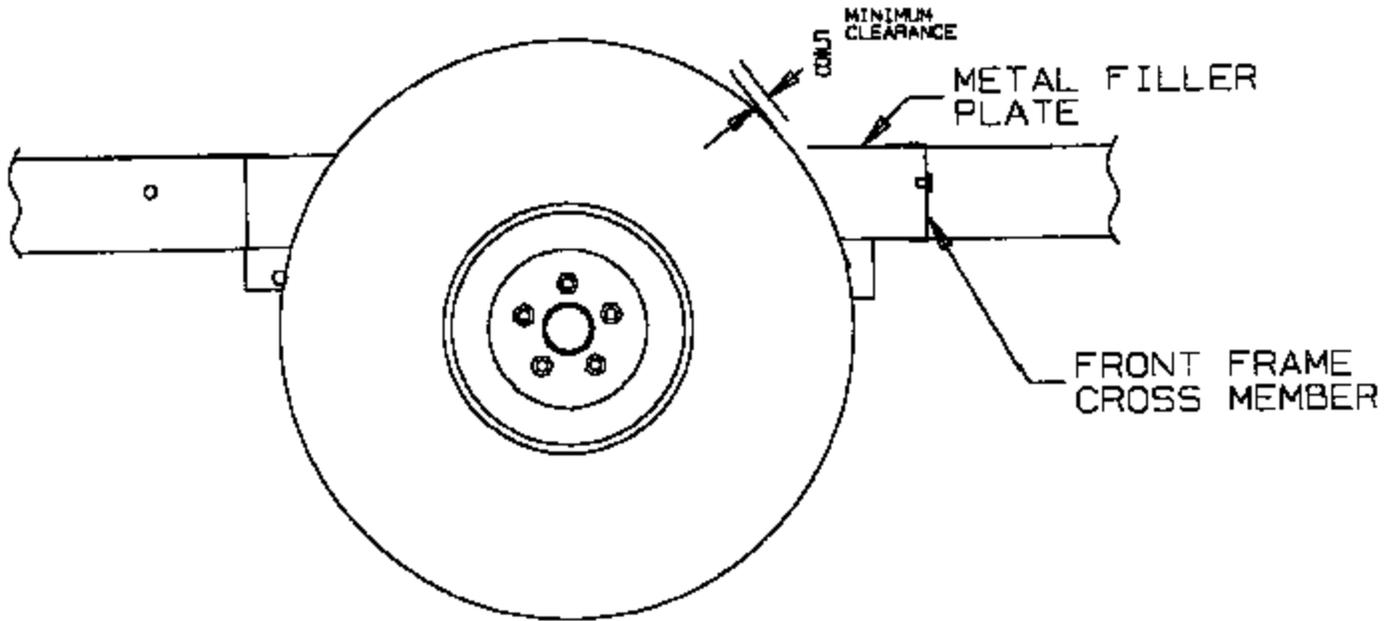
Nature of Defect: Improper tire clearance between the wheel and the front frame cross member.
NOTE: Minimum allowable clearance is 5/8".

1. Using the tape measure, inspect both the roadside and curbside tire clearance between the wheel and the front frame cross member, in particular, the metal filler plate that extends into the wheel well opening. (Refer to attached diagram.)

7. Remove all five of the 13/16" lug nuts and remove the tire and rim. Lay parts aside.
8. Using the electric jig saw or reciprocating saw, with a metal cutting blade, cut back the metal filler plate on the front frame cross channel. The filler plate should be cut back a minimum of 5/8" for tire clearance or as far toward the plastic wheel well as physically possible. Remove any sharp metal burrs from the frame cross member. Finish the rough edges with a grinder if necessary.

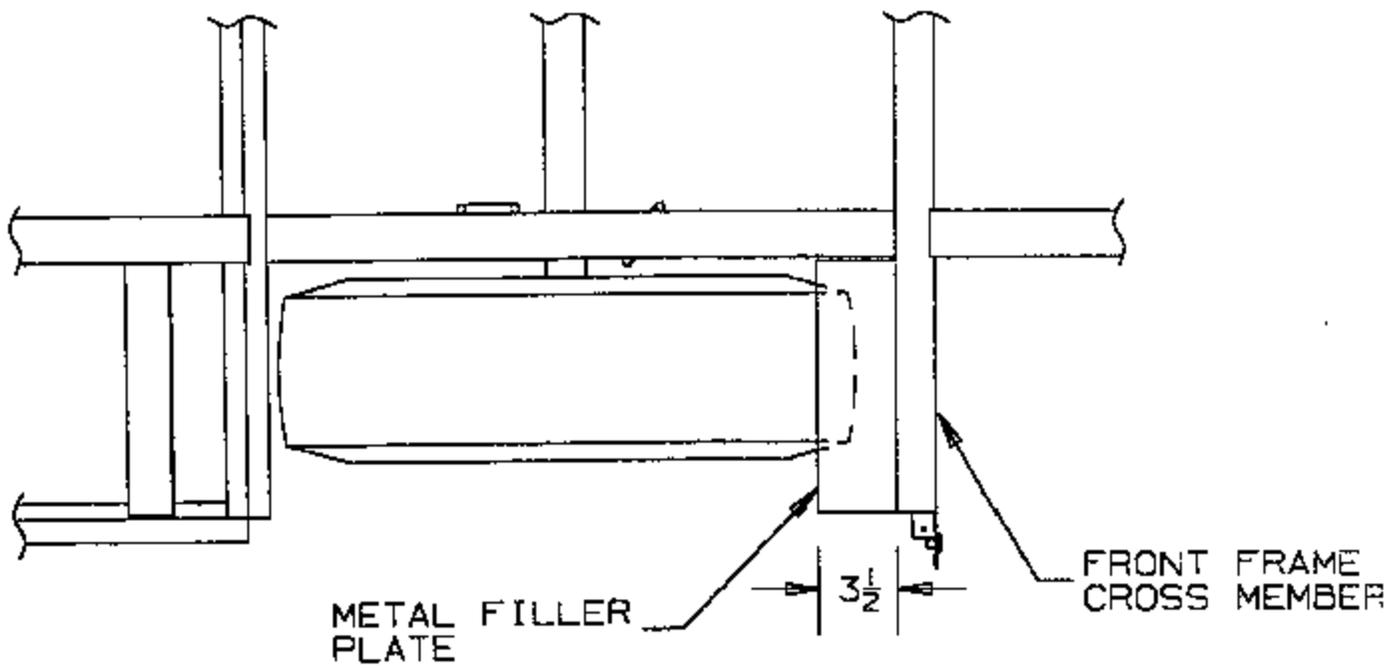
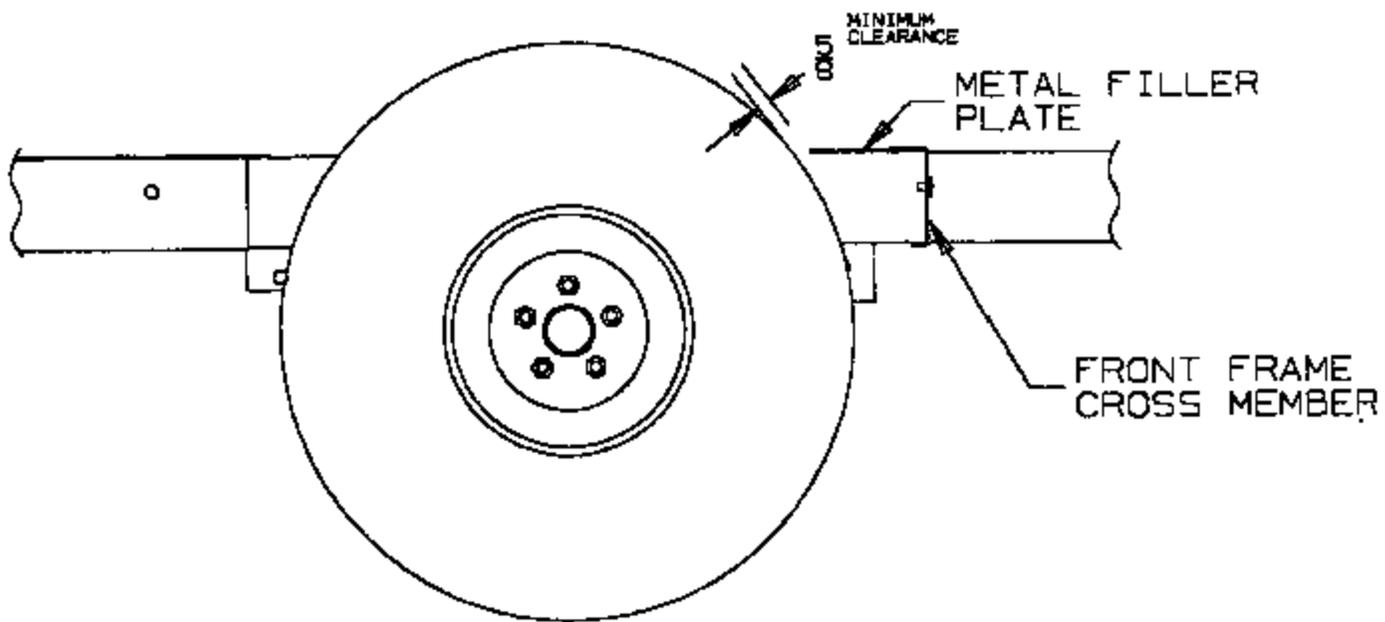
Nature of Defect: Improper tire clearance between the wheel and the front frame cross member.
NOTE: Minimum allowable clearance is 5/8".

1. Using the tape measure, inspect both the roadside and curbside tire clearance between the wheel and the front frame cross member, in particular, the metal filler plate that extends into the wheel well opening. (Refer to attached diagram.)

7. Remove all five of the 13/16" lug nuts and remove the tire and rim. Lay parts aside.
8. Using the electric jig saw or reciprocating saw, with a metal cutting blade, cut back the metal filler plate on the front frame cross channel. The filler plate should be cut back a minimum of 5/8" for tire clearance or as far toward the plastic wheel well as physically possible. Remove any sharp metal burrs from the frame cross member. Finish the rough edges with a grinder if necessary.
