Date	Number	Page
08/12/09	SC0341	1(4)

BFI Front Axle Beam

SC0341, BFI Front Axle Beam

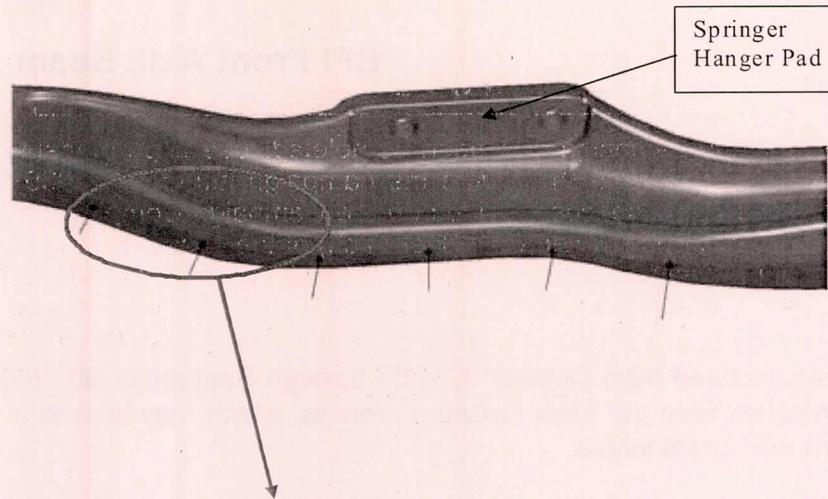
1. **Inspection Area:** The inspection area will be a two foot wide section on both the drivers and passenger side on the bottom of the axle centered on the spring hanger pad. A marker can be used to identify these sections prior to the cleaning and inspection.
2. **Cleaning:** The front steer axle beam must be cleaned to remove any dirt, oil, grease or any loose scale that could hinder visual inspection. A power washer, degreaser, or wire brush can be used to clean up the area. The technician must then visually inspect for notches, as indicated below in

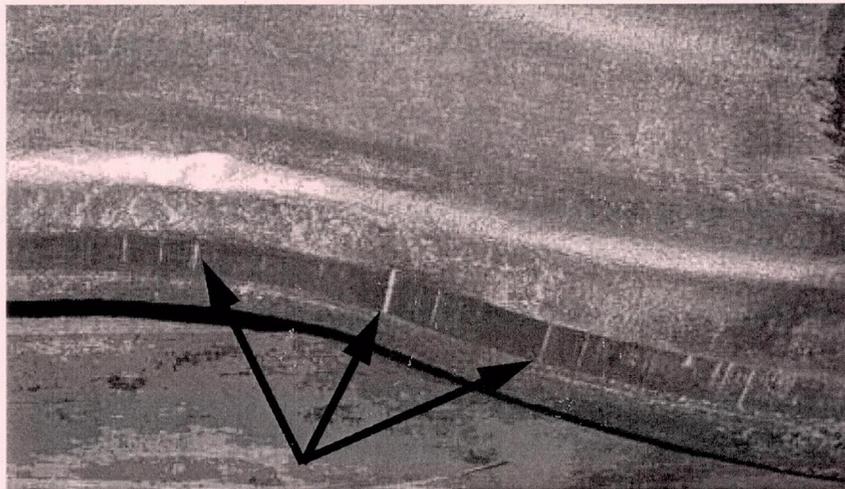
Figures 1 and 2 — Example of inspection area and axle beam with transverse notches

On certain vehicles manufactured from October 1, 2003 through September 30, 2004, the axle beam may have transverse notches from the manufacturing process, which may lead to a fatigue crack that can possibly result in an axle beam failure.

Specifically, the front axle beam is to be inspected for cracks and transverse notches in the bottom flange of the beam. Replacement of the axle is required if a crack is found. Additionally, beams found with cracks or transverse notches (see figure 2 on pg 2) are to be reported to Mack OneCall (1-800-866-1177) for further instruction.

figure 2, or cracks in the axle beam. Special attention must be made in the longitudinal area (parting line) where the axle is forged in two halves (See figure 2). **This area must be smooth without any notches or cracks.**

Axle beams with cracks or transverse notches must be replaced.

- If cracks are found, then the vehicle must be placed out of service until the axle beam is replaced.
- If notches are found, then the vehicle can be placed back in service until the parts are received.
