REPORT NUMBER: 201-CAL-09-03

**SAFETY COMPLIANCE TESTING FOR FMVSS 201  
OCCUPANT PROTECTION IN INTERIOR IMPACT**

**GENERAL MOTORS CORPORATION  
2009 CHEVROLET MALIBU**

FINAL REPORT

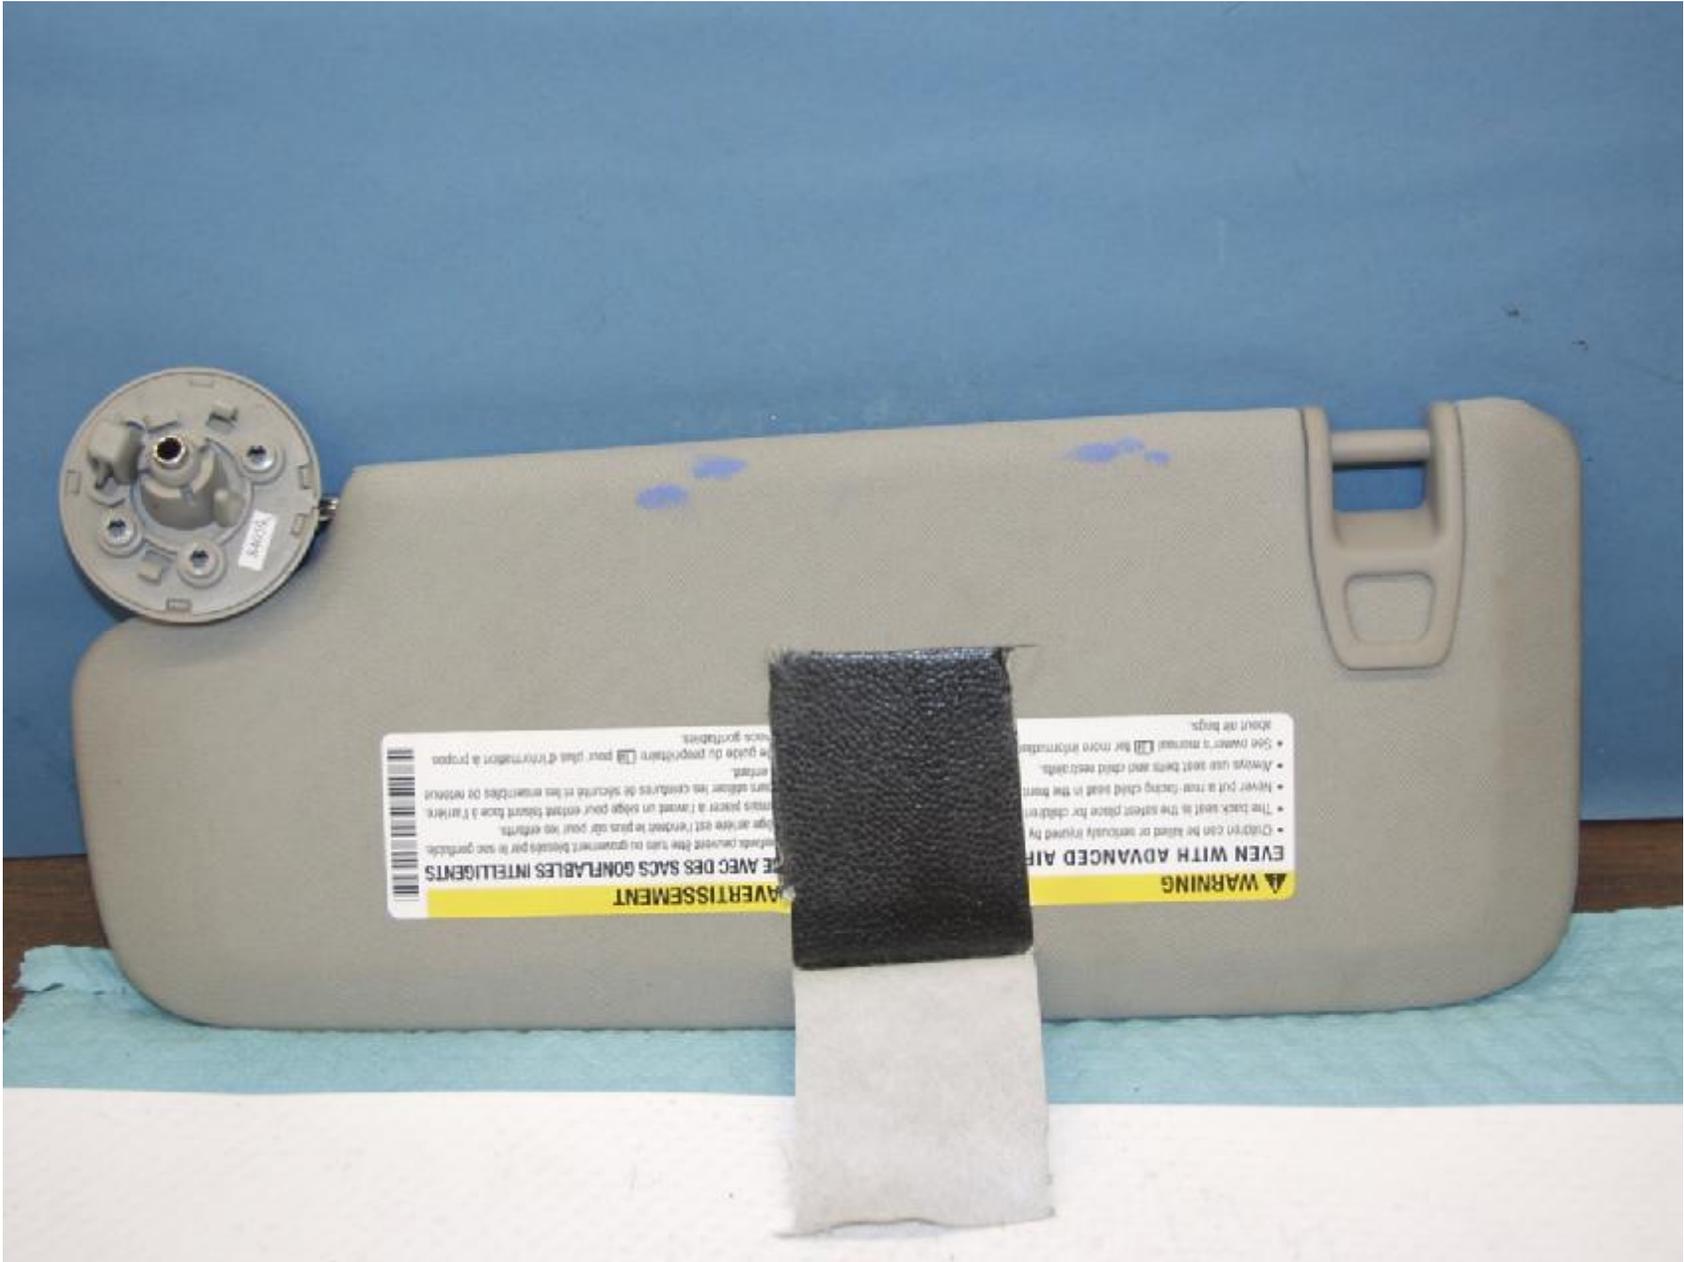
Figure A-7 : SUN VISOR CONSTRUCTION

1. Are sun visors constructed of or covered with energy absorbing material?

YES (PASS): X

2. Are any edges statically contactable by a spherical 165 mm (6.5 inch) diameter head form of radius less than 31.75 mm (1.25 inch)?

NO (PASS): X

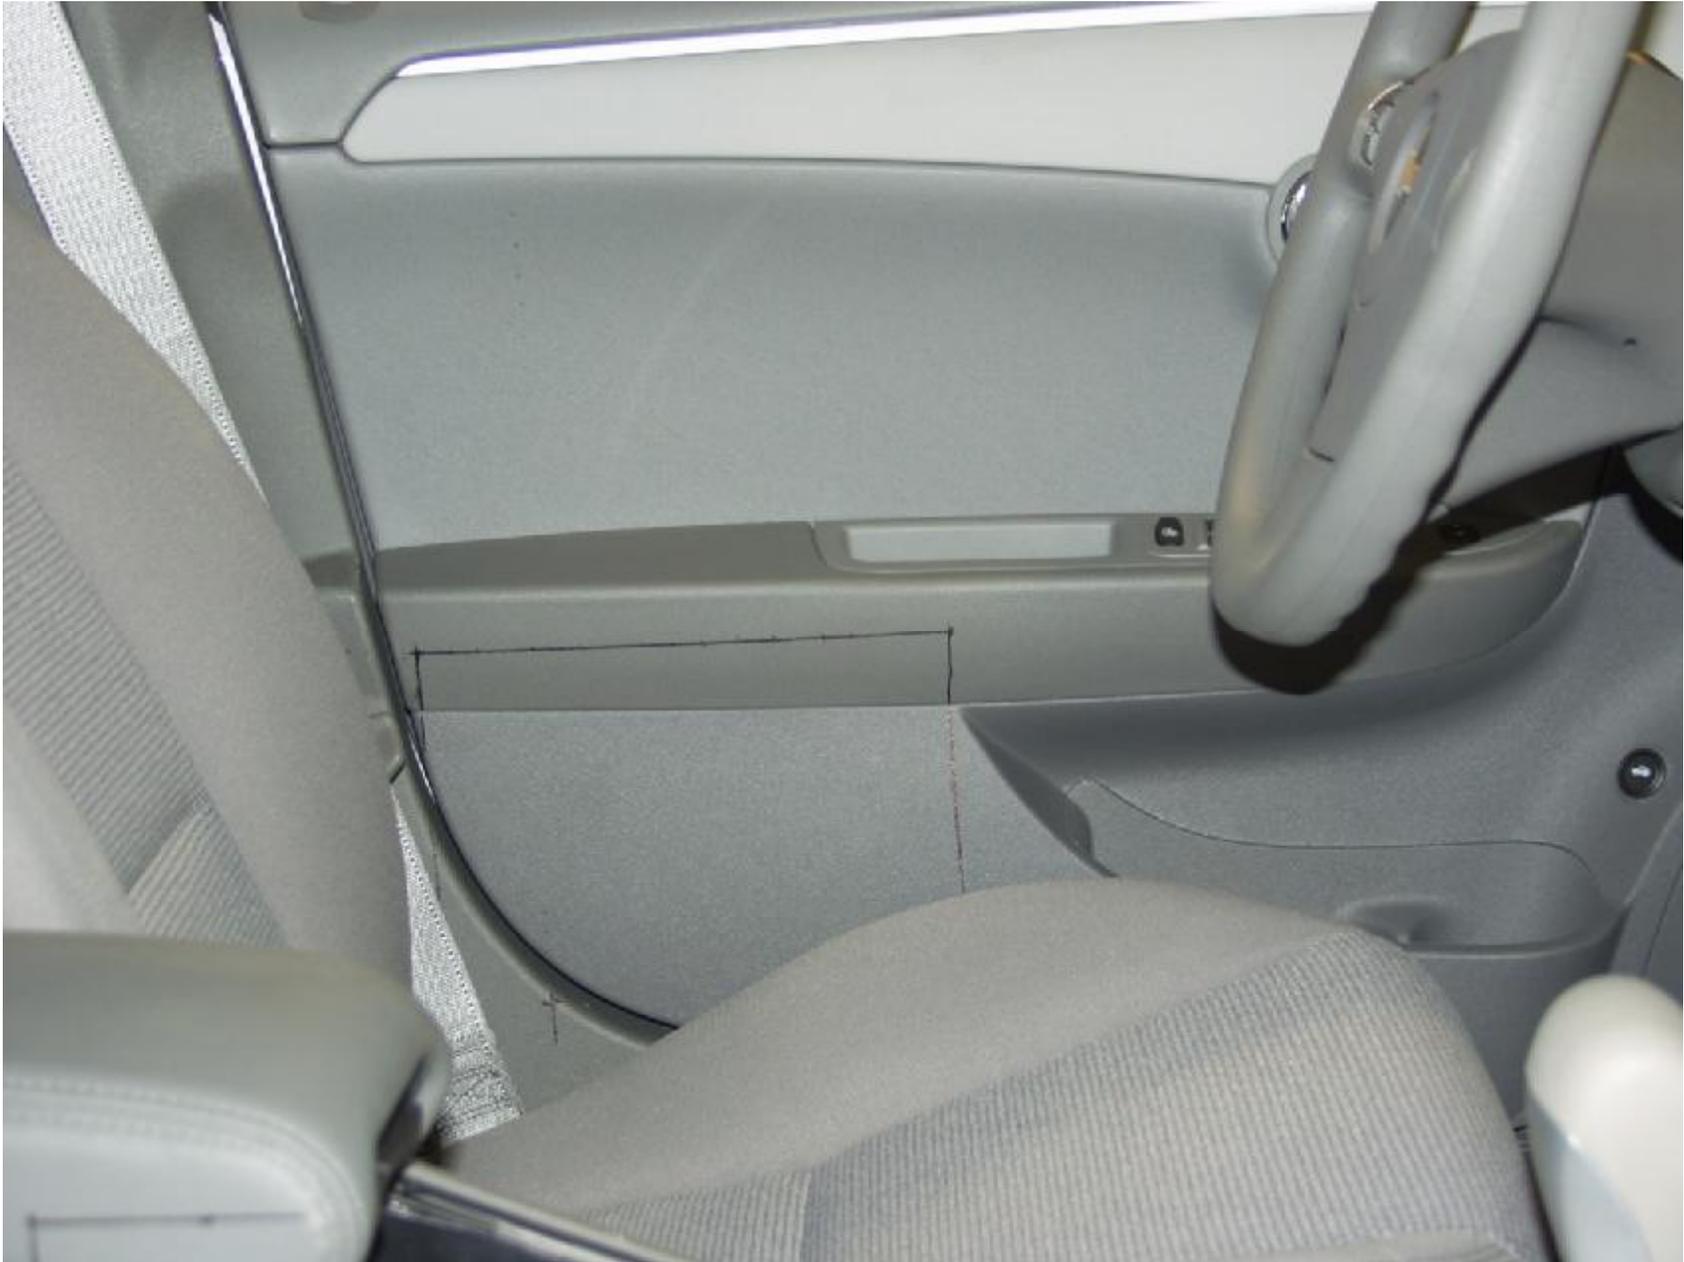
Figure A-8 : ARMREST LEFT FRONT DOOR

3. Does it provide adequate pelvic area impact protection?

YES: X

4. Does it meet at least one of the criteria No. 1 to 3?

YES (PASS): X

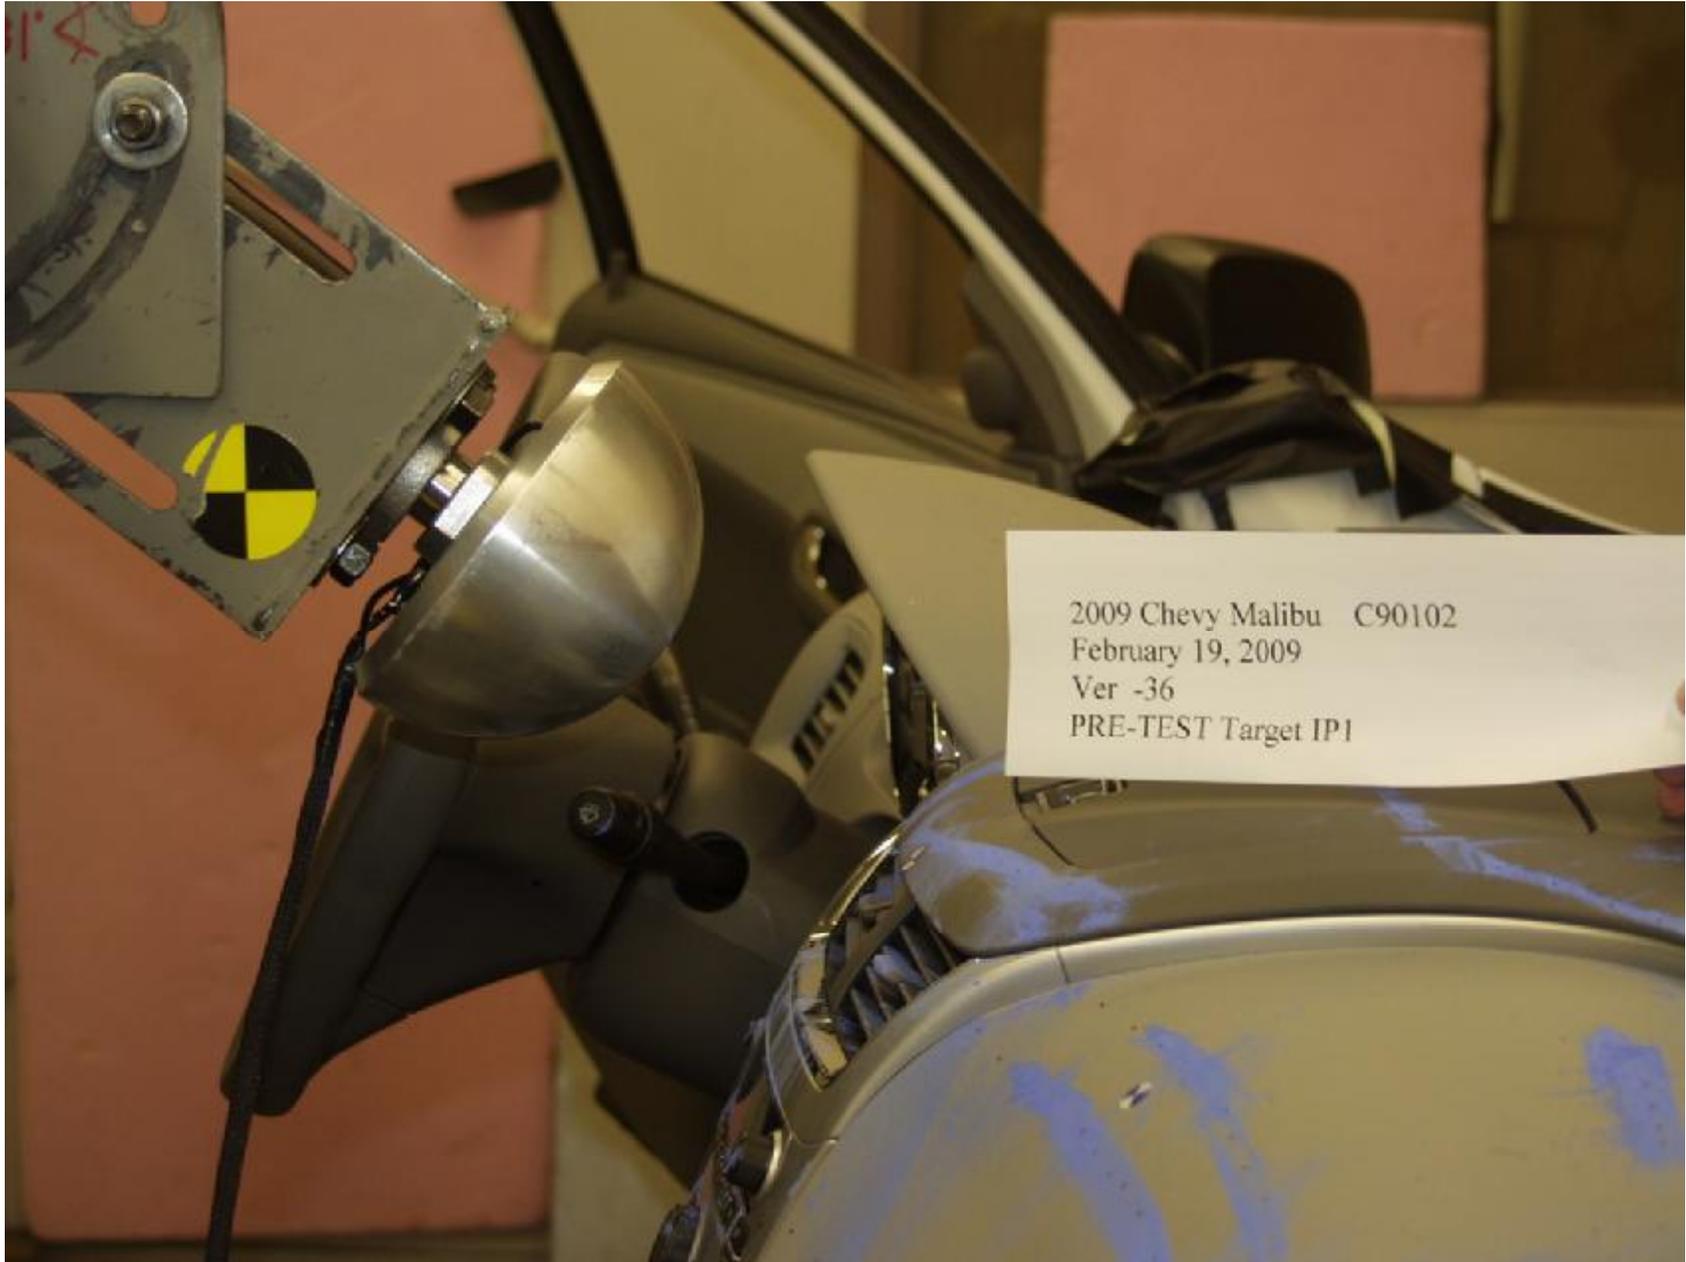
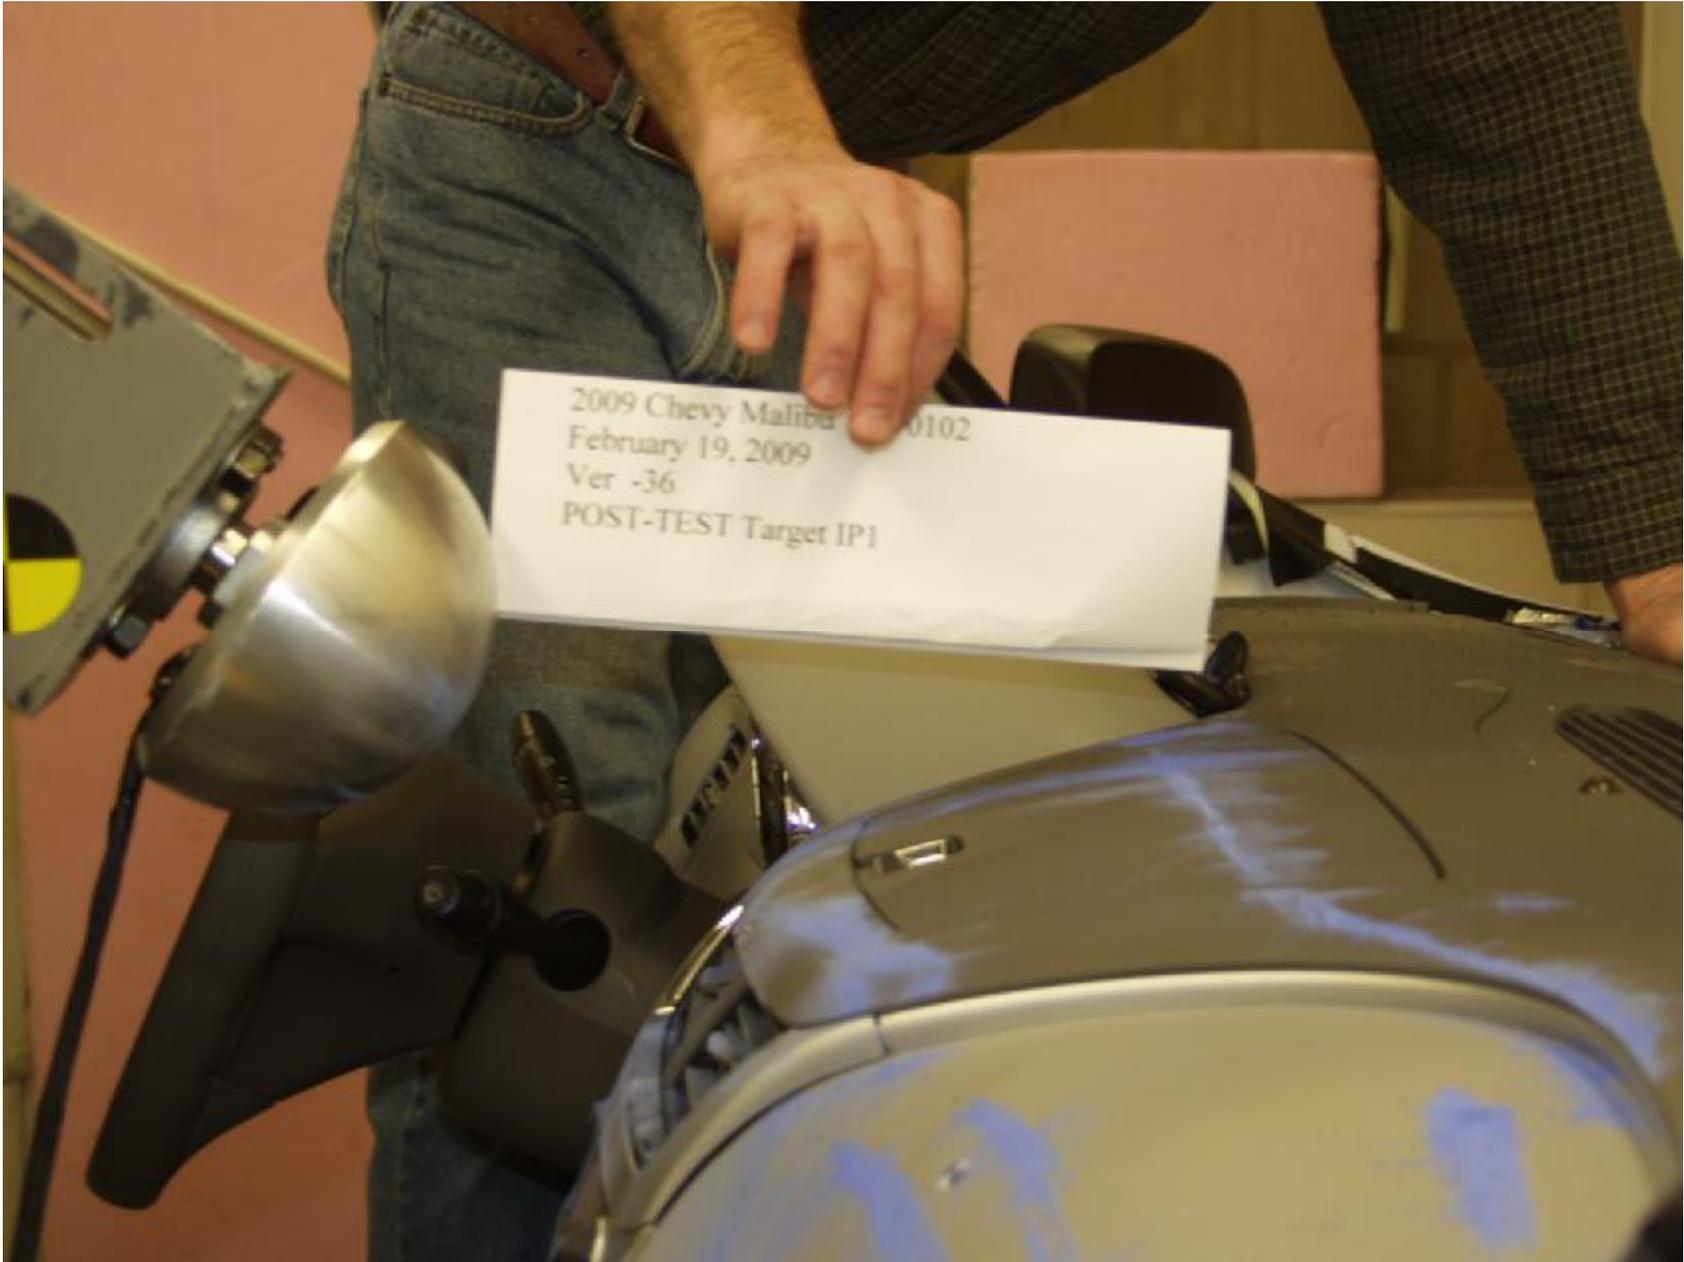
IMPACT LOCATION AND NUMBER				VELOCITY (kph)	PEAK ACCELERATION (3 ms Clip) Gs
TARGET	X (mm)	Y (mm)	ANGLE (degrees)		
Center Cluster below Storage Bin	2488	14	36	18.75	48.19
Left Side of Airbag Cover	2432	263	49	18.60	57.48
Right Side of Airbag Cover	2442	514	49	18.62	56.89

Figure A-14 : INSTRUMENT PANEL IMPACT #1 PRE-TEST

Figure A-15 : INSTRUMENT PANEL IMPACT #1 POST-TEST

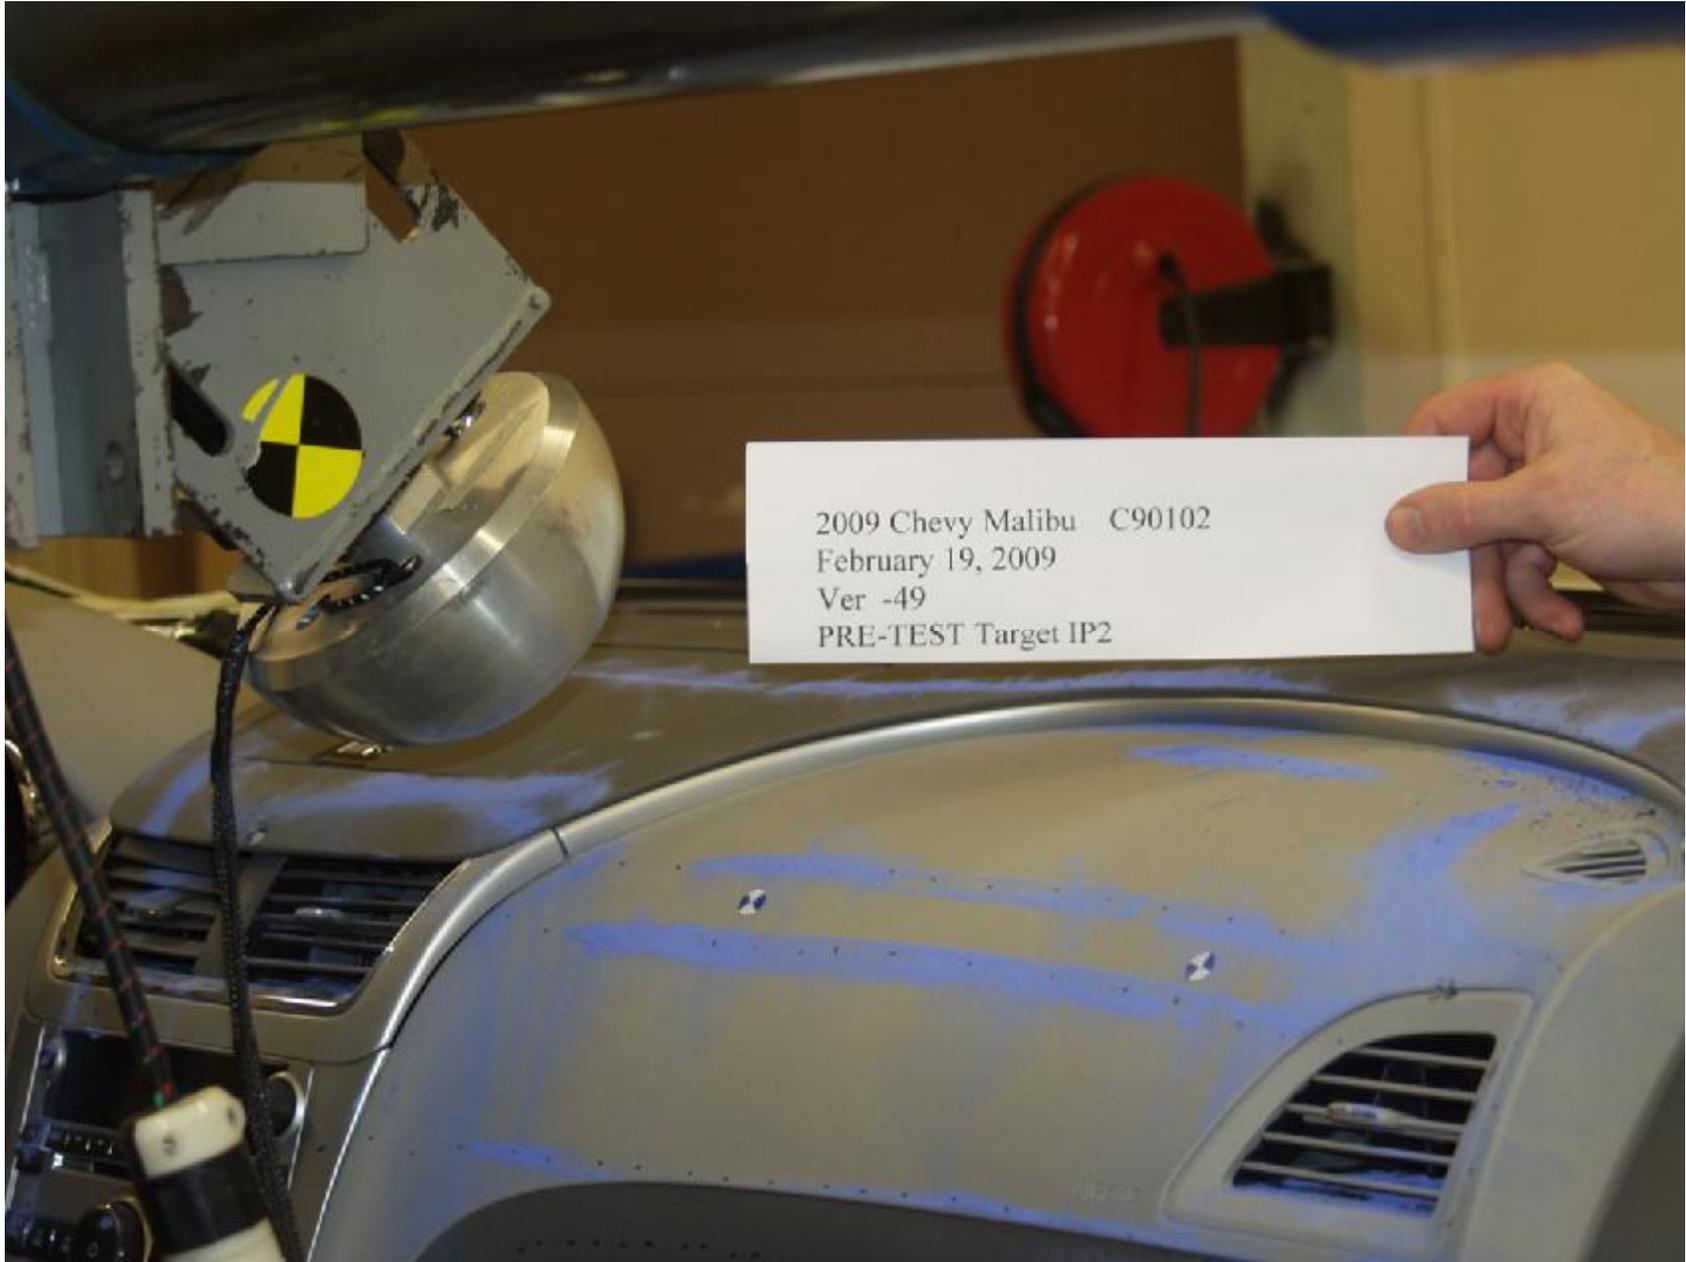
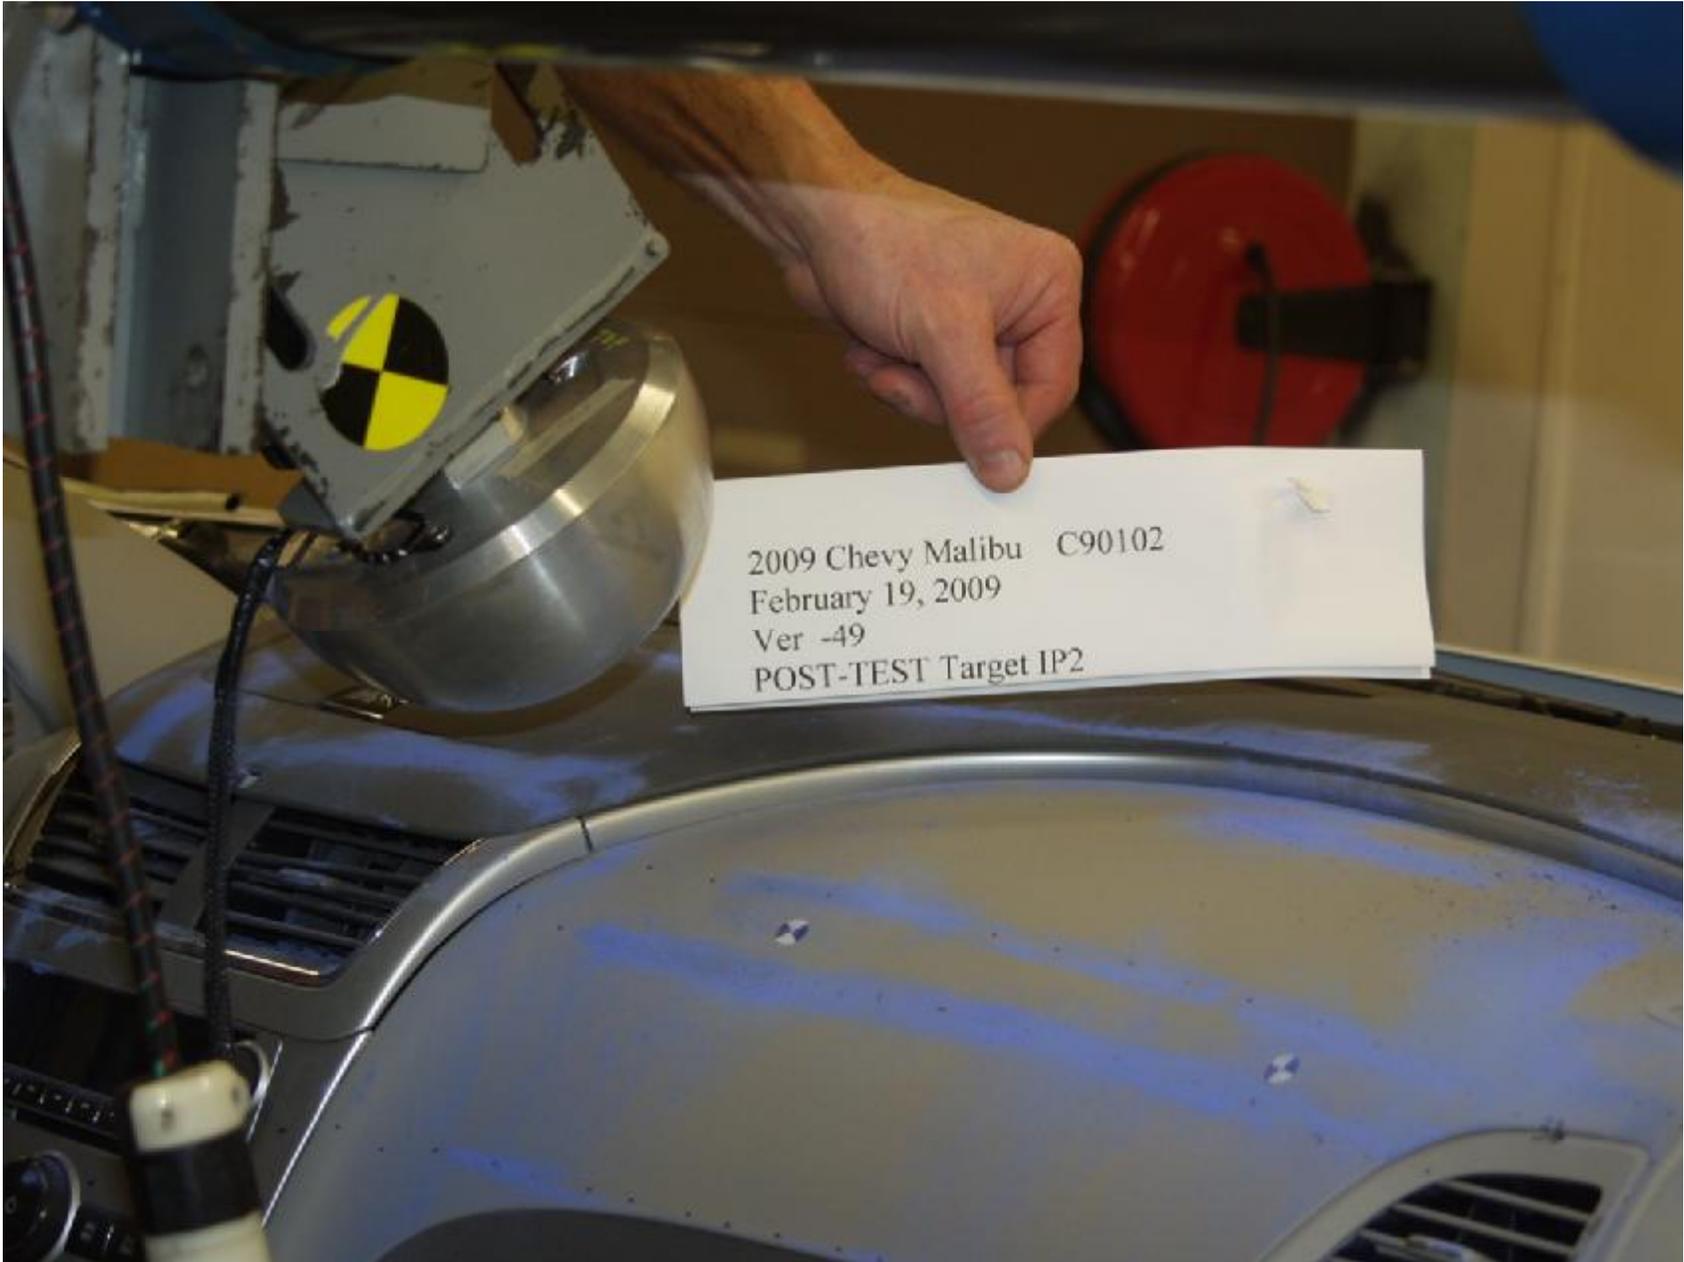
Figure A-16 : INSTRUMENT PANEL IMPACT #2 PRE-TEST

Figure A-17 : INSTRUMENT PANEL IMPACT #2 POST-TEST

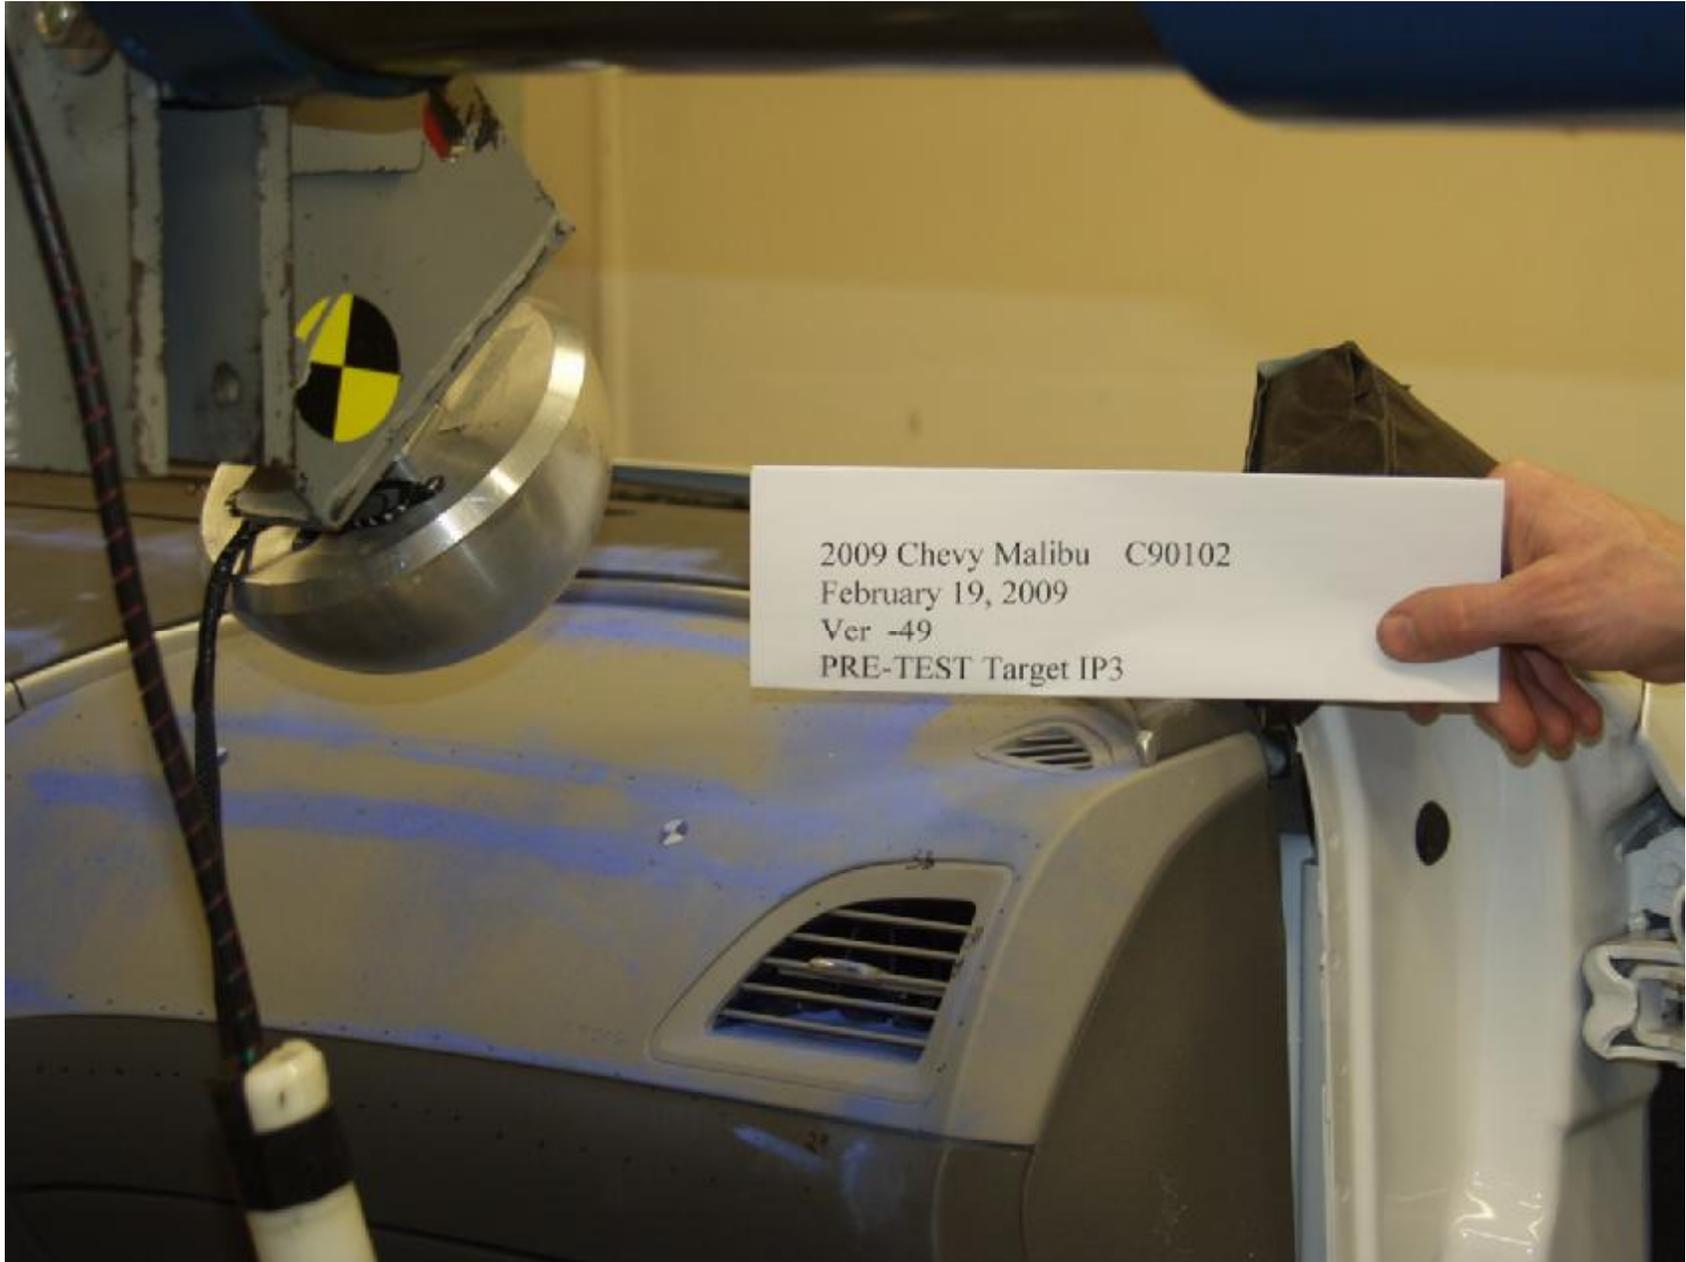
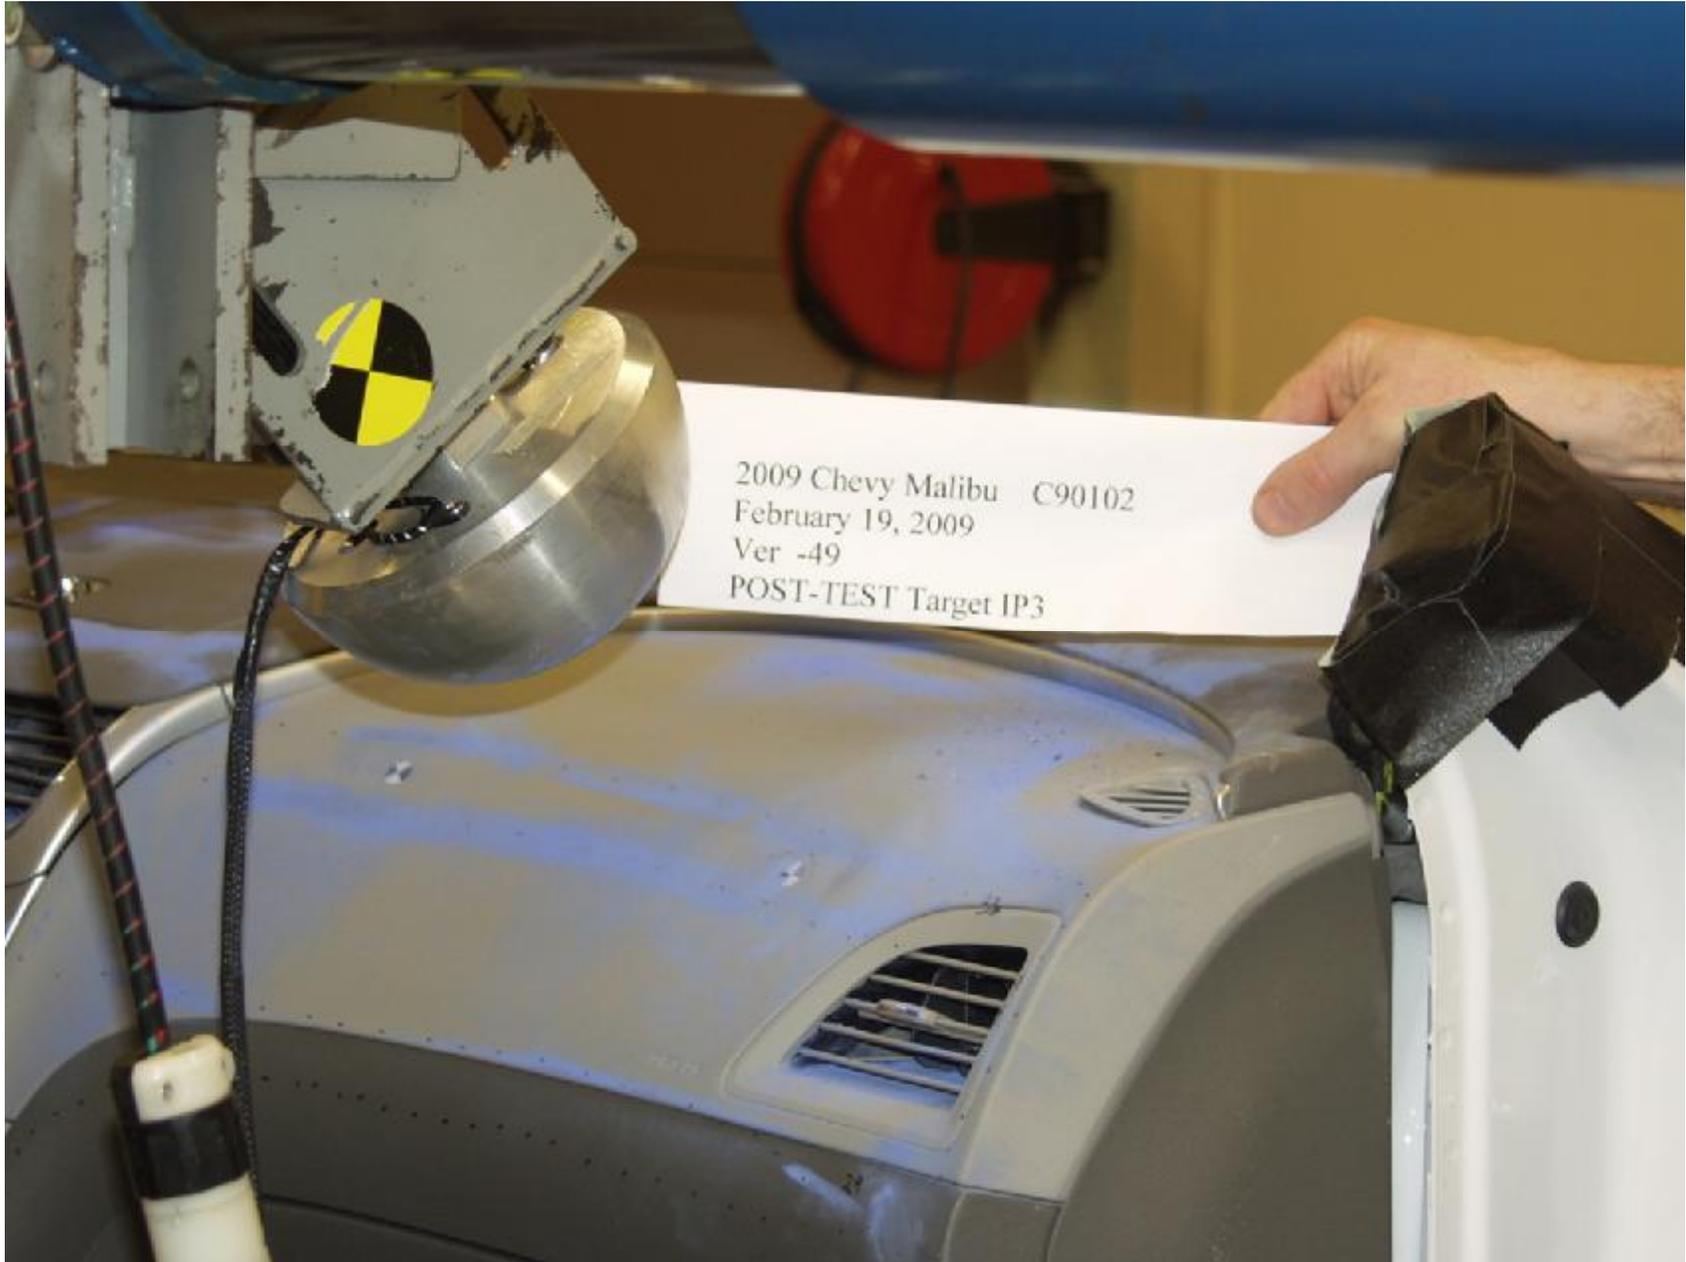
Figure A-18 : INSTRUMENT PANEL IMPACT #3 PRE-TEST

Figure A-19 : INSTRUMENT PANEL IMPACT #3 POST-TEST

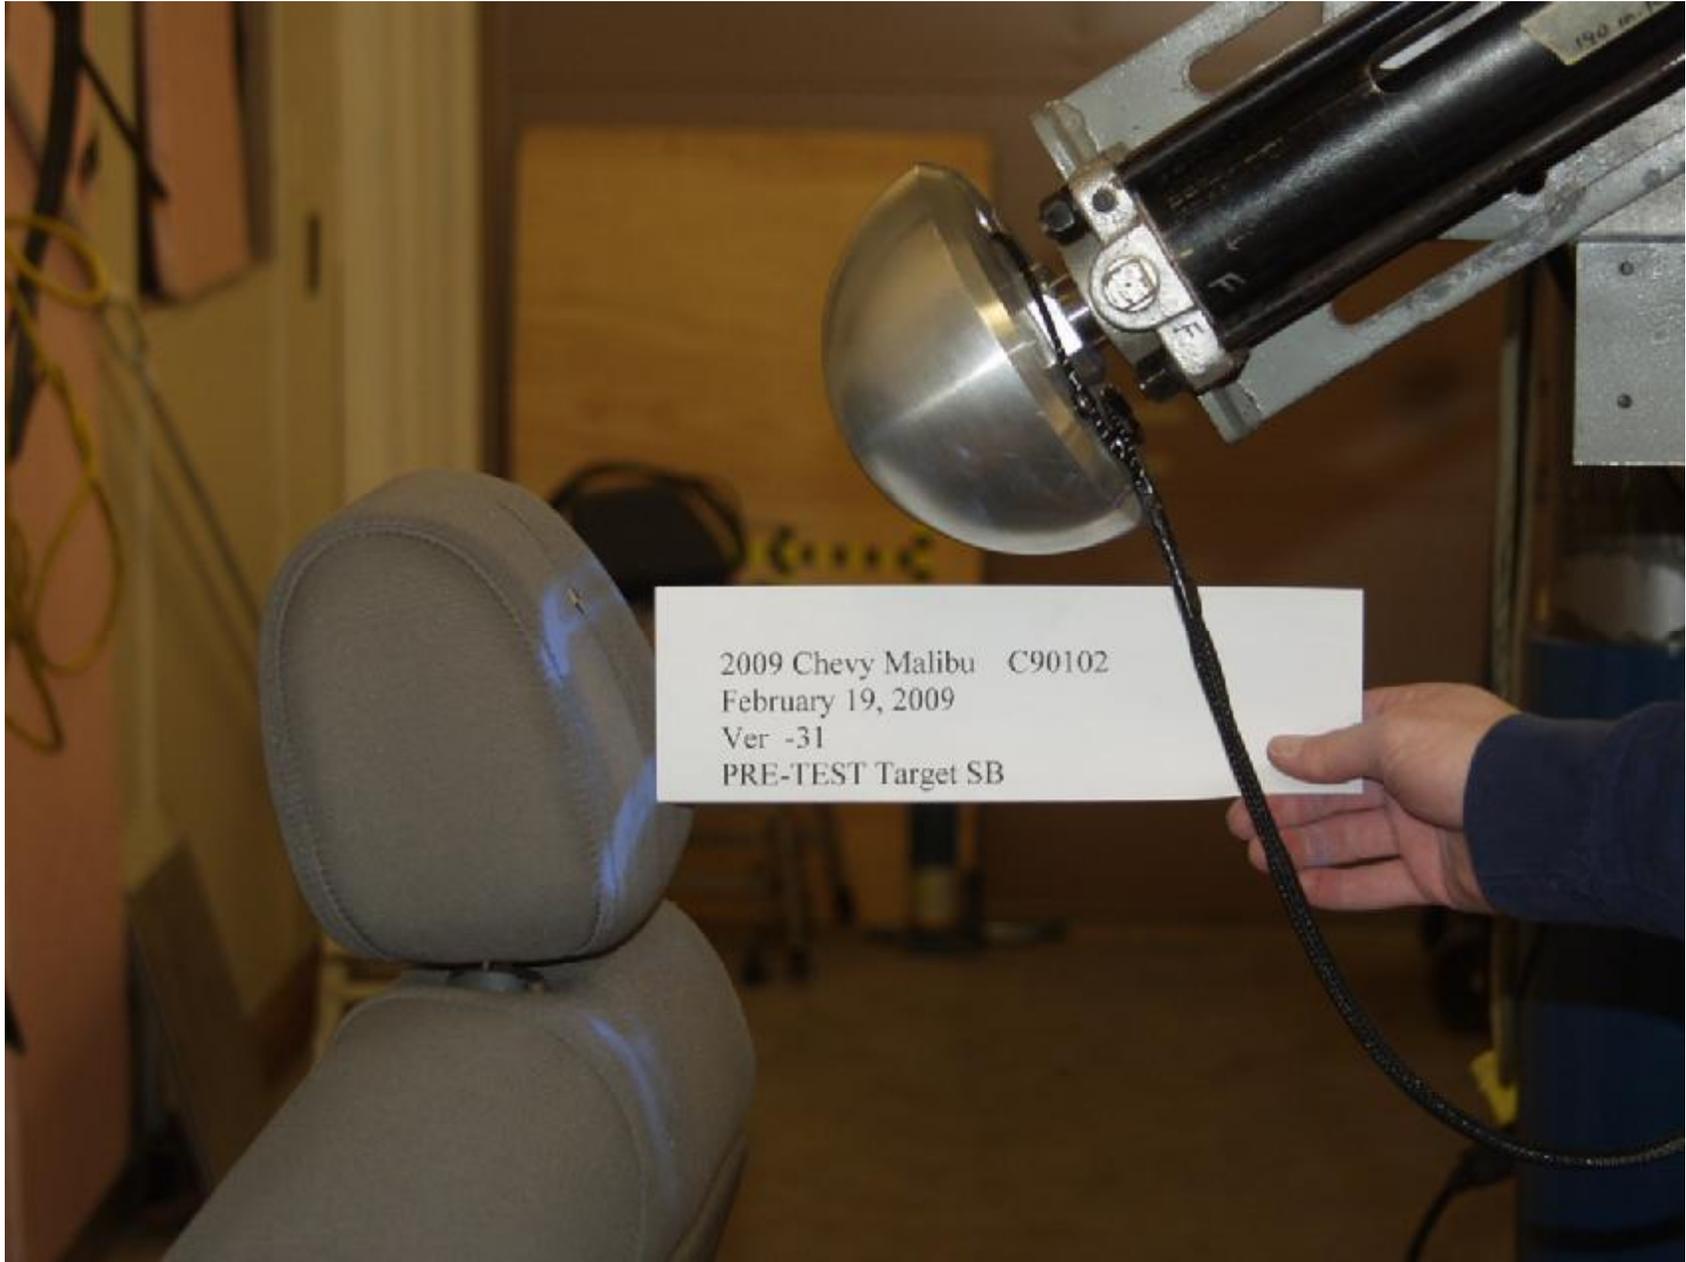
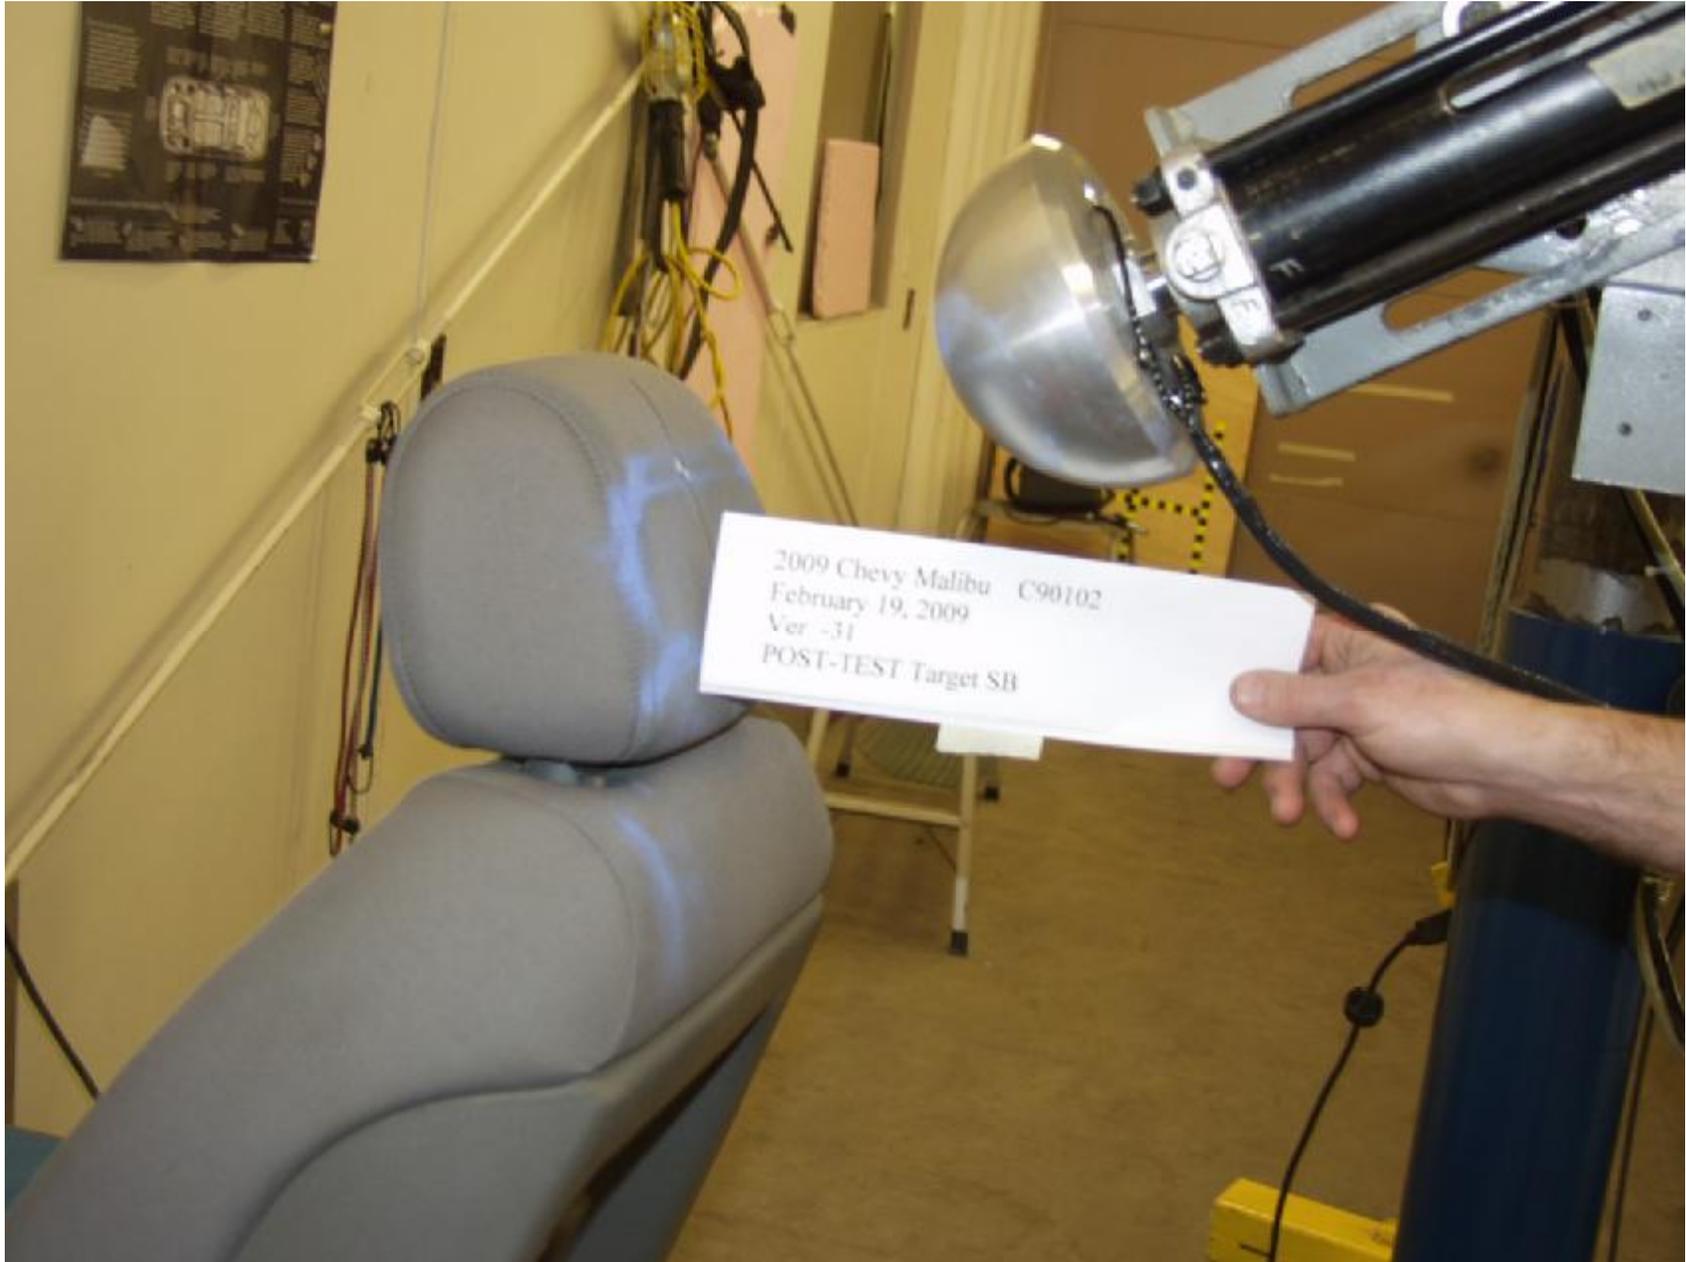
IMPACT LOCATION AND NUMBER				VELOCITY (kph)	PEAK ACCELERATION (3 ms Clip) Gs
TARGET	X (mm)	Y (mm)	ANGLE (degrees)		
Seat Back Head Restraint	3547	354	31	23.61	41.34

Figure A-21 : HEAD RESTRAINT IMPACT AREA PRE-TEST

Figure A-22 : HEAD RESTRAINT IMPACT AREA POST-TEST
