IMPORTANT
DEALER SERVICE INSTRUCTIONS
Safety Recall #541 -- Heater Core
Revised January, 1995

No. 541
May, 1992

Revised January, 1995

To: All Jeep/Eagle Dealers
Subject: Safety Recall #541 -- Heater Core
Models: All 1983 Through 1987 Model Year Renault Alliance & Encore Vehicles

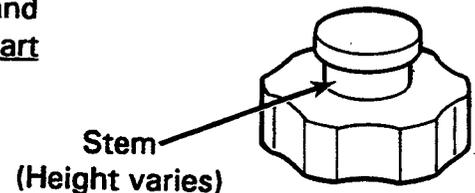
Figure 25

- If a non-black cap with a raised stem is present (Fig. 25), it is an original cap and must be replaced. Install revised cap, Part Number 4546111.

**Raised stem cap
(Not black)
REPLACE**
