Date	Number	Page
09/4/09	<b>SC0341</b>	1(5)

## Front Axle Beam

### SC0341, Front Axle Beam

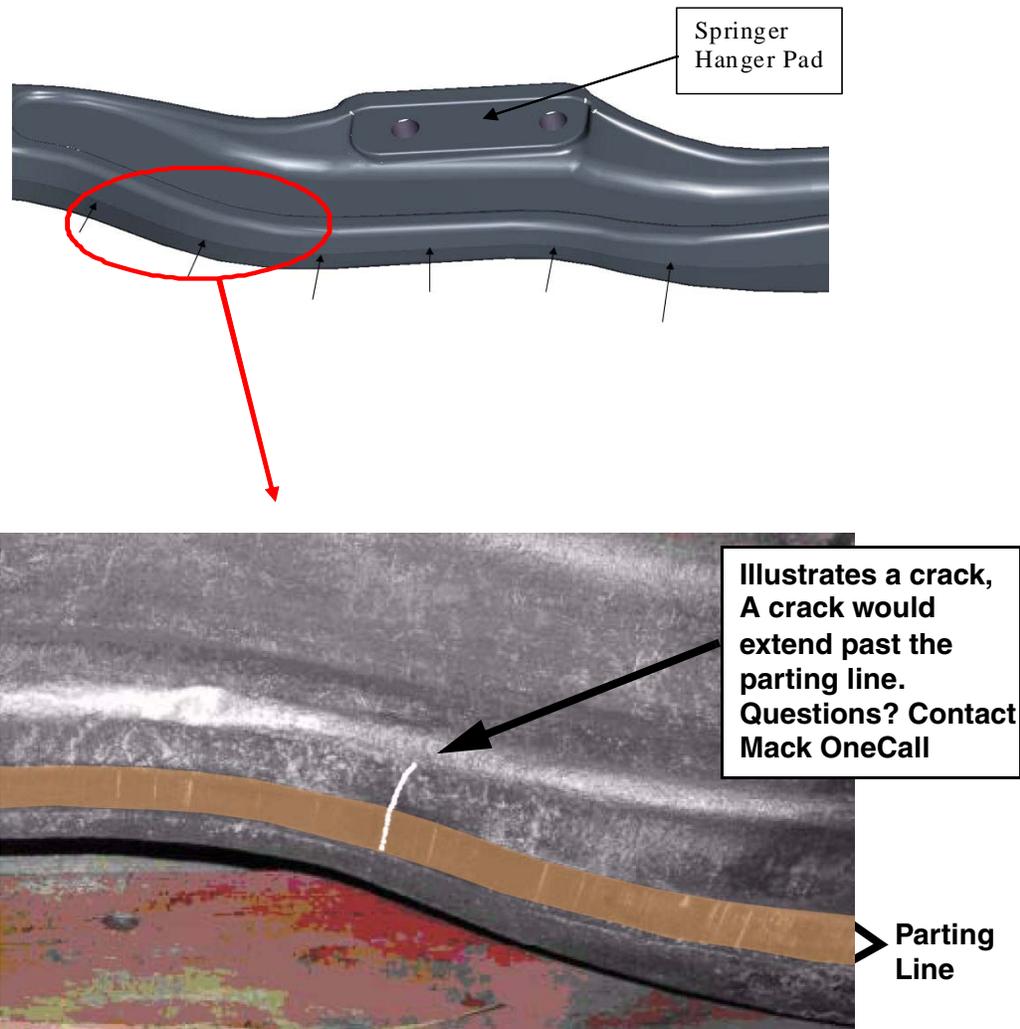
1. **Inspection Area:** The inspection area will be a two foot wide section on both the driver side and passenger side on the bottom of the axle centered on the spring hanger pad. A marker can be used to identify these sections prior to the cleaning and inspection.

2. **Cleaning:** The front steer axle beam must be cleaned to remove any dirt, oil, grease or any loose scale that could hinder visual inspection. A power washer, degreaser, or wire brush can be used to clean up the area. The technician must then visually inspect for notches, as indicated below and cracks in the axle beam. Special attention must be made in the longitudinal area (parting line) where the axle is forged in two halves.

Example of inspection area and axle beam
