Reference: NHTSA Identification Number 99V-245

Safety Recall No. 844 **Brake Warning Lamp Wiring Jumper**

1999 (PR) Plymouth Prowler

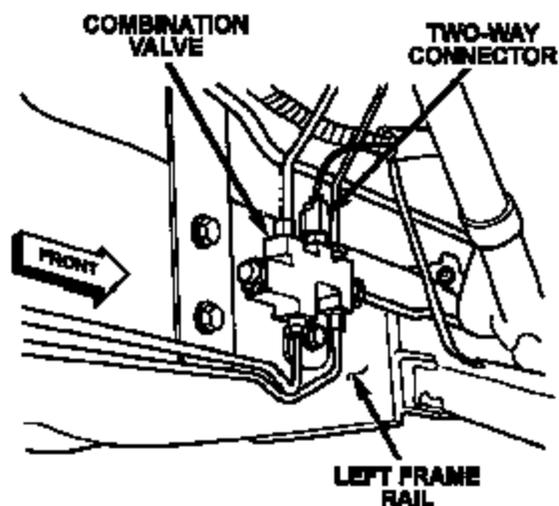
Figure 1

The instrument panel brake warning lamp circuit on about 3,100 of the above vehicles does not contain the required ground wire to illuminate the brake warning lamp in the event of a brake system hydraulic failure. Therefore, the brake system on these vehicles does not comply with Federal Motor Vehicle Safety Standard (FMVSS) No. 105 – Hydraulic Brake Systems.

2. Disconnect the two-way wiring connector on the brake combination valve (Figure 1).
3. Using a small screwdriver, slide the white lock wedge to the unlock position in the two-way connector (Figure 2).
4. Remove and discard the green rubber plug from the two-way connector (if present).
5. Insert the wiring jumper female terminal into the open cavity at the rear of the two-way connector.
