February 10, 2010

**Subject: Customer Notice
Remote Accelerator Switch**

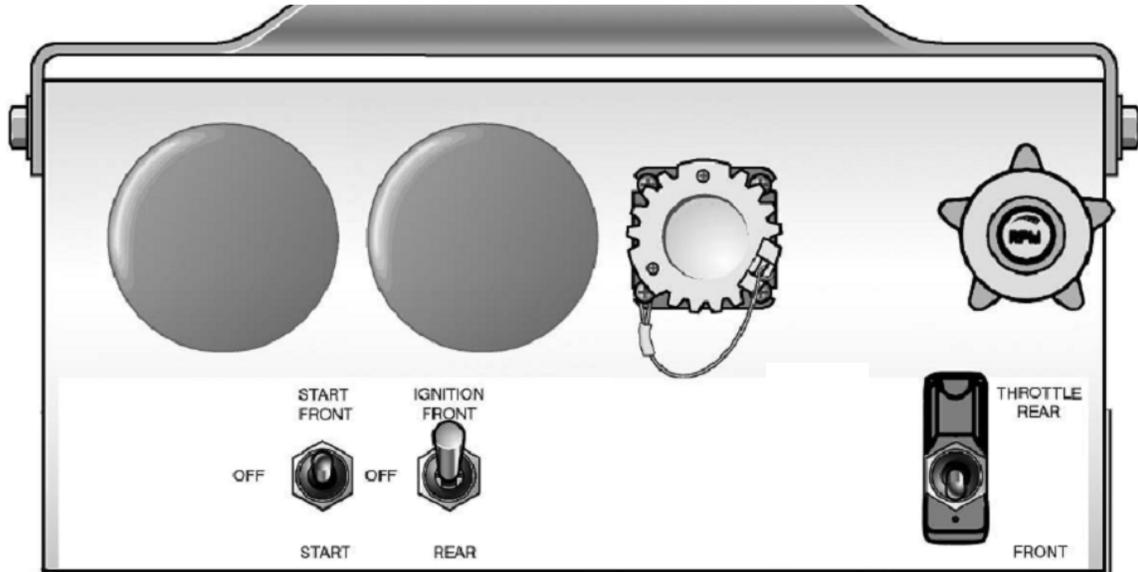
Diagram – Engine Box Configuration

Daimler Bus has determined that after completion of maintenance, if the remote accelerator switch has not been returned to its original position ("FRONT") and the throttle adjustment knob is not set at its minimum value, there is a possibility that a higher than expected acceleration can occur when the bus is first started after maintenance and the bus is put in gear when the brake is applied. **This condition will only occur after maintenance, and will not occur when the vehicle is in revenue service.** Until issuance of the Recall Bulletin and implementation of the required fix, if a bus has the remote accelerator switch option, bus maintainers are to ensure the following service procedures are followed after completion of engine maintenance:

An example of an engine box configured correctly after maintenance has been completed and the vehicle is ready to be started from the front of the vehicle.

- 1) Set the remote accelerator control knob to its lowest setting ('RPM'); and
- 2) Set the remote 'THROTTLE' switch to the 'OFF' or 'FRONT' position; and
- 3) Set the 'IGNITION' switch to the 'FRONT' or 'FORWARD' position.
