**Re: Defect Information Report – Supplemental Report No. 3
09V-357, FL-557, Rack and Pinion Steering Inner Tie Rod Ends**

Subject: Rack and Pinion Steering Inner Tie Rod Ends

Models Affected: Specific Freightliner Cascadia, Century Class S/T, Columbia, and Coronado vehicles manufactured November 11, 2004, through July 20, 2009, with rack and pinion steering.

Work Instructions

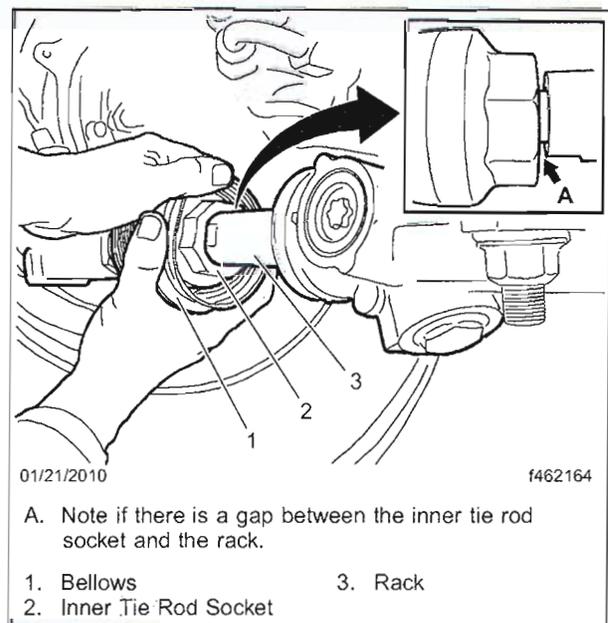
Fig. 2, Inner Tie Rod Inspection

9. Visually inspect the connection between the rack and the inner tie rod. Note if there is a gap present between the inner tie rod socket and the rack (Fig. 2, Items 2, 3, and A). This information will be used in step 32.
10. Place a jack under the left side of the front axle and jack up the driver-side steer tire, making sure the passenger-side tire remains firmly on the ground. Support the vehicle with a jack stand.
11. Remove the cotter pin and castellated nut and disconnect the driver-side outer tie rod from the tie rod arm.
12. Install the holding fixture as follows.

32. If a gap was found between the inner tie rod socket and the rack in step 9, adjust each tie rod length to obtain the specified toe-in dimension, as follows. Use a toe bar or tape measure to complete the following steps. If no gap was found, go to step 33.
 - 32.1 Loosen the driver-side tie rod jam nut. If necessary, hold the inner tie rod in place with a backup wrench on the inner tie rod flat (**Fig. 11**, Item 3).
 - 32.2 With the gear on-center, place a wrench on the driver-side inner tie rod flat and align the left tire by rotating the inner tie rod.

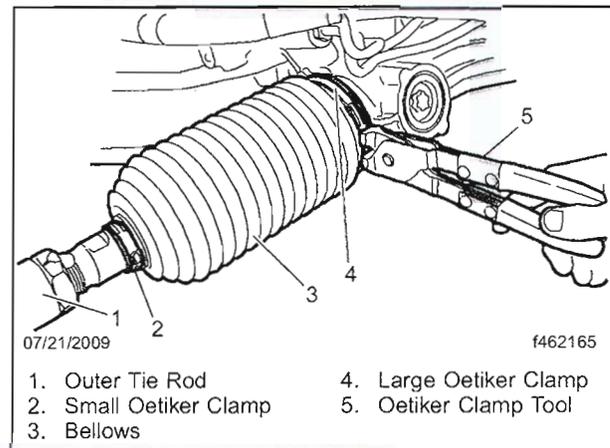
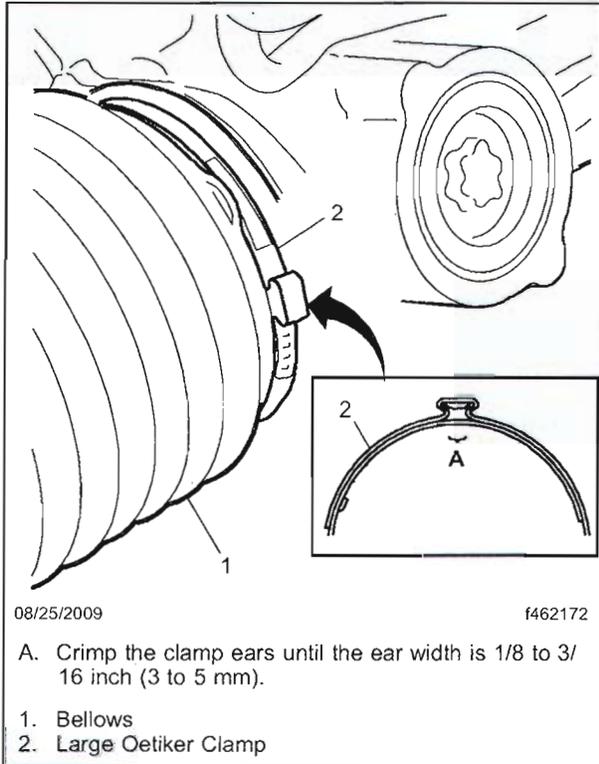
IMPORTANT: All three barbs on the clamp must be engaged. If all three barbs are not engaged after crimping, remove and discard the clamp and install a new clamp. Oetiker clamps must be adequately crimped and the boot must be tightly secured to the gear housing to prevent moisture intrusion and corrosion.

27. Using an Oetiker clamp tool, crimp the large Oetiker bellows clamp ear until the inner ear width is 1/8 to 3/16 inch (3 to 5 mm). See Fig. 8 and Fig. 9.
