SUBJECT: Recall Campaign 094 - Front Passenger Seat Belt Tension Sensor Wiring Harness - TSB# 10-01-008

HYUNDAI Technical Service Bulletin

Group	CAMPAIGN
Number	10-01-008
Date	FEBRUARY, 2010
Model	AZERA 2006 ~ 2009

Subject: **FRONT PASSENGER SEAT BELT AND BTS WIRE FIXING CLIP REPLACEMENT - DTC B1489/B1495 (CAMPAIGN 094)**

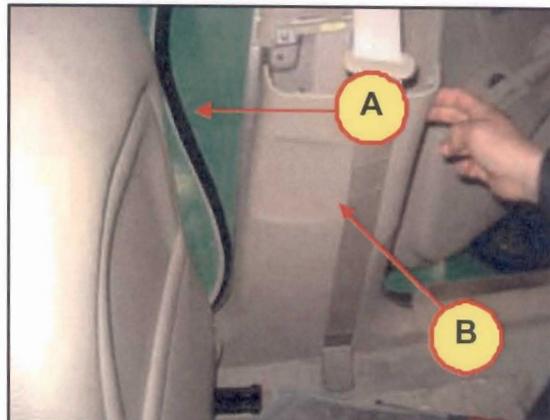
Condition	Procedure
Air bag warning lamp illumination with DTC B1489 or B1495.	Replace the front passenger seat belt and the Belt Tension Sensor (BTS) wire fixing clip with newly supplied components.
No air bag warning lamp illumination or air bag warning lamp illumination with DTCs other than B1489 or B1495.	Replace the BTS wire fixing clip with newly supplied components and reroute the wire harness.

1. Remove ignition key from ignition cylinder.
2. Disconnect the negative terminal of the battery. Wait at least 30 seconds after disconnecting the battery cable before proceeding.
3. Slide the front passenger seat forward
4. Partially remove the right side front and rear weatherstrips (A) to remove the B pillar lower trim (B).
5. Remove the B pillar lower trim (B).
