# TOYOTA CUSTOMER SERVICES

To: All Region/Private Distributor General Managers/Vice Presidents  
From: Bob Waltz, Vice President, Product Quality and Service Support  
Subject: Supplemental Information for Safety Recall A0A  
Replacement Accelerator Pedal for Reinforcement Bar Installation

To: All Toyota Dealer Principals, Service Managers, Parts Managers  
Subject: Safety Recall (Special Service Campaign) – A0A  
Accelerator Pedal Modification Campaign  
Vehicles Equipped with Accelerator Pedals Manufactured by CTS Corporation

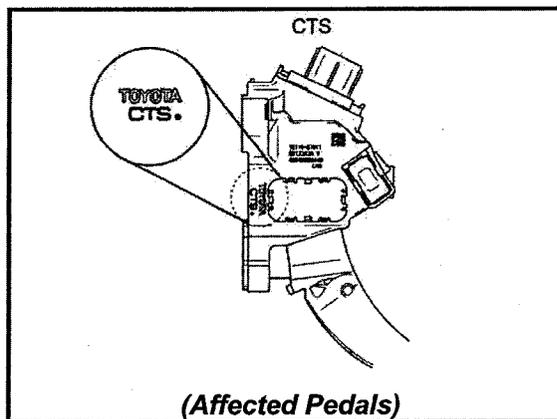
There is a possibility that certain accelerator pedal mechanisms may mechanically stick in a partially depressed position or return slowly to the idle position. Over time, the internal mechanisms in the accelerator pedal may become worn. As a result of this wear combined with certain operating and environmental conditions, friction in the mechanism may increase and intermittently result in the accelerator pedal being hard to depress and/or slow to return or, in the worst case, stick in a partially open position, increasing the risk of a crash.

- **The manufacturer name is embossed (CTS) on the upper sensor housing on the brake pedal side.**
- **This safety campaign addresses the potential for a CTS accelerator pedal to mechanically stick in a partially depressed position or return slowly to the idle position.**
- **This condition is separate from the (DIR) filed in early October, 2009, in reference to the potential for an incorrect or improperly installed floor mat to interfere with the accelerator pedal.**

Toyota dealers are requested to install a precision-cut steel reinforcement bar ("reinforcement bar") that will increase the clearance in between the internal mechanisms in the pedal assembly. This increased clearance will reduce the friction caused by wear and environmental conditions and allow the pedal to operate smoothly for the life of the vehicle. The safety recall remedy will be performed at **no charge** to the vehicle owner.
