Subject: Information Report, NHTSA No. 99V-295

Recall Campaign Information

Subject: ConMet Preset Greased Front Hubs
FL246AB U.S.
FC246AB Canada

Recall Bulletin

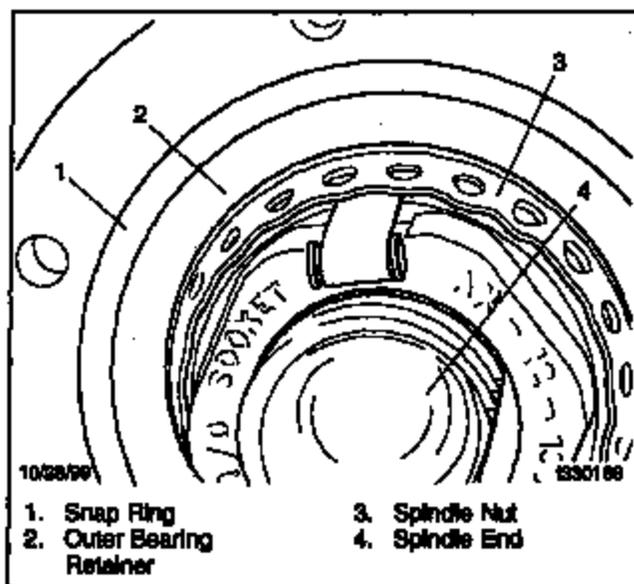
- 4.3 Remove the hub cap and gasket.
 - 4.4 Visually inspect the snap ring, outer bearing retainer, spindle nut, and spindle end for indications of corrosion. See Fig. 1. If there is even the slightest evidence of corrosion, then the entire hub assembly should be replaced. See the instructions for the "Hub Assembly Replacement." If the bearing is in good condition, replacing the hub assembly is not necessary. Proceed to the instructions for the "Hub Cap Replacement."

Fig. 1, Corrosion on Snap Ring, Outer Bearing Retainer, Spindle Nut, and Spindle End

HUB ASSEMBLY REPLACEMENT

NOTE: Hub replacement is required only if corrosion was detected during the outer hub end inspection.
