**Subject:** Poor Throttle Response

**Number:** 03-01

**Model(s):** Golf, Jetta, Jetta Wagon, New Beetle 1998 > 2003  
with 1.9L TDI (Eng. code ALH)

**Date:** Apr. 2, 2003

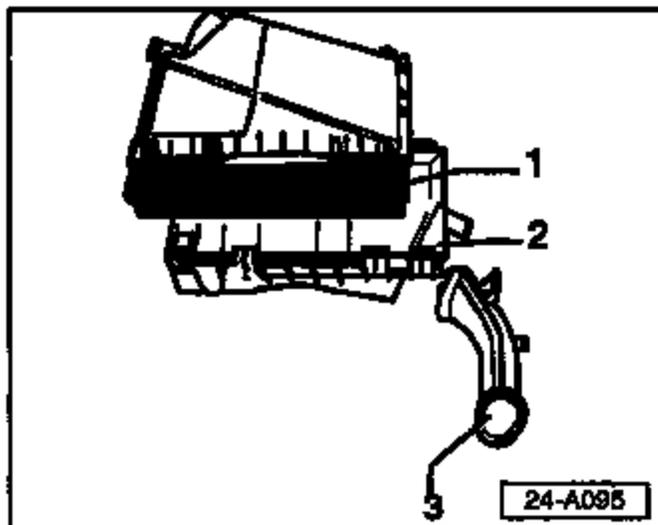
## 3. - Snow screen (if applicable) at Intake air duct, checking

- ◀ - Check snow screen (located below left front fender in air duct -3-) and clean as necessary.
- Inspect air cleaner element -1- for proper installation.

If air cleaner element is deformed due to improper installation this may cause MAF sensor to fall.

- Replace as necessary.

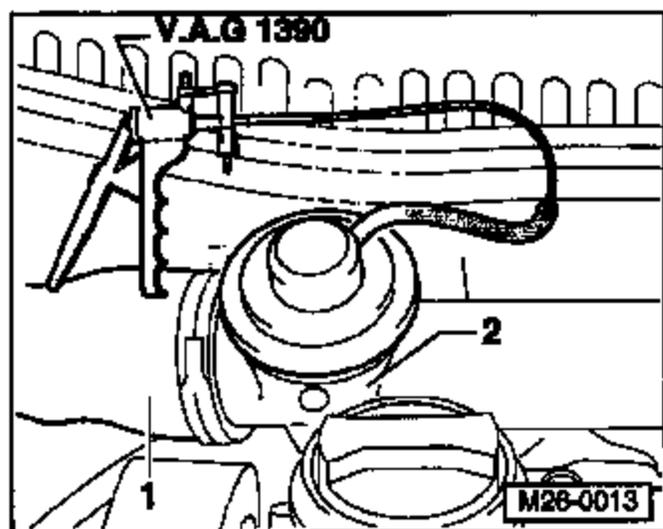
## 5. - EGR valve and intake manifold air flap (Integrated in EGR valve), checking:

- Remove intake hose -1- at EGR valve.
- Remove vacuum hose from EGR valve.
- Connect hand vacuum pump V.A.G 1390 to EGR valve.

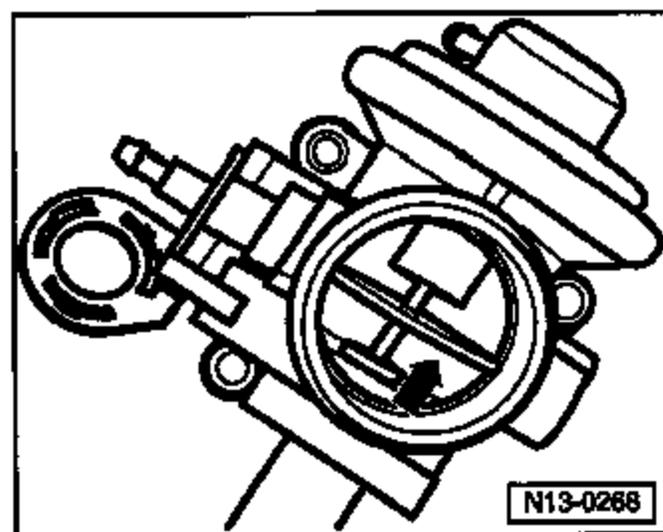
- Apply vacuum and make sure air flap (arrow) opens and closes freely.

If flap does not open and close freely:

- Replace EGR valve/flap.
