Re: AMENDED PART 573 NOTICE RE RICON WHEELCHAIR LIFT
NHTSA # 10V-087

Safety Defect and Noncompliance Report Guide for Vehicles
PART 573 Defect and Noncompliance Report

MCI Service Bulletin 341B

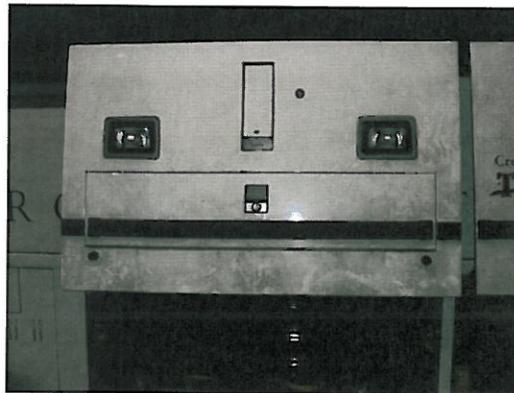
The recalled vehicles have a narrow, secondary opening (the “cassette door”) within the WCL compartment door. The cassette door is located at the bottom of the compartment door and is covered by a bottom-hinged, top-latched panel. The WCL compartment door is the #2 curb-side baggage compartment door. Coaches having a blank #2 curb-side baggage compartment door (i.e., no cassette door) are not affected by the recall, even if they are equipped with a Ricon WCL.

Figure 1Cassette door in #2 baggage bay door

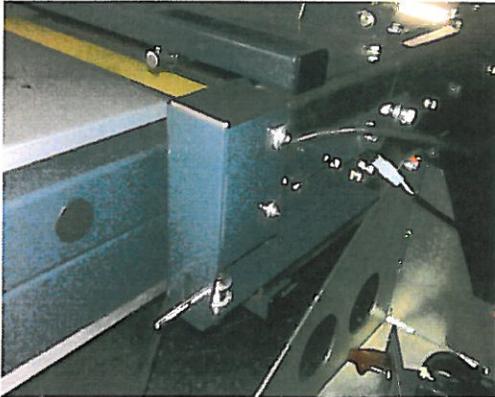
MCI has become aware of instances in which the Ricon WCL experiences a failure of the roll pin that Ricon designed to secure the primary drive chain sprocket to the intermediate shaft. If this occurs, the output driveshaft is no longer connected to the drive mechanism and the WCL can then move freely in or out of the structure due to the lack of a secondary locking mechanism in the Ricon WCL design.

A second potential failure mode in the Ricon WCL is when the operator deploys the WCL manually. The WCL is equipped with provisions for manual operating mode, to be applied in instances when coach power is not available. In manual mode, the operator must disengage the mechanical drive mechanism by rotating a release shaft. This action disengages the output driveshaft pinion gears from the gear rack so that the operator can pull and push the WCL out of and into the storage structure manually. Normally when the operator manually stows the lift, the drive mechanism re-engages automatically. This automatic engagement occurs when a pin connected to the release shaft moves over a reset ramp that rotates the release shaft and re-engages the driveshaft pinion gears to the gear rack. If the reset ramps are not adjusted properly or if the pin is broken, the drive mechanism may not re-engage and the WCL will be able to move freely in or out of the structure due to the lack of a secondary locking mechanism in the Ricon WCL design.

If either of the two foregoing failure modes occur, the Ricon WCL may slide unrestrained on its rollers in the storage structure, potentially breaking through the cassette door and extending beyond the outside of the door when the coach is in motion, particularly when the coach is making a left turn.

Current Lock Mechanism

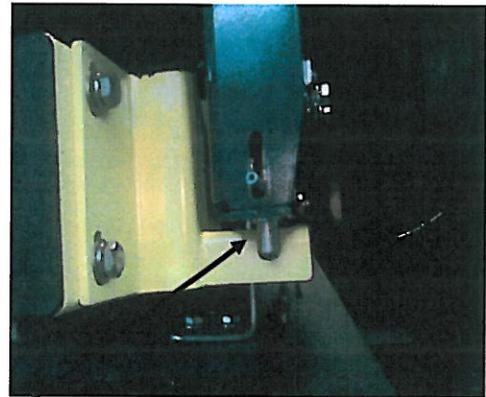
New Spring Loaded Lock.

MCI will provide the parts and labor to install, at no cost to customers, a Ricon-designed retrofit kit that includes a spring-loaded lock mechanism. The mechanism can be activated electrically or manually, but will always return to the "locked" position without power or without the operator holding it in the "unlocked" position. The additional lock mechanism will prevent unintended WCL deployments regardless of cause.
