DEALER OPERATIONAL INFORMATION FOR 'STICKY ACCELERATOR PEDAL' RECALL

As of January 28, 2010

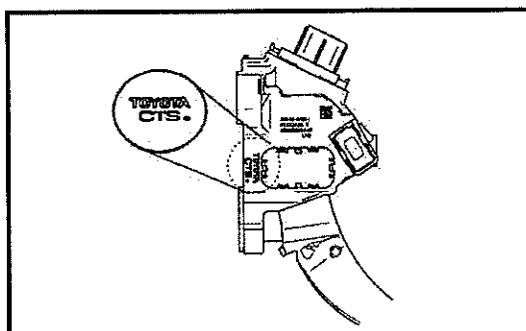
There is a possibility that certain accelerator pedal mechanisms may mechanically stick in a partially depressed position or return slowly to the idle position. Over time, the internal mechanisms in the accelerator pedal may become worn. As a result of this wear combined with certain operating and environmental conditions, friction in the mechanism may increase and intermittently result in the accelerator pedal being hard to depress and/or slow to return or, in the worst case, stick in a partially open position, increasing the risk of a crash.

Toyota dealers are requested to install a precision-cut steel reinforcement bar ("reinforcement bar") that will increase the clearance in between the internal mechanisms in the pedal assembly. This increased clearance will reduce the friction caused by wear and environmental conditions and allow the pedal to operate smoothly for the life of the vehicle. The safety recall remedy will be performed at **no charge** to the vehicle owner.

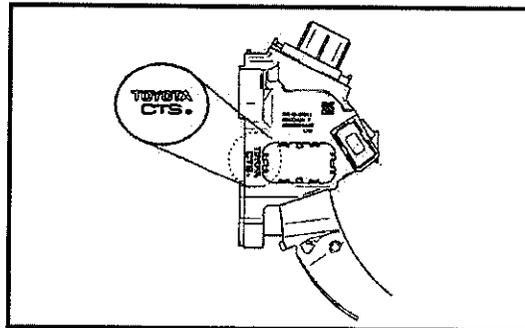
There is a possibility that certain accelerator pedal mechanisms may mechanically stick in a partially depressed position or return slowly to the idle position. Over time, the internal mechanisms in the accelerator pedal may become worn. As a result of this wear combined with certain operating and environmental conditions, friction in the mechanism may increase and intermittently result in the accelerator pedal being hard to depress and/or slow to return or, in the worst case, stick in a partially open position, increasing the risk of a crash.

Toyota dealers are requested to install a precision-cut steel reinforcement bar ("reinforcement bar") that will increase the clearance in between the internal mechanisms in the pedal assembly. This increased clearance will reduce the friction caused by wear and environmental conditions and allow the pedal to operate smoothly for the life of the vehicle. The safety recall remedy will be performed at **no charge** to the vehicle owner.

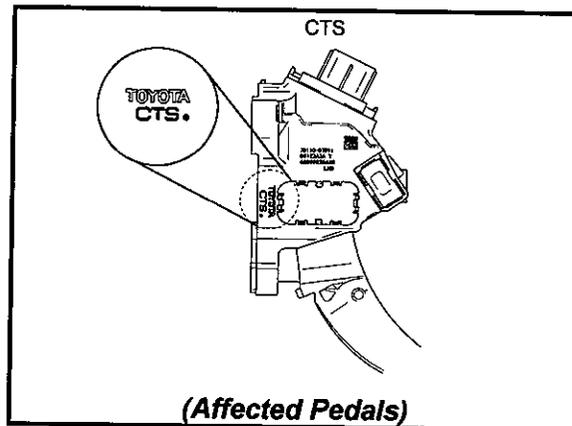
- **The manufacturer name is embossed (CTS) on the upper sensor housing on the brake pedal side.**
- **This safety campaign addresses the potential for a CTS accelerator pedal to mechanically stick in a partially depressed position or return slowly to the idle position.**
- **This condition is separate from the (DIR) filed in early October, 2009, in reference to the potential for an incorrect or improperly installed floor mat to interfere with the accelerator pedal.**

Toyota dealers are requested to install a precision-cut steel reinforcement bar ("reinforcement bar") that will increase the clearance in between the internal mechanisms in the pedal assembly. This increased clearance will reduce the friction caused by wear and environmental conditions and allow the pedal to operate smoothly for the life of the vehicle. The safety recall remedy will be performed at **no charge** to the vehicle owner.

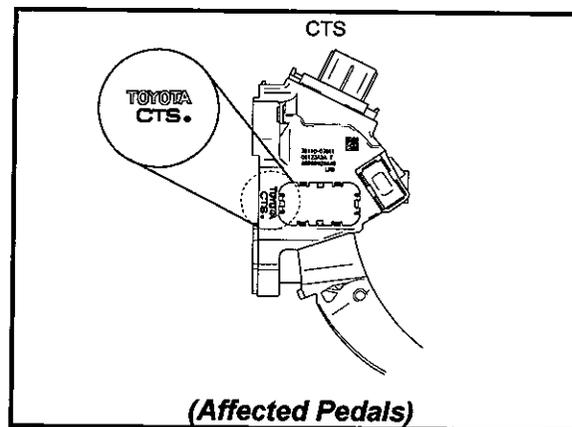
- **The manufacturer name is embossed (CTS) on the upper sensor housing on the brake pedal side.**
- **This safety campaign addresses the potential for a CTS accelerator pedal to mechanically stick in a partially depressed position or return slowly to the idle position.**
- **This condition is separate from the (DIR) filed in early October, 2009, in reference to the potential for an incorrect or improperly installed floor mat to interfere with the accelerator pedal.**

Toyota dealers are requested to install precision-cut steel reinforcement bar ("reinforcement bar") that will increase the clearance in between the internal mechanisms in the pedal assembly. This increased clearance will reduce the friction caused by wear and environmental conditions and allow the pedal to operate smoothly for the life of the vehicle. The safety recall remedy will be performed at **no charge** to the vehicle owner.
