Safety Recall Notice Service Bulletin 36144

March 2010

Trailing Arm Inspection and Reinforcement
Plate Retrofit Instructions
Applicable for 2005-2008 GM Entervan®
Lowered Floor Conversions

2005-2008 GM Entervan® Trailing Arm Bulletin 36144

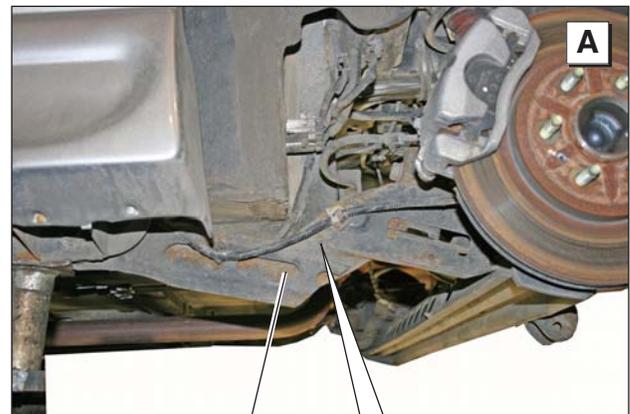
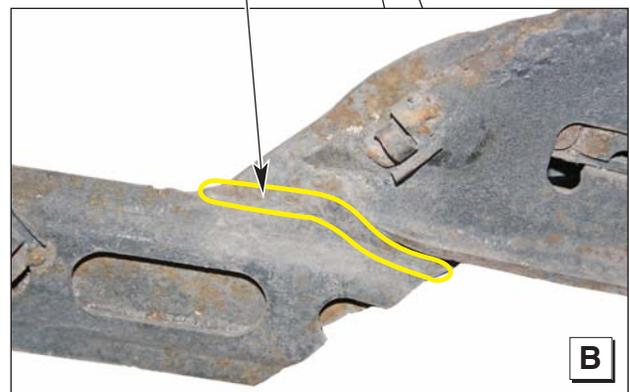
Inspect the weld identified below in Photos A and B (remove debris and undercoating from weld area). There must be solid penetrating

welds where identified. Missing or questionable welds must be repaired and/or replaced by a certified welder.

Ensure the presence of the weld and verify the weld is free of cracks.

Trailing Arm
Inspect this Weld

A Braun-supplied reinforcement plate must be welded to the inside of the trailing arm if a problem weld is detected. Procedures are typical for both sides (driver side shown).

If the weld is present and free of cracks, no further action is required. Apply undercoating and install rear wheel.

If the weld is missing or cracked proceed to Step 3.
