Subject: **Safety Recall 09C2**
EPA07 MBE 4000 Low Pressure Fuel Line

SAFETY RECALL BULLETIN

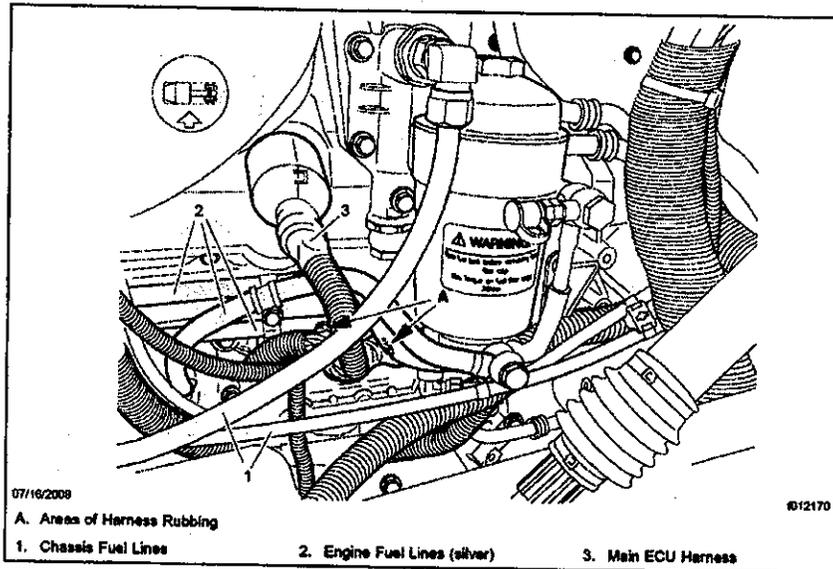
Figure 2 – Main ECU Harness On Left Side Of Engine

1. Find the main ECU harness on the left side of the engine. Reference Figure 2.

2. Disconnect the ECU harness from the engine.
3. If necessary, remove the left quarter fender. For instructions, see **Group 88** in the applicable vehicle service/workshop manual.
4. Remove the existing standoff bracket and cushion clamp that hold the ECU harness to the engine.
5. Remove any tie straps and extra loops of wiring as needed to gain more slack in the harness.
6. Install the new Z-bracket to the engine block where the previously removed bracket was.

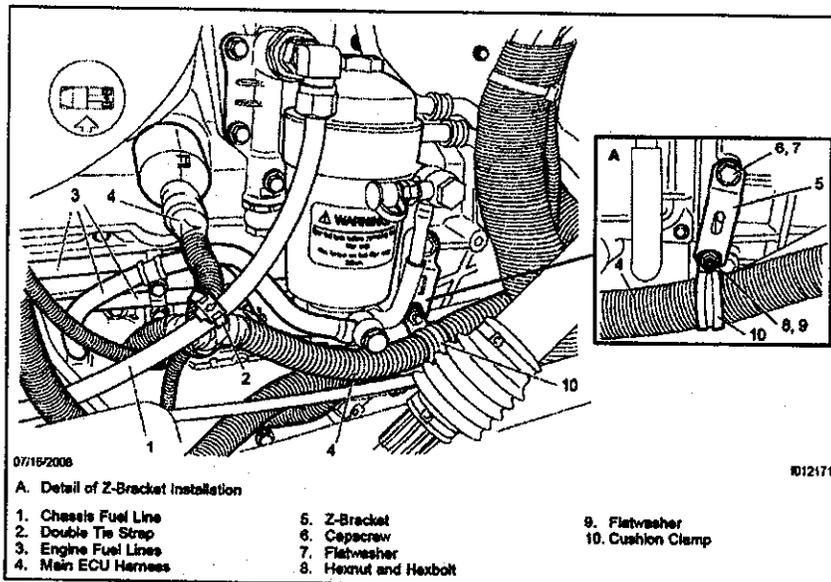
Figure 3 – Rerouted Main ECU Harness and Fuel Lines

2. Certain vehicles may have been built with a vehicle electrical harness routing that contacts the low pressure fuel line. The electrical harness will be rerouted. The new routing became effective at the truck plants on July 31, 2008. There are approximately 8,800 vehicles involved. Rerouting the electrical harness will prevent fuel leaks that may result in customer dissatisfaction.

7. Reroute the ECU harness, making sure there is enough clearance between it and the engine fuel lines. Using a new cushion clamp and new fasteners, secure the harness to the new Z-bracket. Reference Figure 3.
