PACCAR Inc
Law Department

RE: Federal Recall Campaign 200-C
Caterpillar Engine Routing on Peterbilt trucks
Built Between December 15, 1997 and December 21, 1998
Expiration Date: None

SUBJECT: SAFETY RECALL #200-C
 CATERPILLAR ENGINE ROUTING
 EXPIRATION DATE: NONE

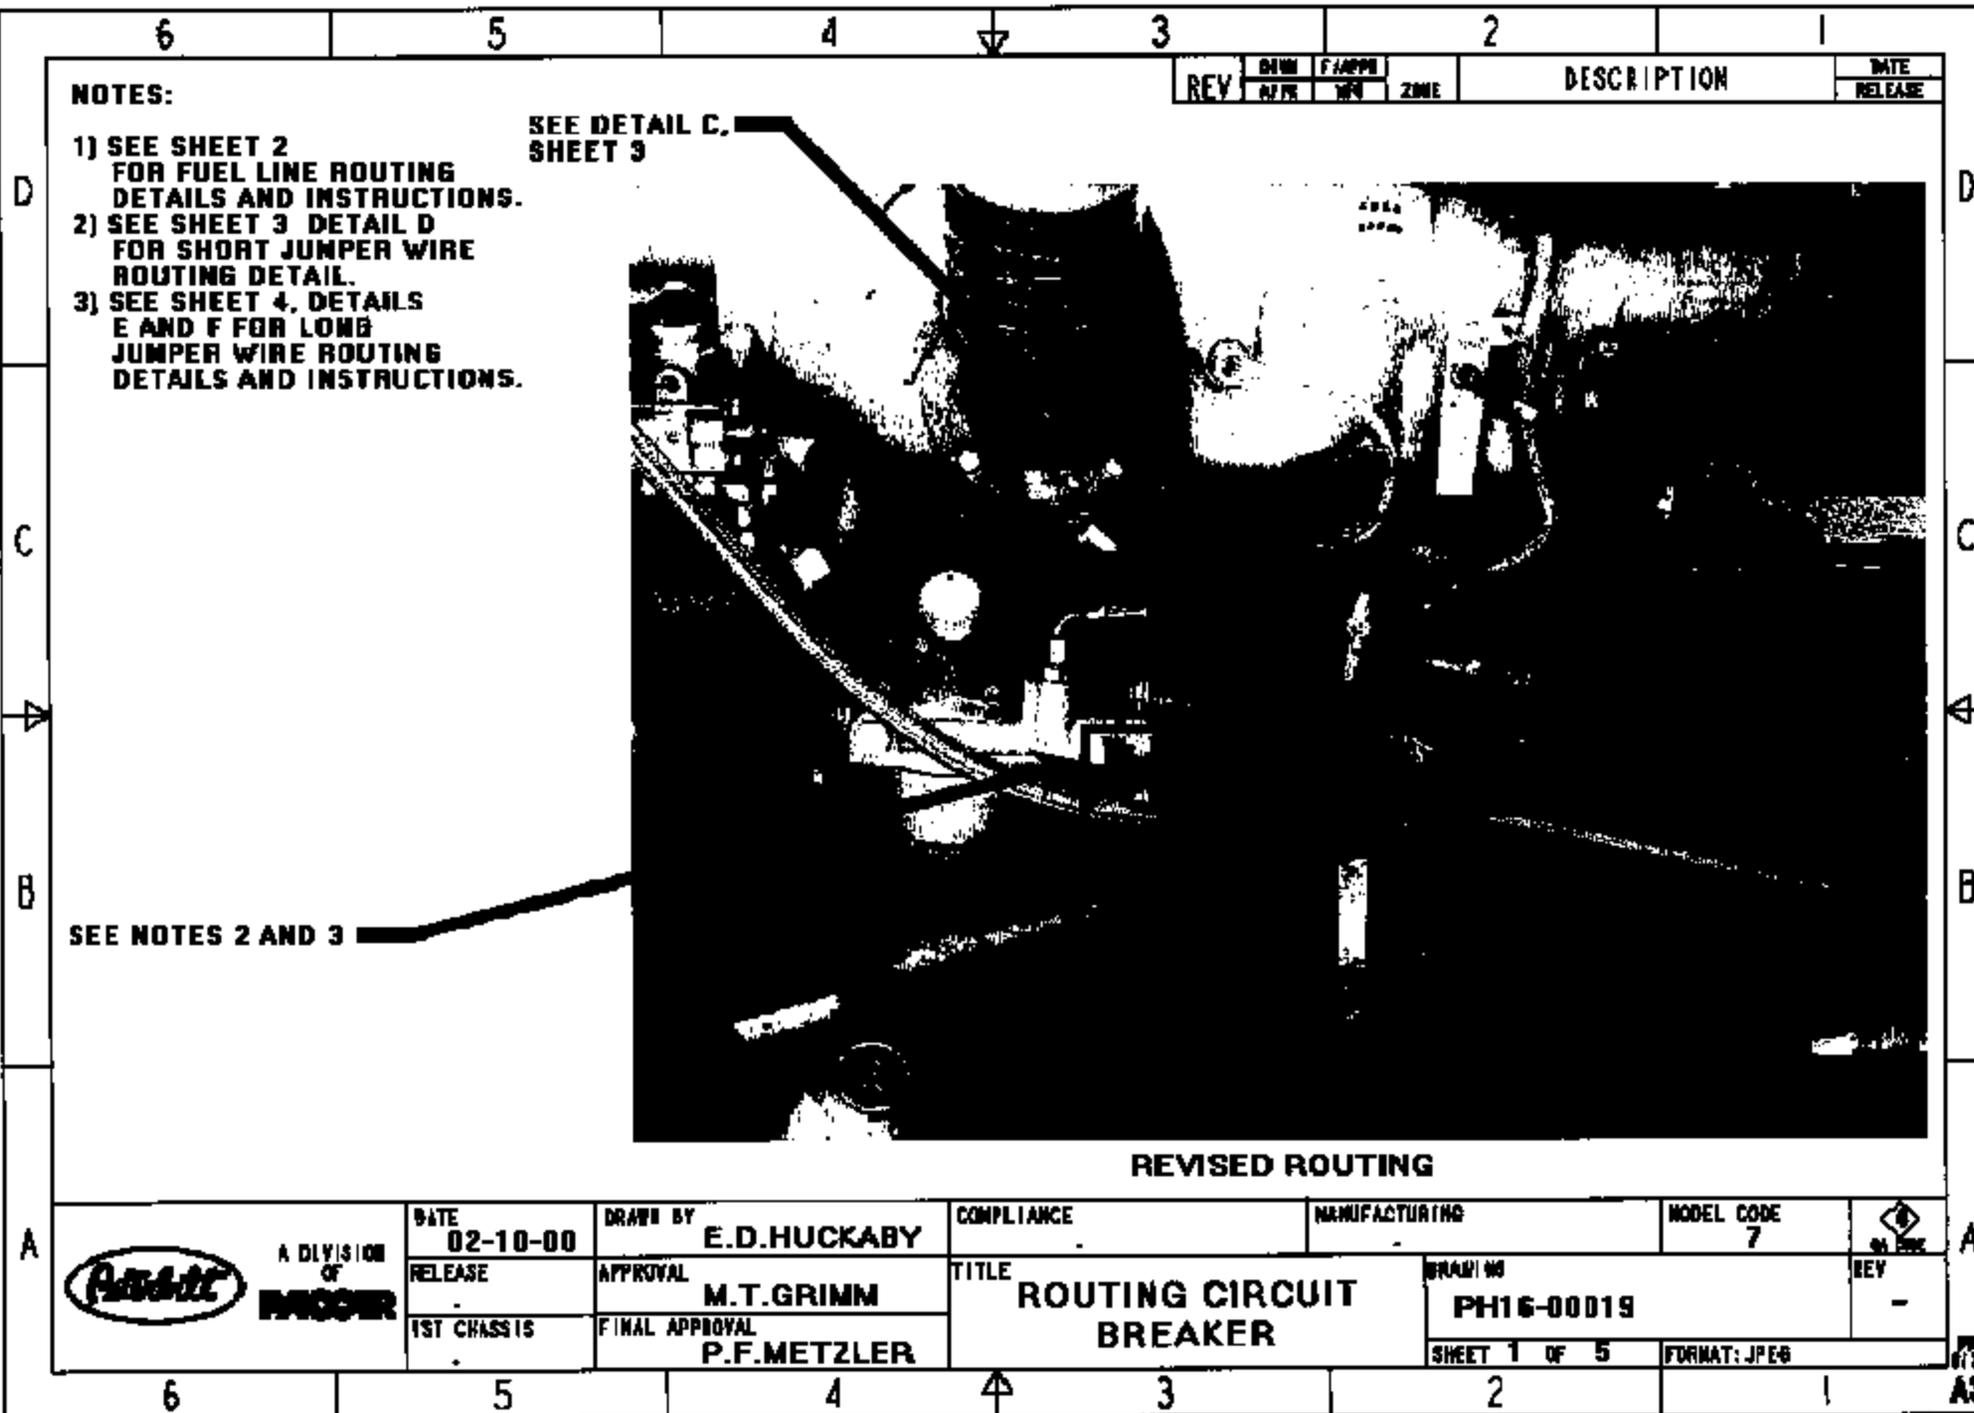
Peterbilt has become aware of the potential for chaffing (rubbing) between Peterbilt engine wiring and Caterpillar fuel lines near the fuel filter housing on the left hand side of the Caterpillar 3406E engine. The chaffing condition can cause a fire without warning.

1. Drive truck into service bay and turn wheel right until contact with stop for easy access.
2. Inspect for signs of chafing (rubbing) between the Caterpillar fuel lines and the Peterbilt electrical jumpers and harnesses. Inspect near the engine ECU and the air intake pipes on the left side of the engine (see drawing PH16-00019 for area of concern).

REVISED ROUTING

6. With the fuel lines and electrical wires in good condition, route electrical harnesses, jumpers and fuel lines as shown in drawing PH16-00019.
 - A. If filtered fuel return line and/or filtered supply line is routed behind engine harness alternator jumper as shown in Detail A on drawing PH16-00019 sheet 2, reroute both fuel lines so they are in front of the engine harness and secure with (2) 22-01265 tie straps as shown in Detail B on drawing PH16-00019 sheet 2.

- 1) SEE SHEET 2 FOR FUEL LINE ROUTING DETAILS AND INSTRUCTIONS.
- 2) SEE SHEET 3 DETAIL D FOR SHORT JUMPER WIRE ROUTING DETAIL.
- 3) SEE SHEET 4, DETAILS E AND F FOR LONG JUMPER WIRE ROUTING DETAILS AND INSTRUCTIONS.
