ODI RESUME

Investigation: EA 09-009
Prompted by: PE-08-058 (COMPONENT SUPPLIERS)
Date Opened: 06/18/2009 **Date Closed:** 08/13/2010
Investigator: Tom Bowman **Reviewer:** Bruce York-B
Approver: Richard Boyd
Subject: AIR BRAKE SYSTEM CONTROL VALVES

Closing Report – EA09-009

Air-Actuated Rear Brake Control Valves Manufactured by
Haldex Brake Products Corporation,
Distributed by Meritor WABCO Vehicle Control Systems,
And installed in
Vehicles Manufactured by Mack Trucks, Inc.

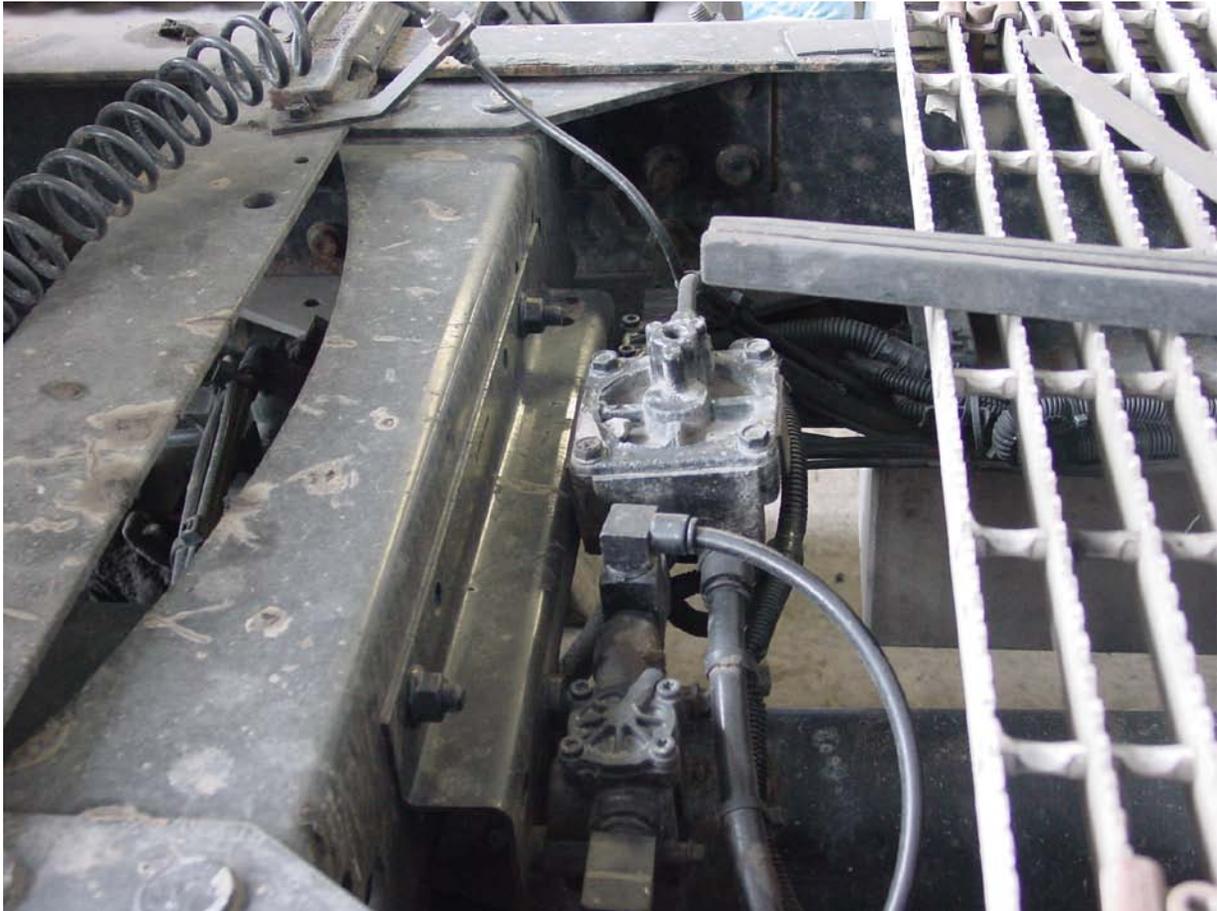
Photograph 1 (below) depicts a representative rear brake control valve mounted on the cross-member of a 2004 model year Mack model CXN 613 tractor.

Photograph 1 – Rear brake control valve as installed on Mack CXN613 tractor frame cross-member.

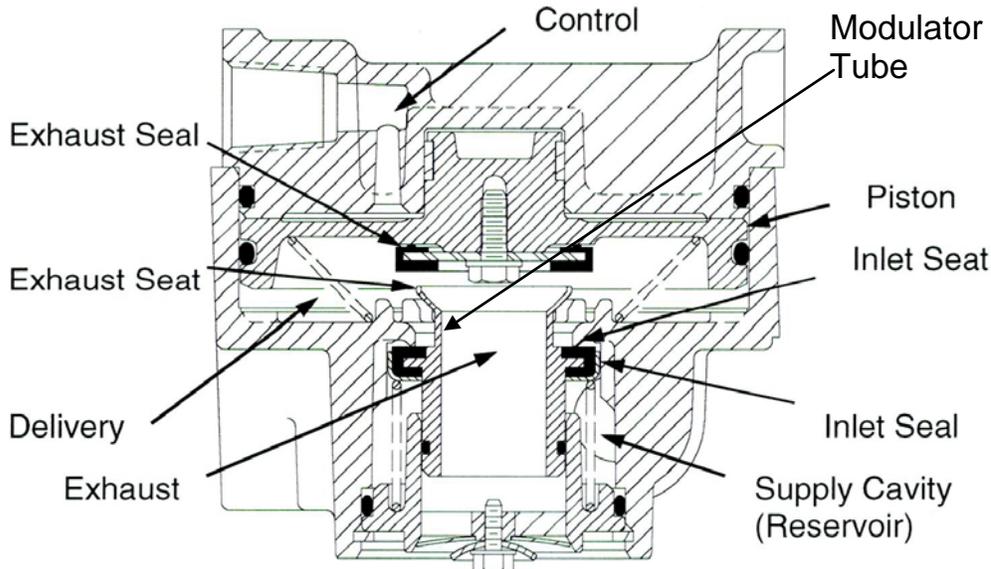
Engineering Assembly Drawing No.1 - Source: Attachment D, Meritor WABCO response to ODI's request for Information, dated November 21, 2008.

Engineering Assembly Drawing No. 1 below depicts a cross section view of a representative control valve.

When the exhaust seal or inlet seal is degraded, “the opening of the inlet seal may be reduced. The reduced valve travel may restrict the rate at which air passes through the inlet opening” [resulting in slower application of the affected brakes].

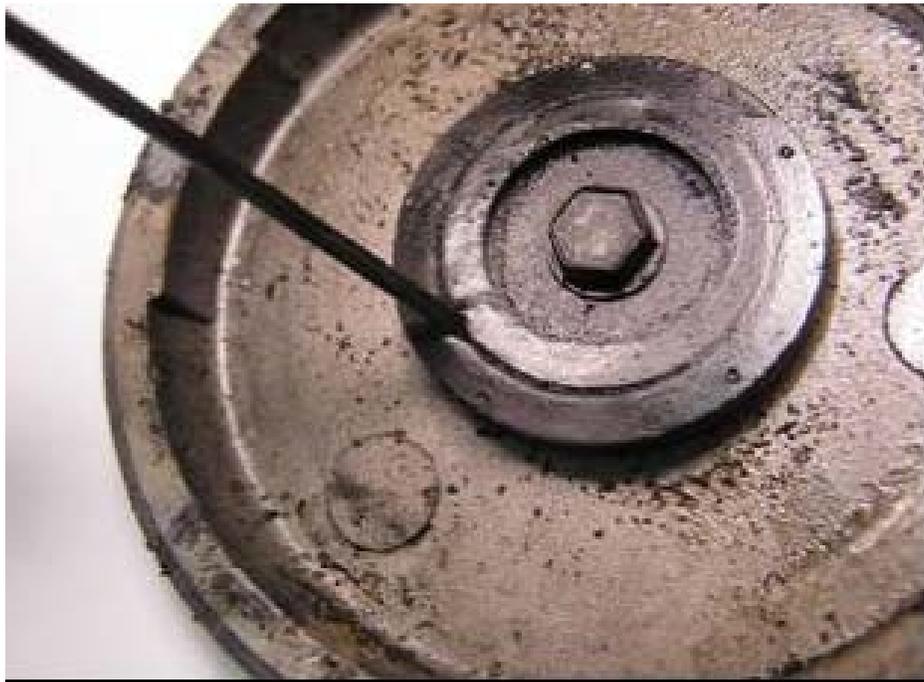
In the present investigation, evidence from field returned valves generally indicate a softening and/or cutting of the exhaust valve set as depicted in Photograph 2 (below).

Photograph 2 – Example of a severely (not intended to indicate representative or typical) damaged (softened and cut) exhaust seal. The black probe indicates a circumferential cut on the face of the exhaust port seal.

Inspections of components collected during fieldwork that were conducted at Meritor WABCO during the course of this investigation detected evidence of n-Butyl Benzene Sulfonamide (BBSA) on the surfaces of the affected field-returned

air valve seals. BBSA is a “plasticizer” that is used to “soften” elastomeric materials.

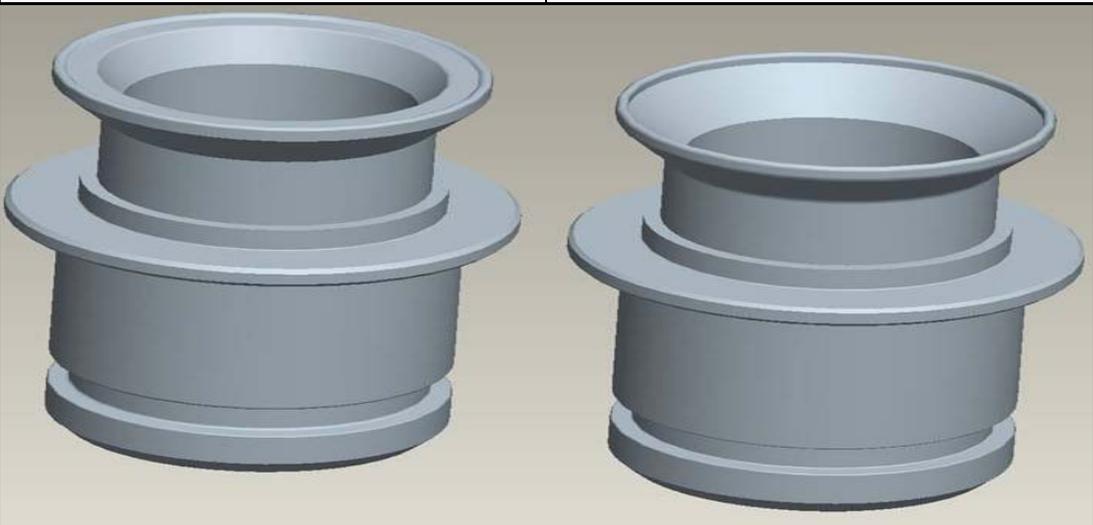
Current Design (since January, 2009)	Former Design (prior to January, 2009)
<p>The current modulator tube is designed with a wide “upper” (as shown in the orientation of the photograph) contact face below to reduce the contact pressures and deflections on the rubber face of the mating exhaust valve seal thereby reducing the risk of premature deformation and/or cuts in the seal face.</p>	<p>The former modulator tube is designed with a narrow “upper” (as shown in the orientation of the photograph) contact face which could impose increased contact pressures and deflections in the rubber face of the mating exhaust valve seal facilitating premature deformation and/or cuts on the seal face.</p>

In January 2009, Haldex / Meritor WABCO changed the profile of the circumferential lip of the exhaust seal seat face of the modulator tube. This change reduces the risk of the modulator valve seat deforming and/or cutting the surface of exhaust seal face (when actuated) by distributing the actuation forces over a larger contact area.
