**Re: ArvinMeritor FF981 series non-drive steer axle hubs
NHTSA Recall No.: 03V-125
Peterbilt Recall No.: 303-A**

SUBJECT: SAFETY RECALL #303-A
ARVIN MERITOR FRONT AXLE MODEL FF981 with SKF UNITIZED HUBS
EXPIRATION DATE: NONE

Technical Bulletin

Unitized Wheel-End Assembly Inspection with a Dial Indicator Replacement Hub Inspection Spindle and O-Ring Installation Hubcap Installation All Meritor Front Non-Drive Steer Axles with Unitized Wheel Ends

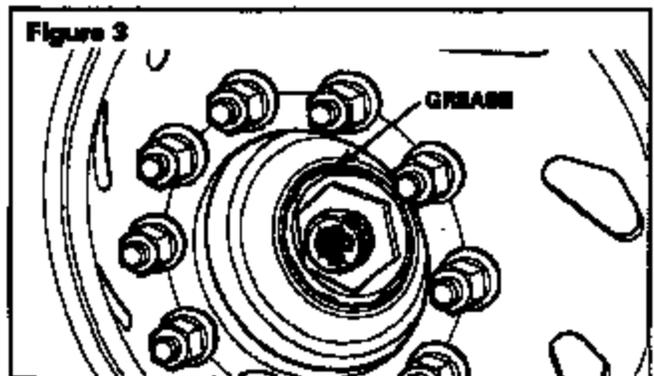
NOTE: The outboard and inboard seals may purge small amounts of grease that are visible during inspection. Figure 3. This is a normal occurrence.

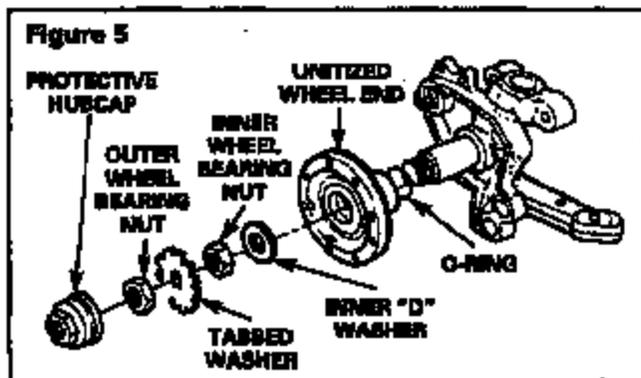
6. Push the uninitialized wheel end straight IN. Note the reading. Pull the uninitialized wheel end straight OUT. Note the reading.
- If the total movement of the dial indicator is less than 0.003-inch (0.08 mm): Inspection is complete. No adjustment is required.
 - If the total movement of the dial indicator is 0.003-inch (0.08 mm) or greater: Remove the OUTER wheel bearing nut and tabbed washer. Tighten the INNER wheel bearing nut to 500-700 lb-ft (679-949 N·m) while rotating the uninitialized wheel end a minimum of five rotations. Figure 5. ①

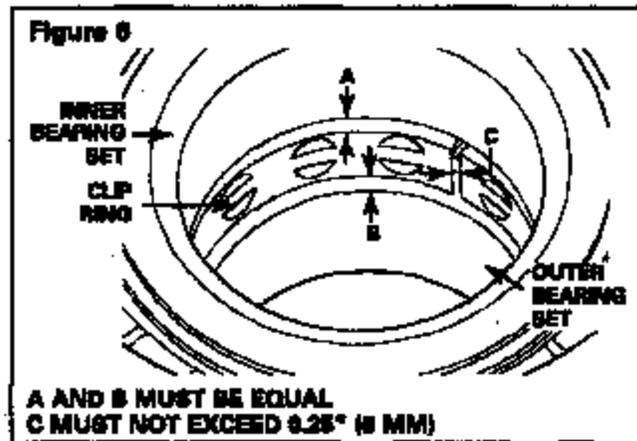
1. Remove the replacement hub from the box and place it on a clean surface.
2. Examine the interior of the hub to verify the following.
 - A. The inner clip ring has not become dislodged in shipment and is in correct alignment with the inner and outer bearings. The gap between the inner and outer bearing sets and the clip ring must be equal. Figure 6.
 - B. The gap between the ends of the clip ring must be equal and not exceed 0.25-inch (6 mm). If necessary, adjust by hand. Figure 6.
 - C. The bearing face must be clean with no seal coating, dirt or dust.

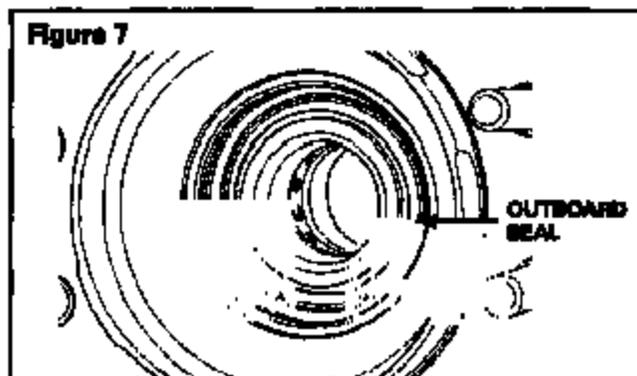
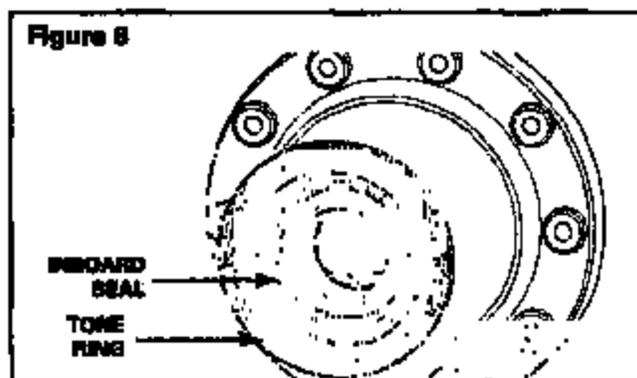
3. Examine the exterior of the hub to verify the following.
 - A. There is no visible damage to the inboard or outboard seals and the bearings have not become unseated. Figures 7 and 8.
 - B. The tone ring teeth are not damaged and there are no broken or missing teeth on the tone ring. Figure 8.

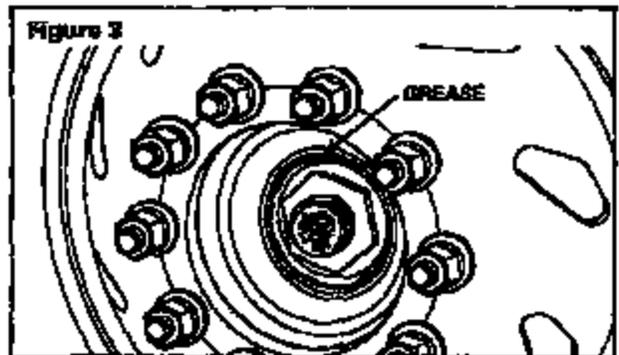
NOTE: The outboard and inboard seals may purge small amounts of grease that are visible during inspection. Figure 3. This is a normal occurrence.

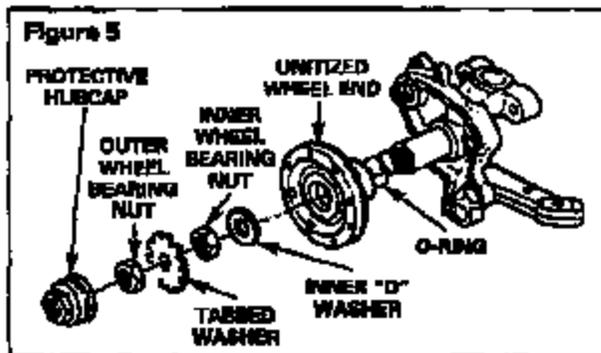
6. Push the unitized wheel end straight IN. Note the reading. Pull the unitized wheel end straight OUT. Note the reading.
 - If the total movement of the dial indicator is less than 0.003-inch (0.08 mm): inspection is complete. No adjustment is required.
 - If the total movement of the dial indicator is 0.003-inch (0.08 mm) or greater: Remove the OUTER bearing nut and tabbed washer. Tighten the INNER wheel bearing nut to 600-700 lb-ft (879-949 N·m) while rotating the unitized wheel end a minimum of five rotations. Figure 5. ①

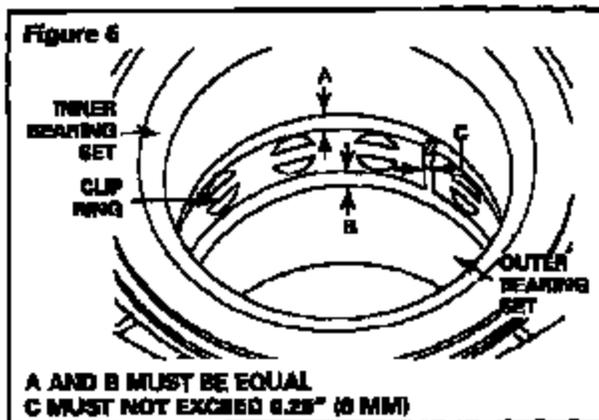
1. Remove the replacement hub from the box and place it on a clean surface.
2. Examine the interior of the hub to verify the following.
 - A. The inner clip ring has not become dislodged in shipment and is in correct alignment with the inner and outer bearings. The gap between the inner and outer bearing sets and the clip ring must be equal. Figure 6.
 - B. The gap between the ends of the clip ring must be equal and not exceed 0.25-inch (6 mm). If necessary, adjust by hand. Figure 6.
 - C. The bearing face must be clean with no seal coating, dirt or dust.

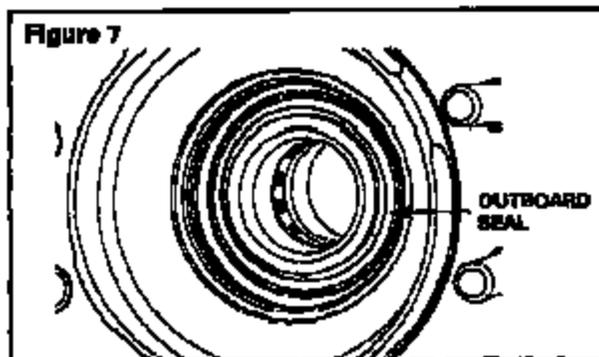
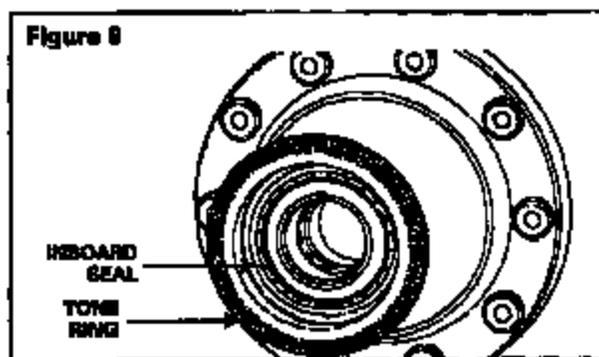
- A. There is no visible damage to the inboard or outboard seals and the bearings have not become unseated. Figures 7 and 8.
- B. The tone ring teeth are not damaged and there are no broken or missing teeth on the tone ring. Figure 8.
