Regarding: Amended
1999 ~ 2010 Model Year Accessory Yamaha Double "T" Fat Handlebars
Insufficient handlebar tube thickness, Factory Modification Campaign

Initial Failure Report

(Sample failed part: STR-5PX75-12-00)

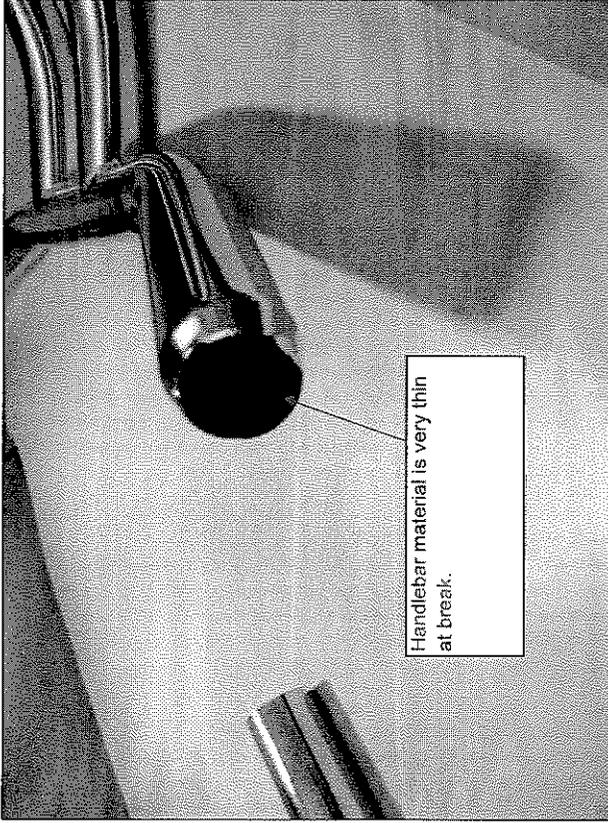
Handlebar material is very thin at break.

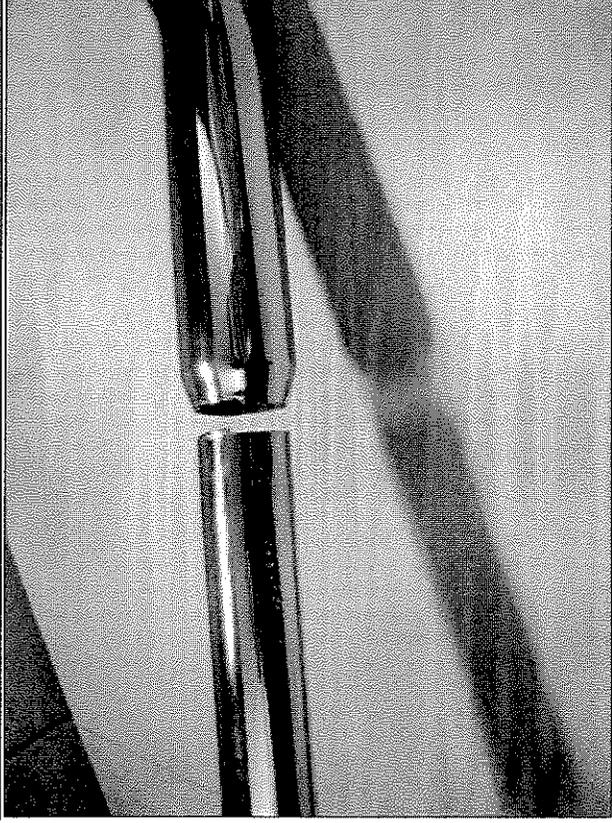
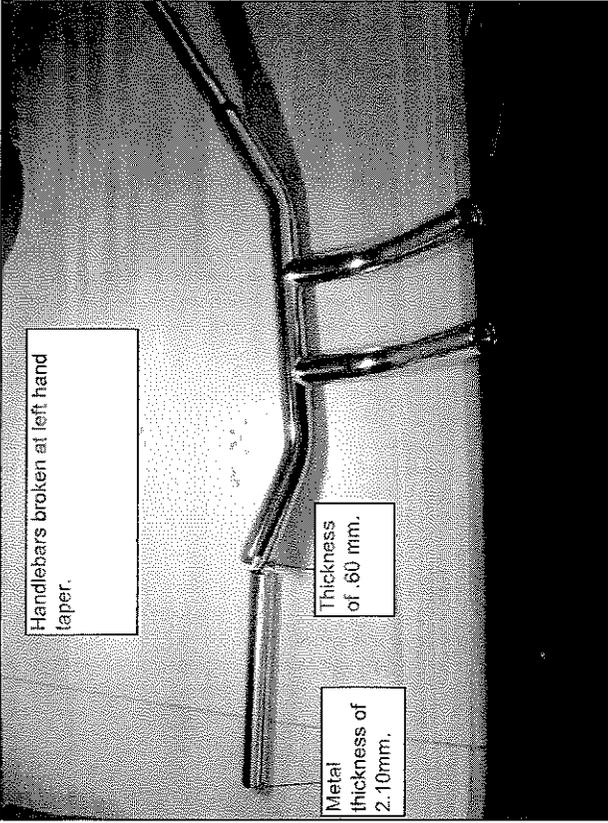
Handlebars broken at left hand taper.

Metal thickness of 2.10mm.

Thickness of .60 mm.

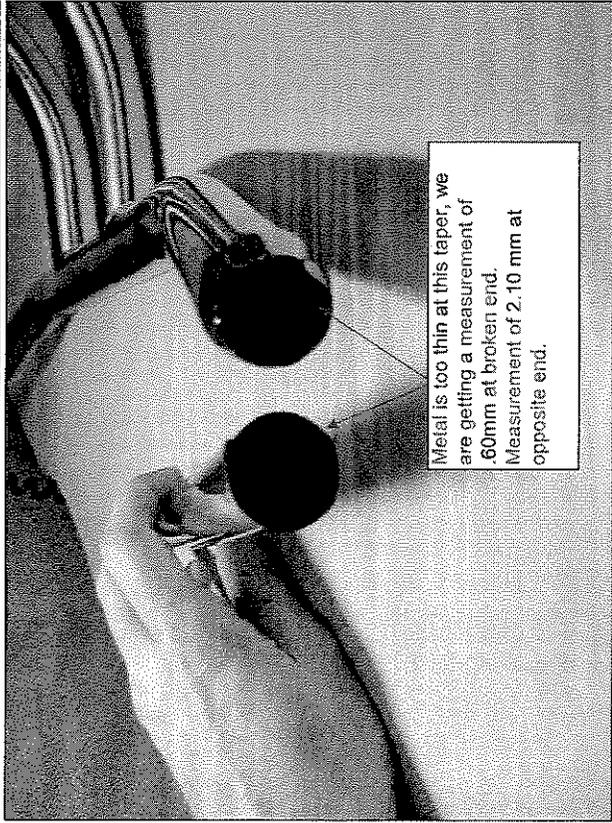
Metal is too thin at this taper, we are getting a measurement of .60mm at broken end. Measurement of 2.10 mm at opposite end.

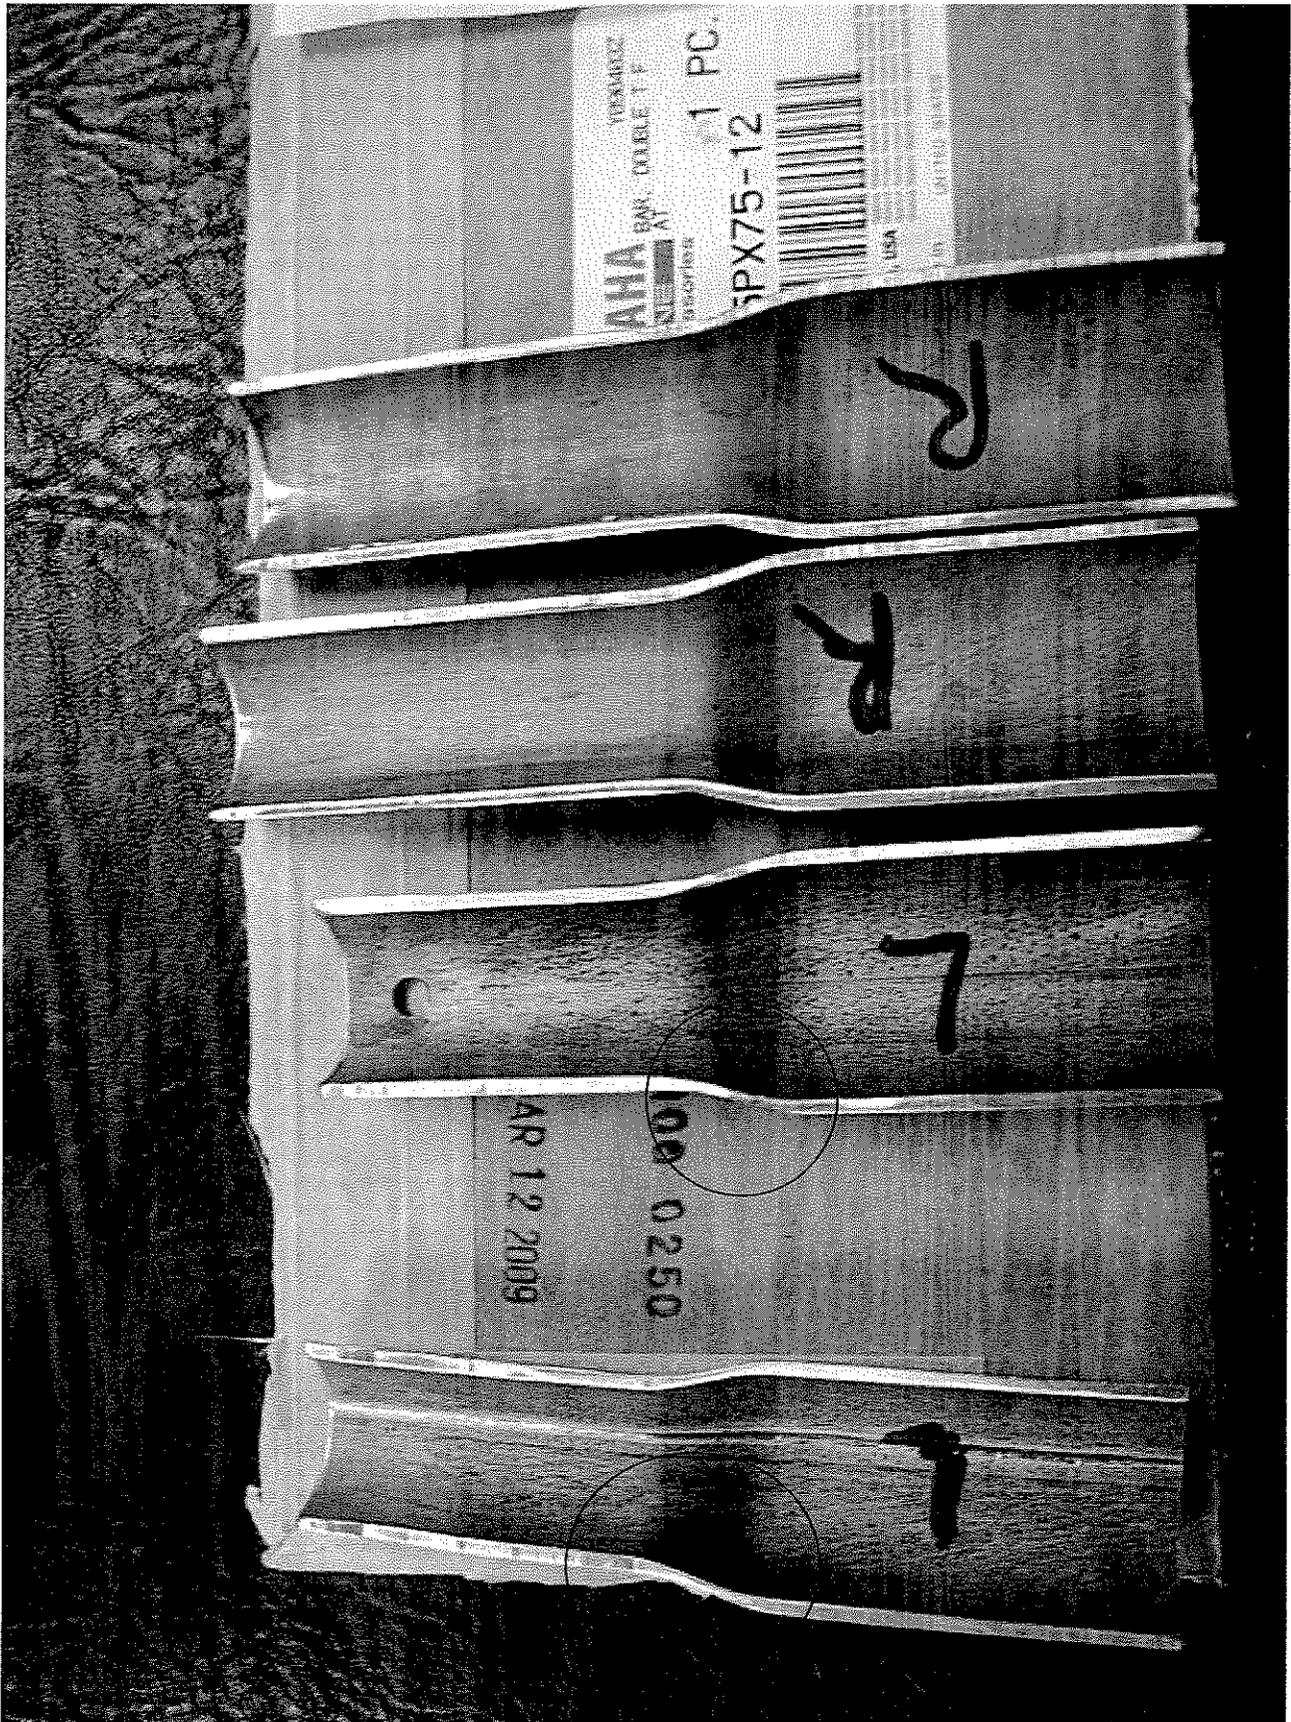
H-BAR-#)

- Results of inspection found 4 locations on one sample where tube thickness was minimal
 - 6/3/09 reviewed routing and production instructions to find if production change approved

(3-SPX BARS CUT FROM KENNESAW'S STOCK.)

DATE OF CUTTING
6/2/2009
