ITB10-033a

August 25, 2010

VOLUNTARY SAFETY RECALL CAMPAIGN EQUIPMENT / SERVICE PARTS SUSPENSION LOWER LINK

CAMPAIGN ID #: PC050
NHTSA #: 10E-019
APPLIED VEHICLES: 2004 - 2010 QX56 (JA60)

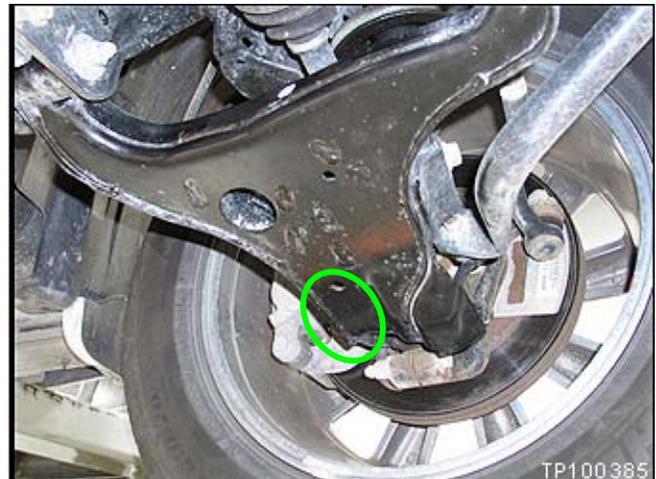
Rear

1. Raise the vehicle.
2. Locate and write down the "Lot Number" stamped on the bottom side of the suspension lower links.
 - Refer to the Lot Number Locations below.
 - Inspect front and rear (all 4) lower links.
3. Compare the Lot Number of each lower link to the Lot Number examples on the next page.
