EA10-004

Service Bulletin

SUBJECT: Special Coverage Adjustment – Front and Rear Chrome Interior Door Handle Lever

MODELS: 2007 Cadillac Escalade, Escalade ESV, Escalade EXT
2007 Chevrolet Avalanche, Silverado, Suburban, Tahoe
2007 GMC Sierra, Yukon, Yukon XL
Equipped with Chrome Interior Door Handles

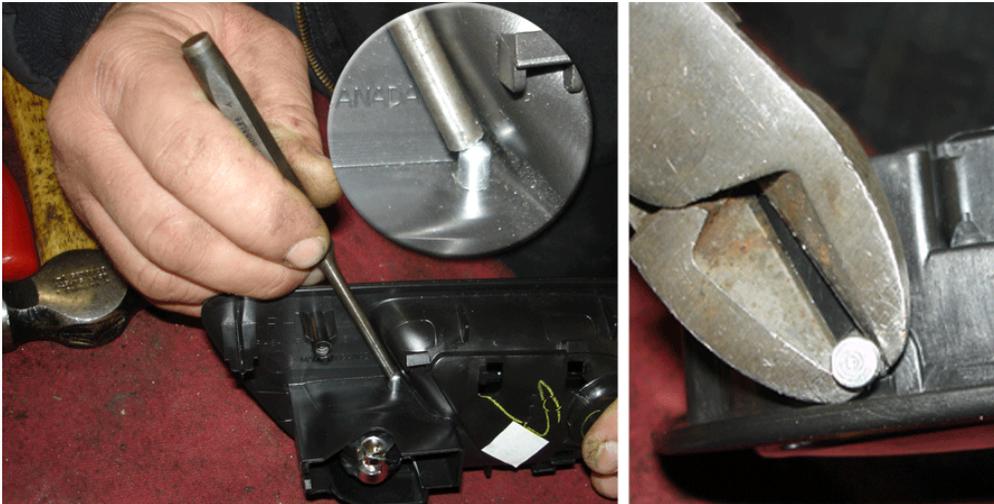
2415819

Note: Using the punch and hammer, strike the rounded end of the roll pin to loosen the roll pin. The head of the roll pin should protrude from the handle housing. Remove the roll pin with pliers as shown in the illustration.

3. Using a punch, hammer, and pliers, remove the roll pin from the inside door handle.
4. Discard the roll pin.

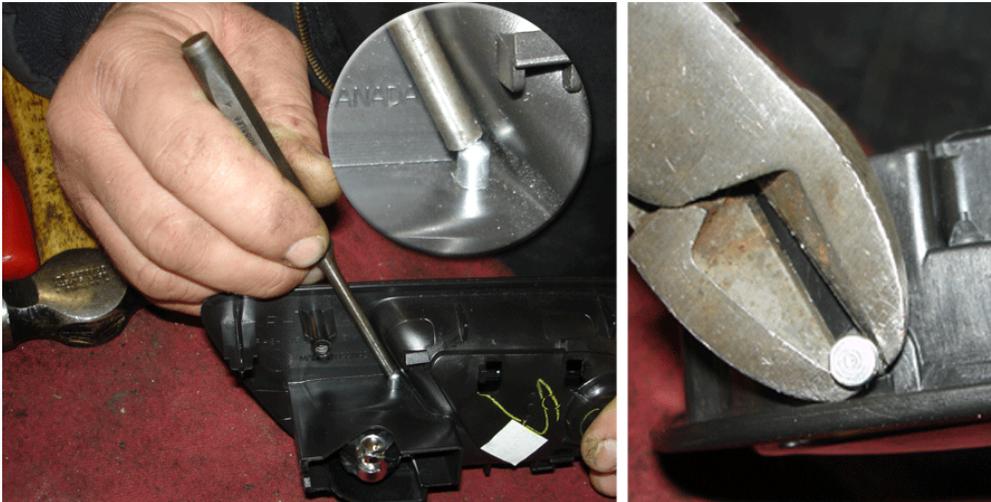
2415819

Note: Using a punch and hammer, strike the rounded end of the roll pin to loosen the roll pin. The head of the roll pin should protrude from the handle housing. Remove the roll pin with pliers as shown in the illustration.

3. Using a punch, hammer, and pliers, remove the roll pin from the inside door handle.
4. Discard the roll pin.

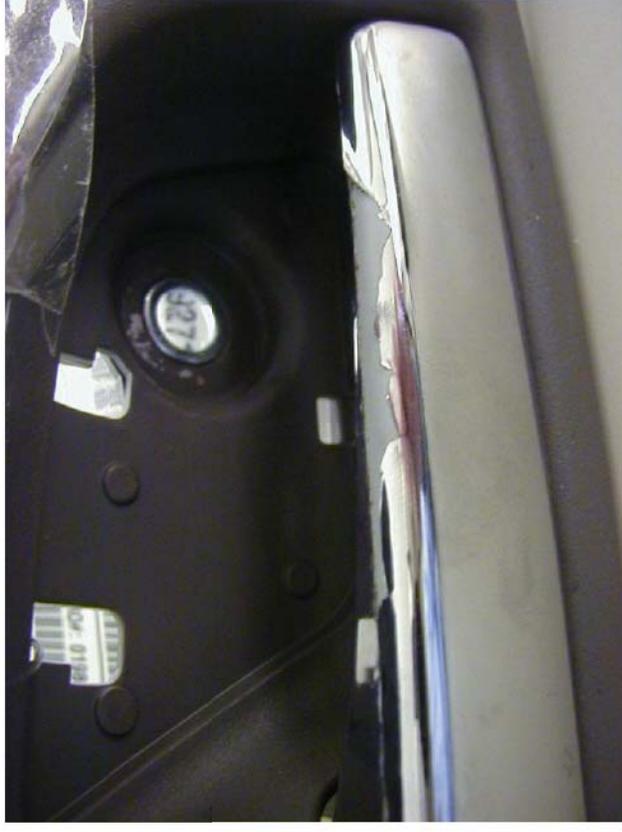
Condition: The chrome plating may separate from the base plastic handle on front or rear interior door handles.

Effects: This condition is visible with the door in the closed position. Peeling of the plating may create a sharp edge and pose a laceration hazard.

- Plating was applied over an irregular parting line creating thinner sections .
- Thinner sections of plating are susceptible to fracture. Fractures may propagate due to continued exposure to loads resulting in a gradual delamination from the plastic handle.

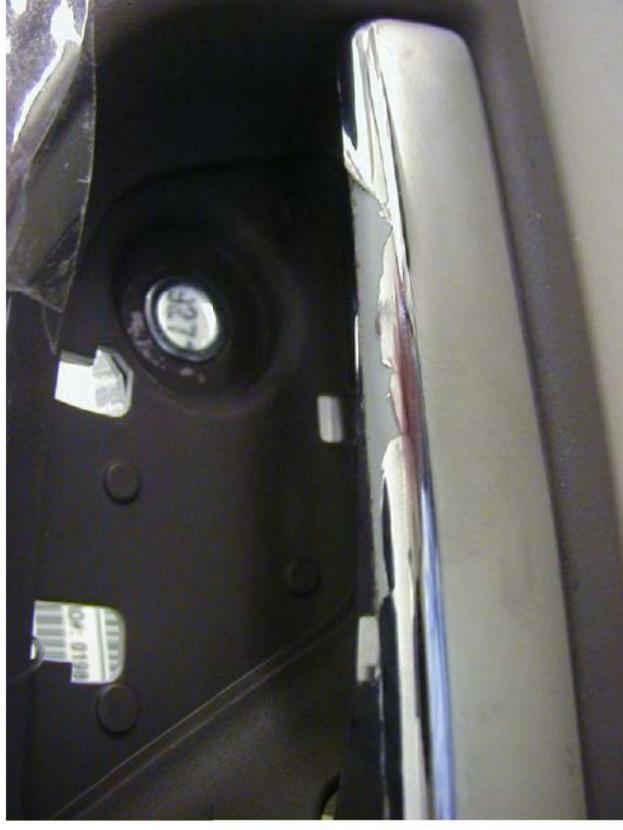
Condition: The chrome plating may separate from the base plastic handle on front or rear interior door handles.

Effects: This condition is visible with the door in the closed position. Peeling of the plating may create a sharp edge and pose a laceration hazard.

- Plating was applied over an irregular parting line creating thinner sections .
- Thinner sections of plating are susceptible to fracture. Fractures may propagate due to continued exposure to loads resulting in a gradual delamination from the plastic handle.

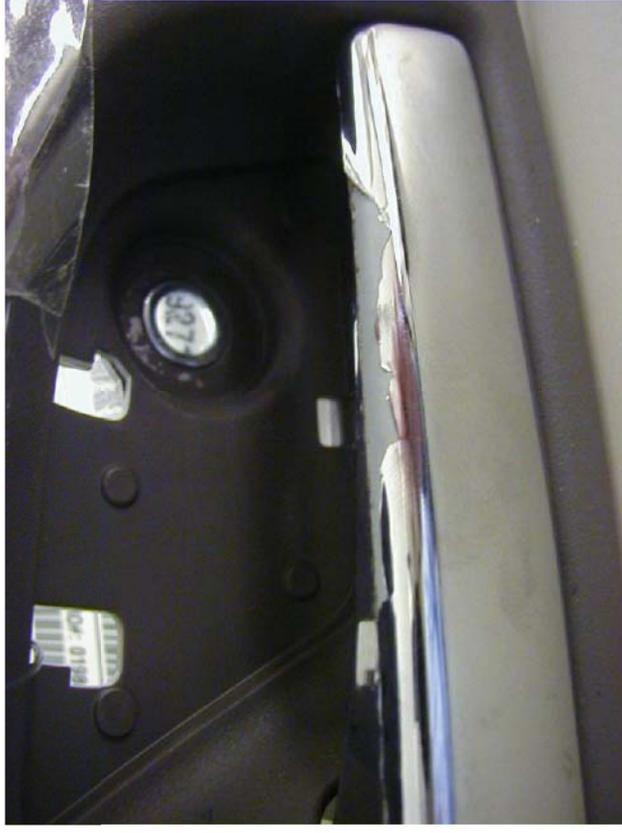
Condition: The chrome plating may separate from the base plastic handle at the parting line (top of handle). This condition may be present on front or rear interior door handles.

Effects: This condition is visible with the door in the closed position and may be evident to the vehicle operator or passengers.
Peeling of the plating may create a sharp edge and a laceration hazard.

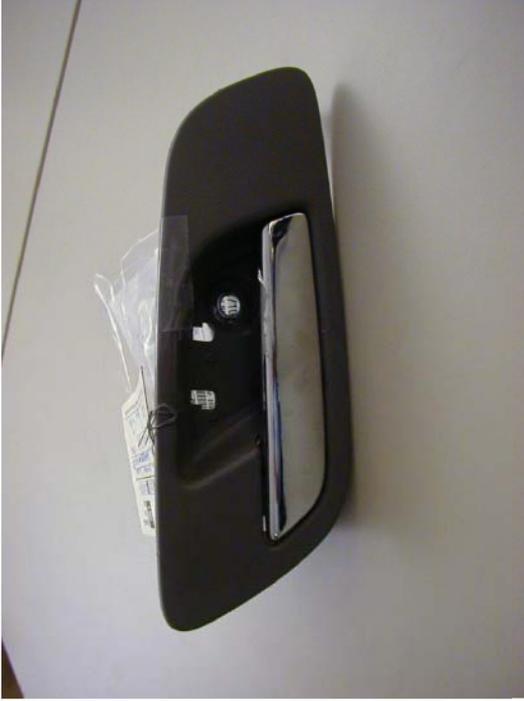
2007 GMT900 Interior Chrome Door Handle

- The chromed lever of the handle assembly is common Front & Rear.
- Right/Left chromed levers are mirror parts.
- Bezels are unique (right/left, front/rear and color).

- On certain handles the plating was applied over an irregular parting line creating thinner sections of plating.
- Thinner sections of plating are susceptible to fracture.
- A fracture may propagate due to continued exposure to loads resulting in a gradual delamination from the base plastic handle.
