DP92-017:NEF-12jad
Supplement
November 17, 1992

Robert H. Munson
Director
Automotive Safety Office
Environmental and Safety
Engineering Staff

Subject: DP92-017:NEF-12jad

This supplements our letter dated October 30, 1992, and contains our answer to Question No. 4 and the remainder of our answer to Question Nos. 2 and 3 of your September 21, 1992 letter concerning the Institute for Injury Reduction petition regarding alleged "inadvertent" seat belt buckle "unlatching" from inertial forces.

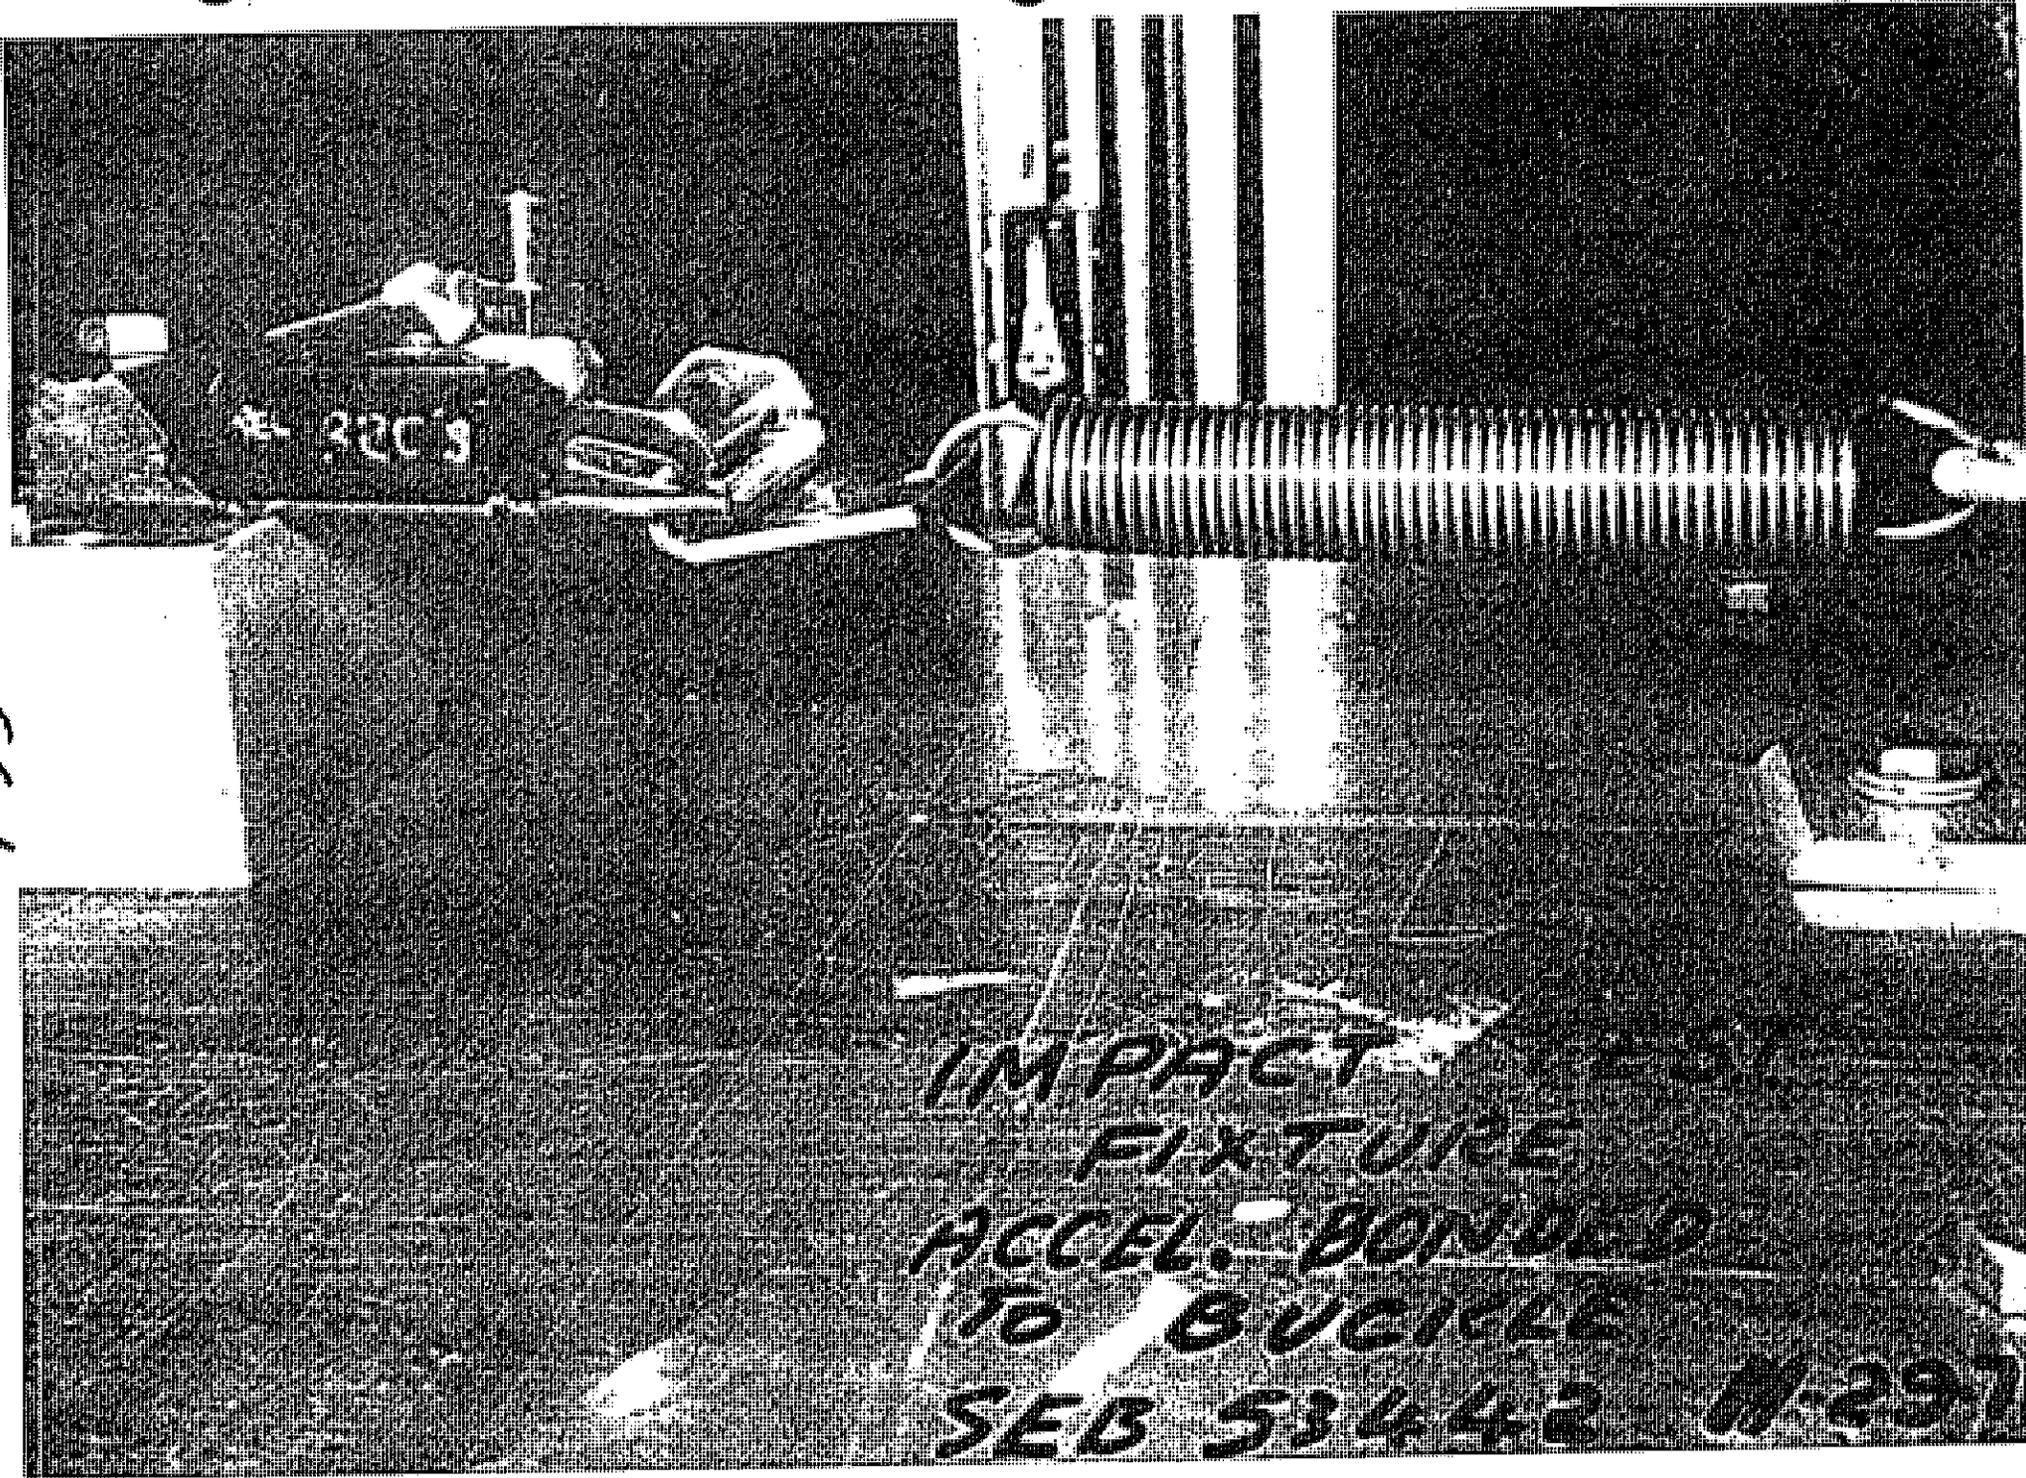
FIG 1

GRAPH SHOWING G READINGS
FOR VARIOUS TYPE BUCKLES.
RUN ON AVCC TEST MACHINE

X - IMPACT ON KNEE II MAX READING
Y - ACCELEROMETER ON AVCC TABLE
Z - " " " BUCKLE
A - ADJUSTABLE TONGUE
R - REAR SEAT STRAP TONGUE
F - FRONT BELT CONNECTOR PIN SLOT
● - BUCKLE RELEASED
○ - NOT RELEASED HIGHEST READING
