Date	Number	Page
2/17/11	<b>RVXX1006</b>	1(3)

**Inversion Valve, Fifth Wheel Air  
Release****VNM, VNL****RVXX1006, Inversion Valve, Fifth Wheel Air Release**

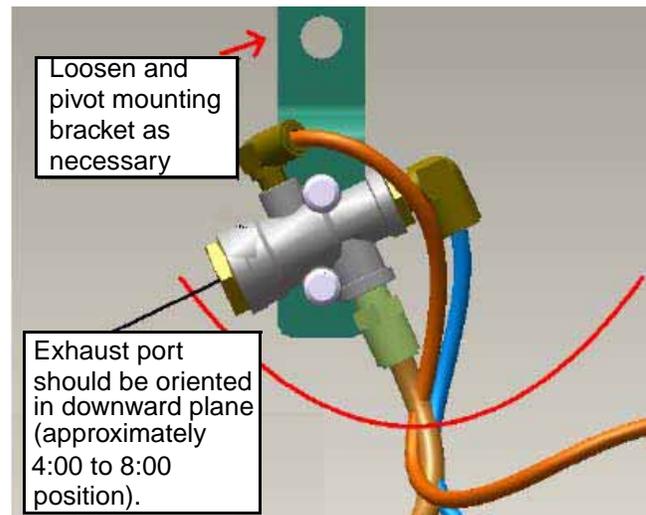
The inversion valve on the frame may be orientated where contaminants can enter the valve through the exhaust port. If this occurs, corrosion may occur, which can cause the valve to malfunction and in extreme cases possibly result in unintended opening of the fifth wheel's locking mechanism that holds the trailer's king pin.

**Figure 1 — Position exhaust flapper in a downward plane.**

1. Visually inspect the TR-3 inversion valve for proper orientation (i.e. 4-8 o'clock position). If the orientation results in the exhaust port being outside of the 4-8 o'clock position, replace the valve with Volvo part number 8084521 (Bendix part number 281459N) (see Figure 1). All valves must be purchased from a Volvo dealer. Make certain that the existing or replacement valve is installed inside the frame rail with the exhaust facing in a downward plane (see figure #3 photo). It may be necessary to remove and reposition the mounting bracket to ensure the TR3 inversion valve exhaust is facing in a downward plane. Use a grade 8 bolt and lock nut of the proper length to secure mounting bracket to frame. Torque to 140 +/- 24 Nm (103 +/- 18 ft-lb).
