TAC-SER11-001  
01-31-11

**Subject: EM1 Gen V Evaporator Units**

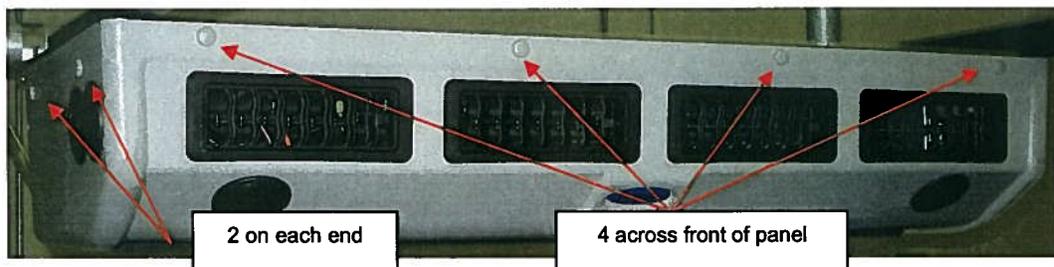
- 1) Remove the cover from the evaporator by removing the 8 screws shown below. Properly support the cover while removing the screws.

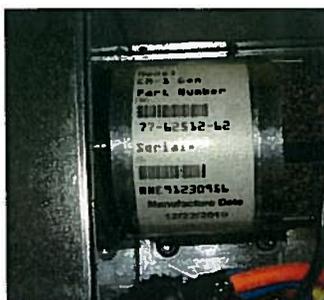
Serial Number Tag

- 2) Once the cover has been removed, the identification tag containing the unit part number, manufacture date, and serial number can be found on the motor "cradle" mount, as seen in the photo below (on left). Compare the information to the above mentioned manufacture date, and/or serial number. Units employing a fuse holder as appears circled in red below require the upgrade with the new fuse holder.
