REPORT NUMBER: 305-CAL-10-1

**SAFETY COMPLIANCE TESTING FOR FMVSS 305
ELECTRIC POWERED VEHICLES: ELECTROLYTE SPILLAGE
AND ELECTRICAL SHOCK PROTECTION**

Toyota Motor Corporation
2010 Lexus HS250h
Sedan

NHTSA NUMBER: CA5102

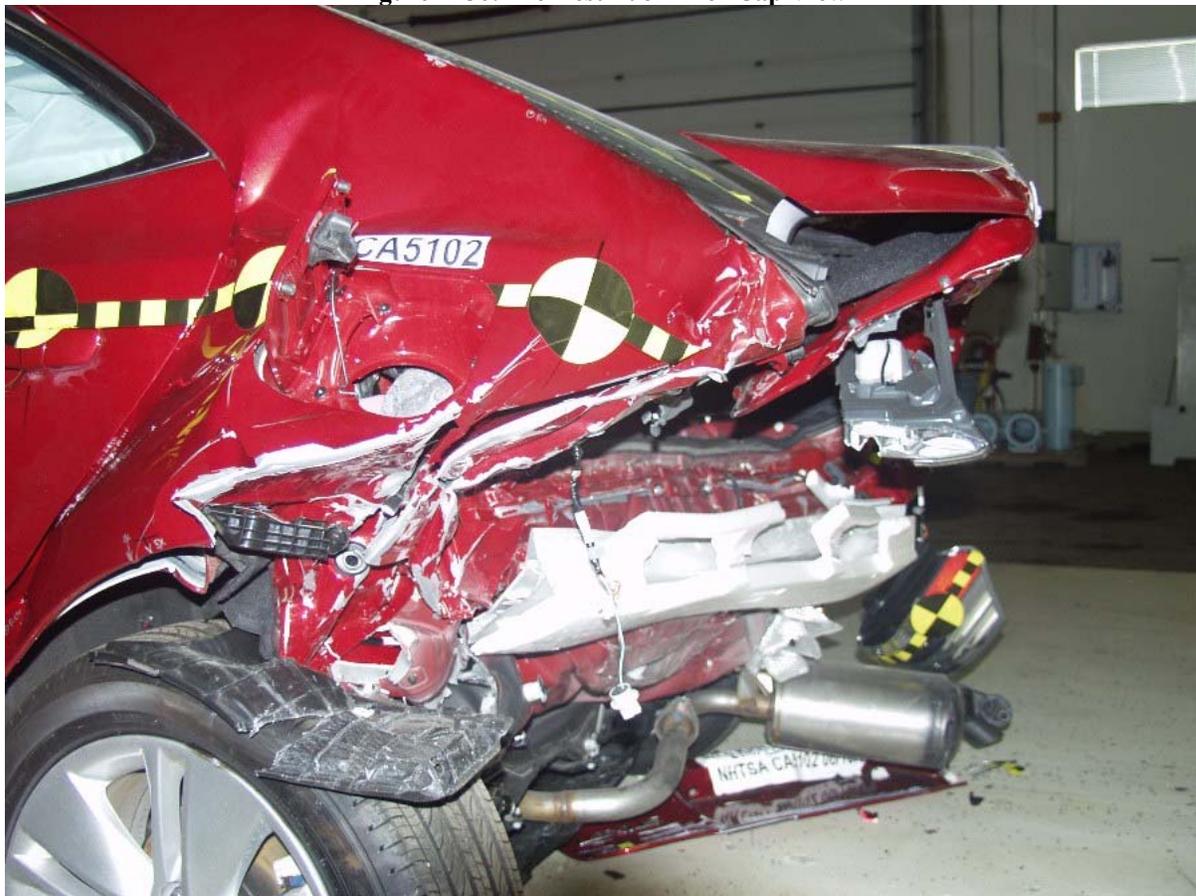
Figure A-57: Post-Test Fuel Filler Cap View

Rollover Stage	Spillage Location
0° - 90°	Stoddard appeared to leak from the fuel filler neck area that was pulled from the left rear fender area during the impact.
90° - 180°	Not collected – stage 1 exceeded
180°-270°	Not collected – stage 1 exceeded
270°-360°	Not collected – stage 1 exceeded
