Date	Number	Page
3/7/11	RVXX1006	1(3)

VNM, VNL, VHD, VT

RVXX1006, Inversion Valve, Fifth Wheel Air Release

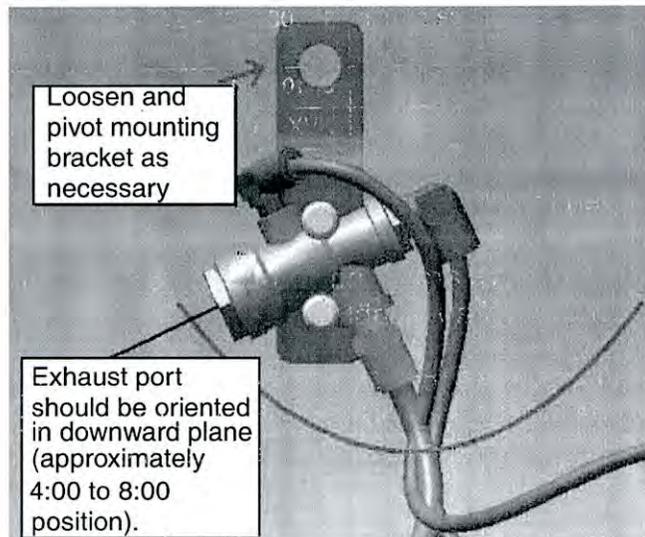
The inversion valve on the frame may be orientated where contaminants can enter the valve through the exhaust port. If this occurs, corrosion may occur, which can cause the valve to malfunction and in extreme cases possibly result in unintended opening of the fifth wheel's locking mechanism that holds the trailer's king pin.

Figure 1 — Position exhaust flapper in a downward plane.

1. Visually inspect the TR-3 inversion valve for proper orientation (i.e. 4-8 o'clock position). If the orientation results in the exhaust port being outside of the 4-8 o'clock position, replace the valve with Volvo part number **85102791** (see Figure 1). All valves must be purchased from a Volvo dealer. Make certain that the existing or replacement valve is installed inside the frame rail with the exhaust facing in a downward plane. It may be necessary to remove and reposition the mounting bracket to ensure the TR3 inversion valve exhaust is facing in a downward plane. Use a grade 8 bolt and lock nut of the proper length to secure mounting bracket to frame. Torque to 140 +/- 24 Nm (103 +/- 18 ft-lb).

Repositioning the valve may cause the airline(s) to be too short. If this occurs, then replace the airline(s) that are too short.
